MSP430F5529 Device Erratasheet

1 Functional Errata Revision History

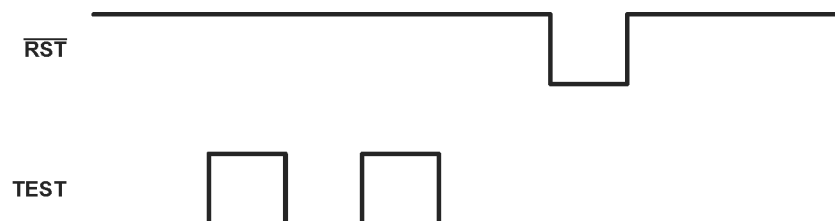
- Toggle the TEST pin twice when nRST is high and after 50us pull nRST low.

Note: This toggling of TEST pins is not subject to timing constraints. The appropriate level transitions on TEST pin, followed by a RST pulse after 50us, are sufficient to trigger an exit from BSL mode.

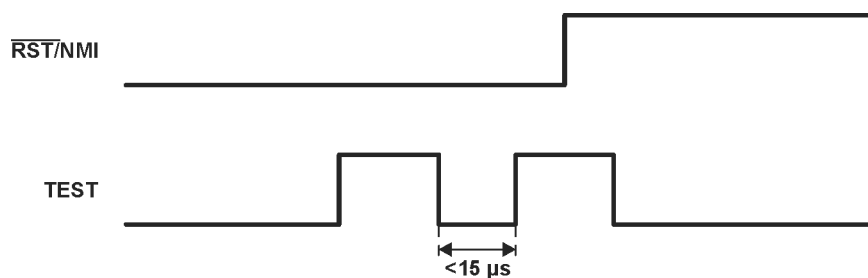
Category	Functional
Function	BSL entry sequence is subject to specific timing requirements
Description	The BSL entry sequence requires that the low phase of the TEST/SBWTCK pin does not exceed 15us. This timing requirement is faster than most PC serial ports can provide, as shown in the following picture. If this requirement is not met, the entry sequence fails and the SYSBSLIND is not set.

Workaround	An external hardware solution is recommended to provide the appropriate BSL entry sequence. See http://processors.wiki.ti.com/index.php/BSL_(MSP430) for recommendations on available BSL hardware.
-------------------	--
