Applicability

This document applies to the part numbers of STM32L476xx and STM32L486xx devices listed in [Table 1](#) and their variants shown in [Table 2](#).

[Section 1](#) gives a summary and [Section 2](#) a description of workarounds for device limitations, with respect to the device datasheet and reference manual RM0351.

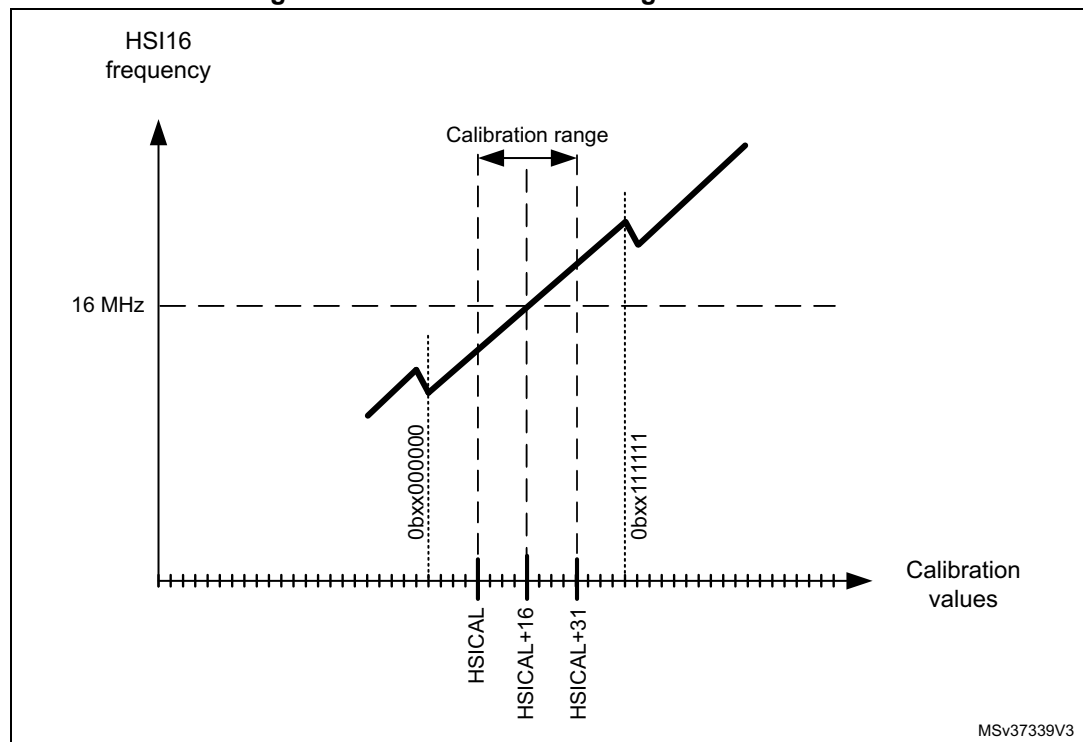
Figure 1. HSI oscillator trimming characteristics

Consequently, the user trim correction must not jump over the codes multiple of 64, which can limit the user correction either in positive or in negative direction.

Workaround

None.

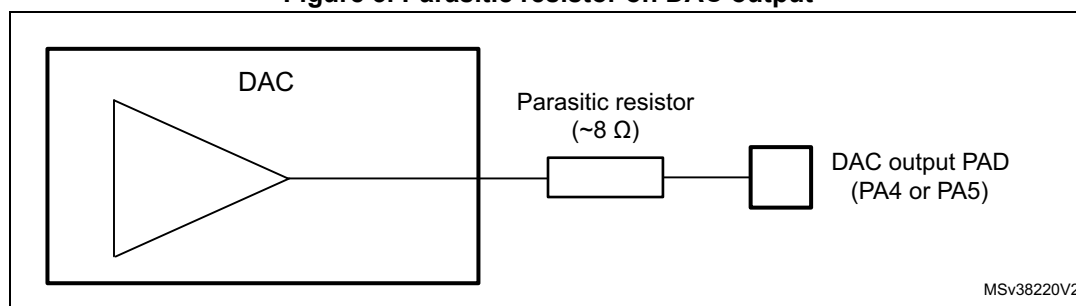
Figure 3. Parasitic resistor on DAC output

Resistor value between DAC outputs and I/O (PA4 or PA5) is greater than expected: 8 Ω typical, as shown in [Figure 3](#). As a consequence, the DAC characteristics can be impacted depending on the current sunk on DAC output.

Workaround

None.

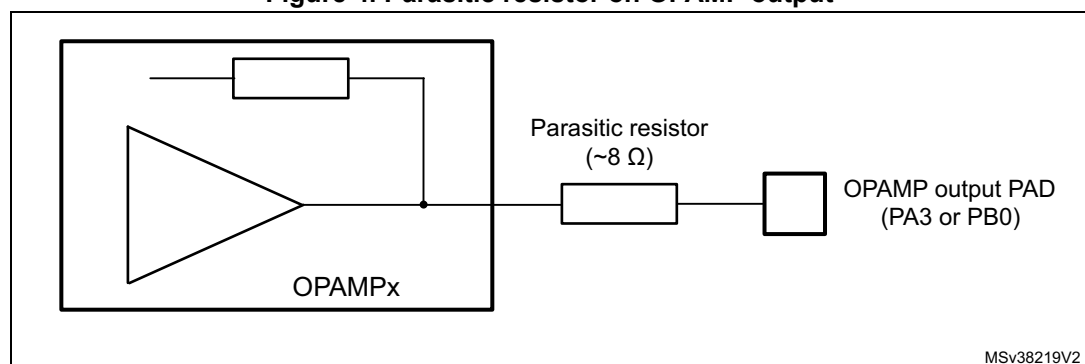
Figure 4. Parasitic resistor on OPAMP output

Resistor value between OPAMP outputs and I/O (PA3 or PB0) is greater than expected: 8 Ω typical, as shown in [Figure 4](#). As a consequence the OPAMP characteristics can be impacted depending on the current sunk on the output.

Workaround

None.

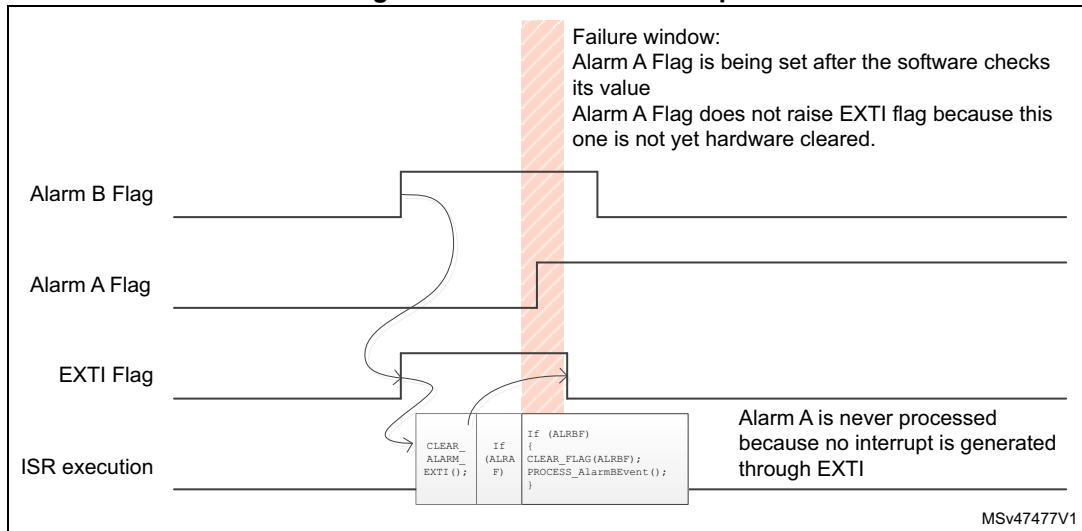
Figure 5. Masked RTC interrupt

The following code example and figure illustrate the failure mechanism: The Alarm A event is lost (fails to generate interrupt) as it occurs in the failure window, that is, after checking the Alarm A event flag but before the effective clear of the EXTI interrupt flag by hardware. The effective clear of the EXTI interrupt flag is delayed with respect to the software instruction to clear it.

Workaround

In the interrupt service routine, apply three consecutive event flag checks - source one, source two, and source one again, as in the following code example:
