Ref: Maclay Bridge Alliance consultant letter on problems at Maclay Bridge

## **Attachment A: Response to Sylte Comments**

## **Attachment B: Summary of Maclay Bridge Washouts and Rebuilding and Future Flood Potential**

### **Attachment C: Missoula Area Bridge Sites**

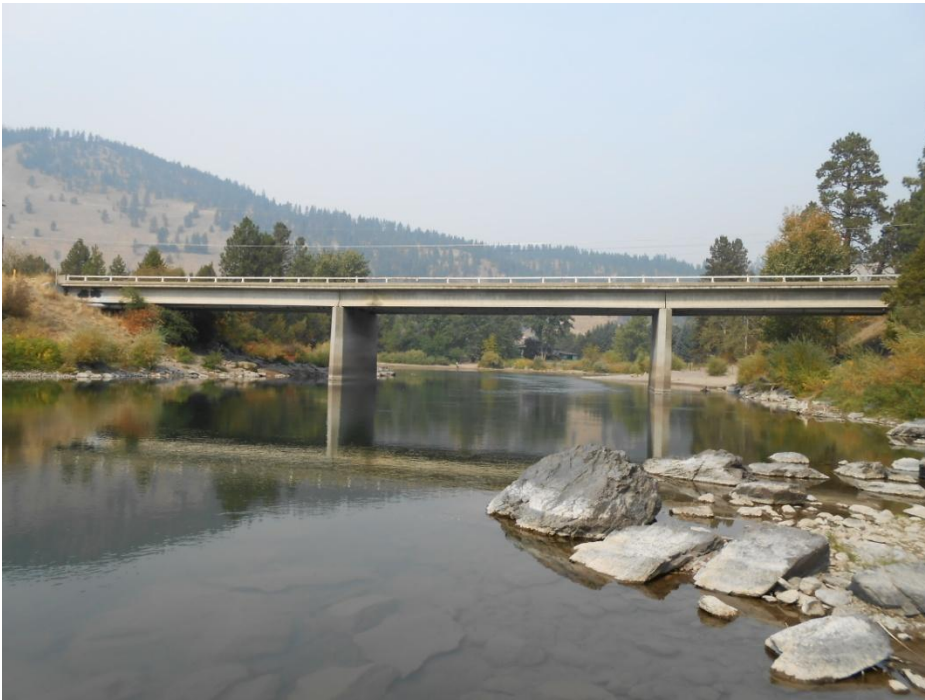
East Missoula Bridge on the Clark Fork looking upstream. Notice the well designed piers and lack of abutments that constrict the flow. The point bar upstream of the bridge on the right is the recreational draw in the area.

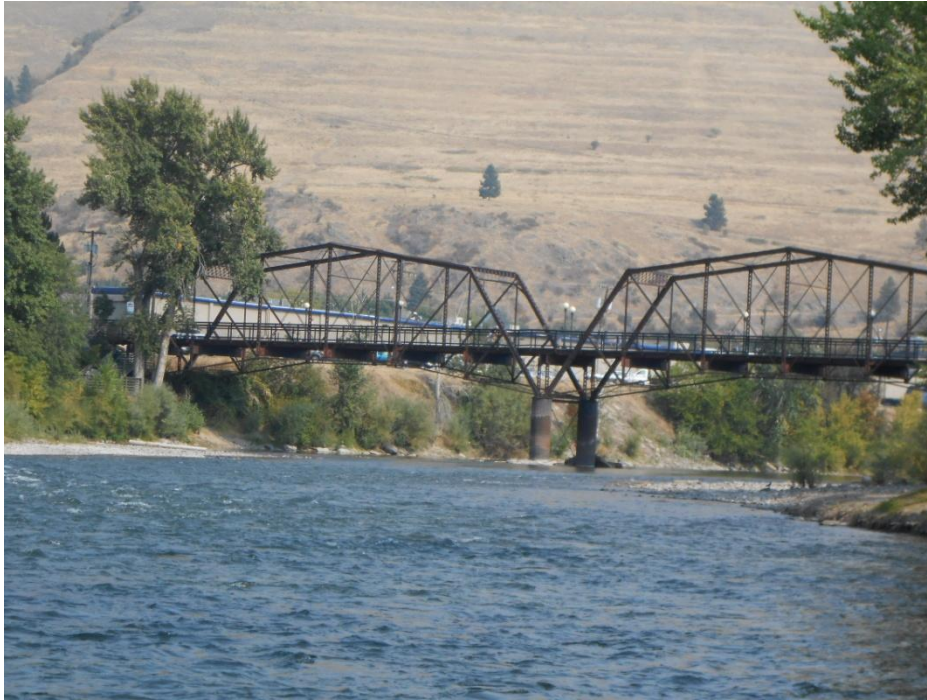
University pedestrian bridge on the Clark Fork looking upstream. Notice the few piers, lack of scour and sandbars, and little evidence of recreation use.

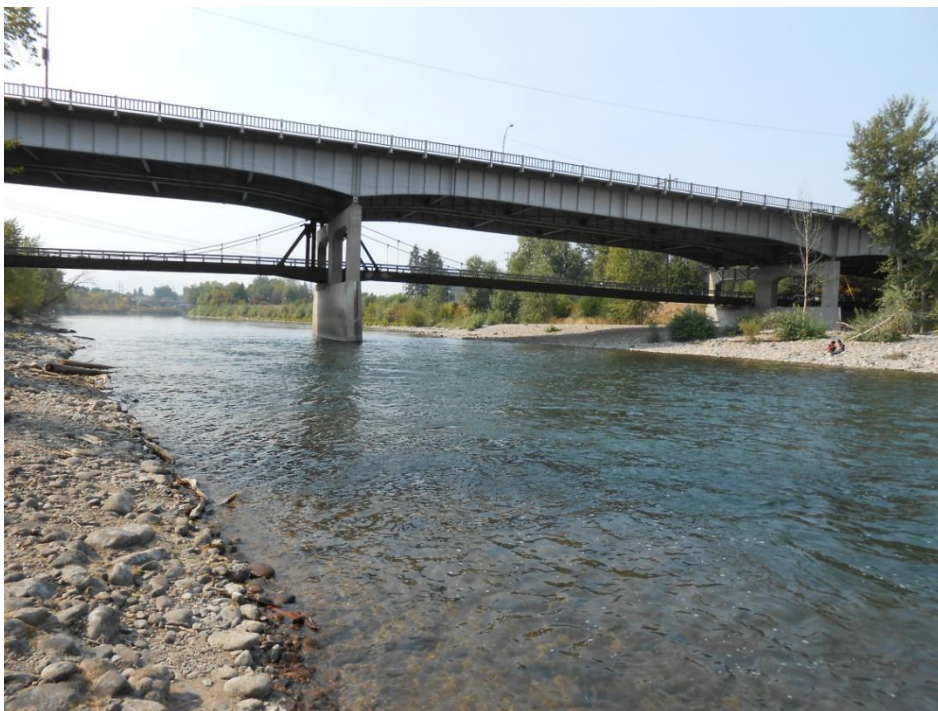
Madison Street Bridge on the Clark Fork looking downstream. The gravel bar on right is partly due to the delta from Rattlesnake Creek which enters the Clark Fork just upstream. Notice the well designed pier and lack of channel constriction.

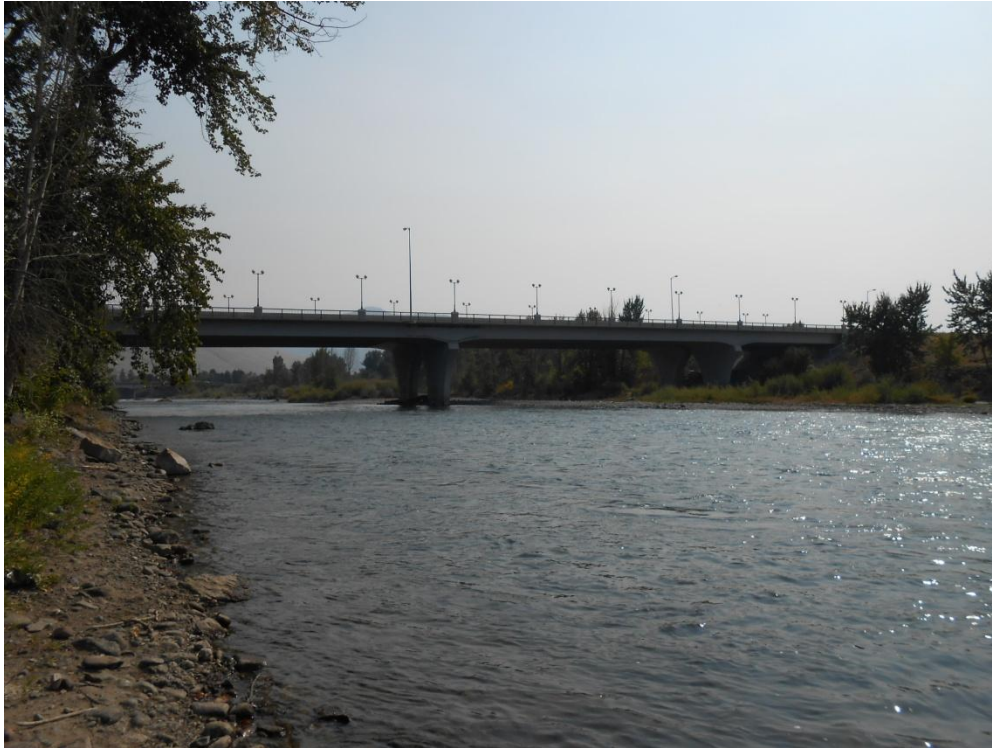
Orange Street Bridge on the Clark Fork looking upstream. Again the piers and abutments do not constrict the flow and thus little scour or sand bar development is evident. There is little evidence of recreation use.

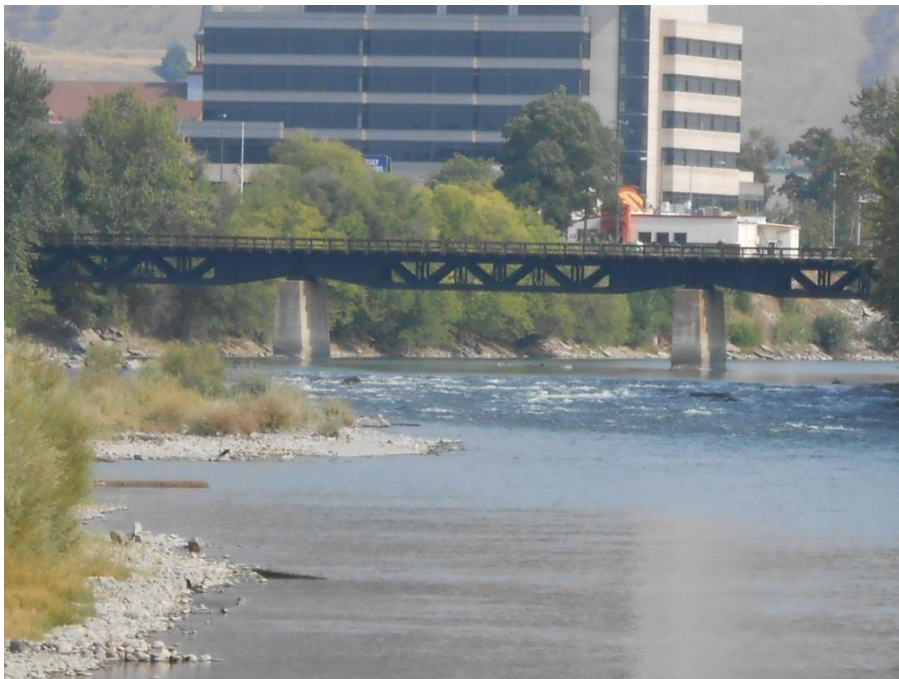
Missoula railroad bridge on the Clark Fork looking upstream. The piers are blocky and not streamlined but do not appear to be significantly constricting the flow. No evidence of recreation use.

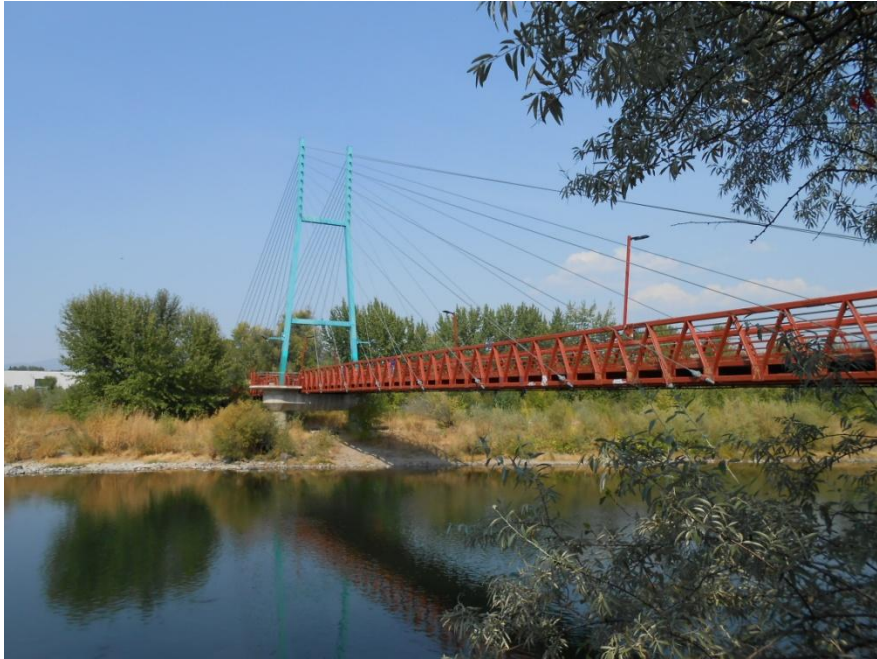
California Street pedestrian bridge on the Clark Fork, a suspension bridge with one pier located on a pre-existing island. Again the abutments and piers do not constrict the river flow.

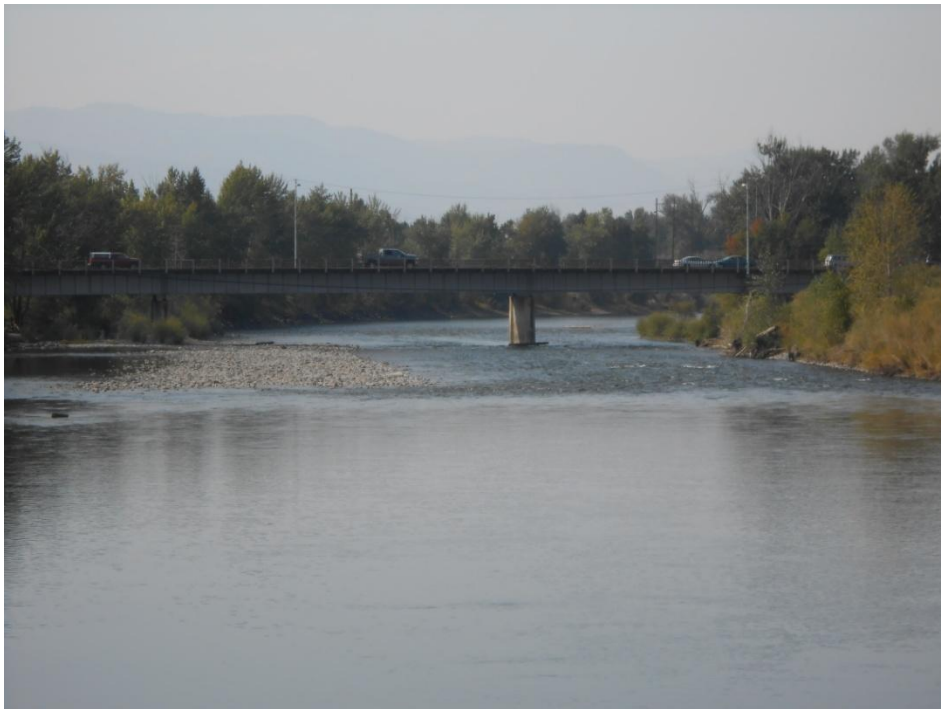
Russell Street Bridge on the Clark Fork from upstream. Again there is minimal pier and abutment constriction of the channel and little evidence of recreation use.

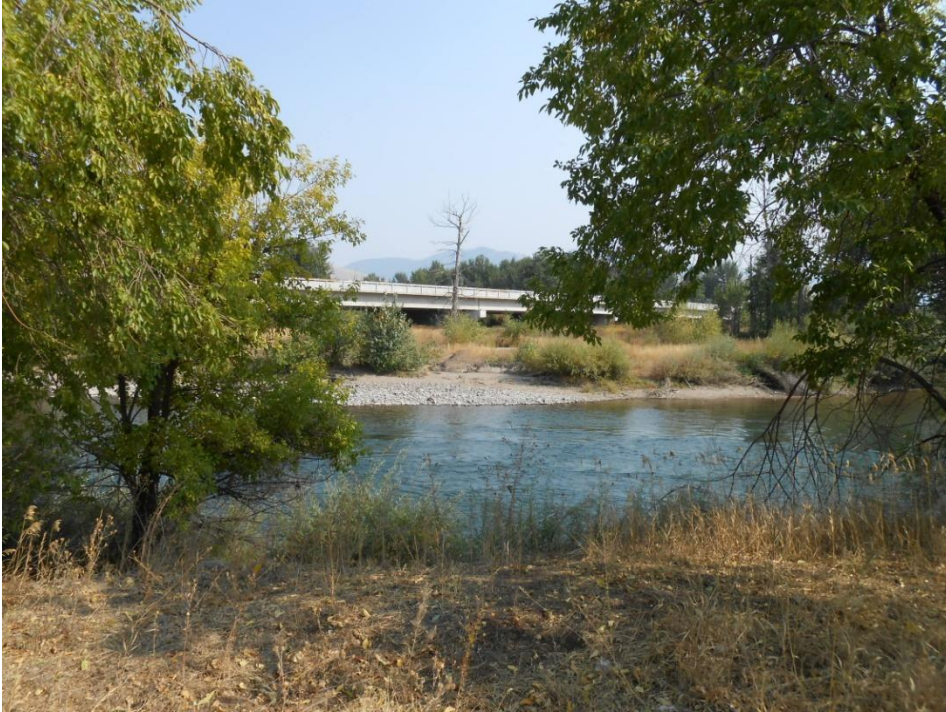
Reserve Street Bridge on the Clark Fork looking upstream. Again there are minimal piers and abutments constricting the flow and no evidence of scour or sand bar creation due to these structures.

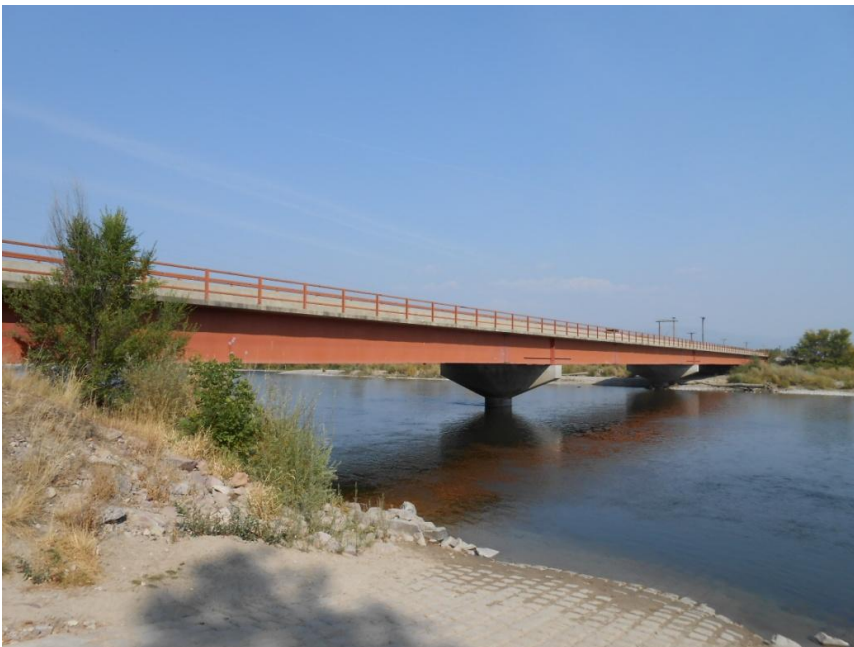
Kona Ranch Bridge on the Clark Fork looking downstream. Again it shows well designed abutments and piers with minimal river constriction, scour, or sand bar development. The only recreation use is at the river access point nearby, constructed by the MTFWP.

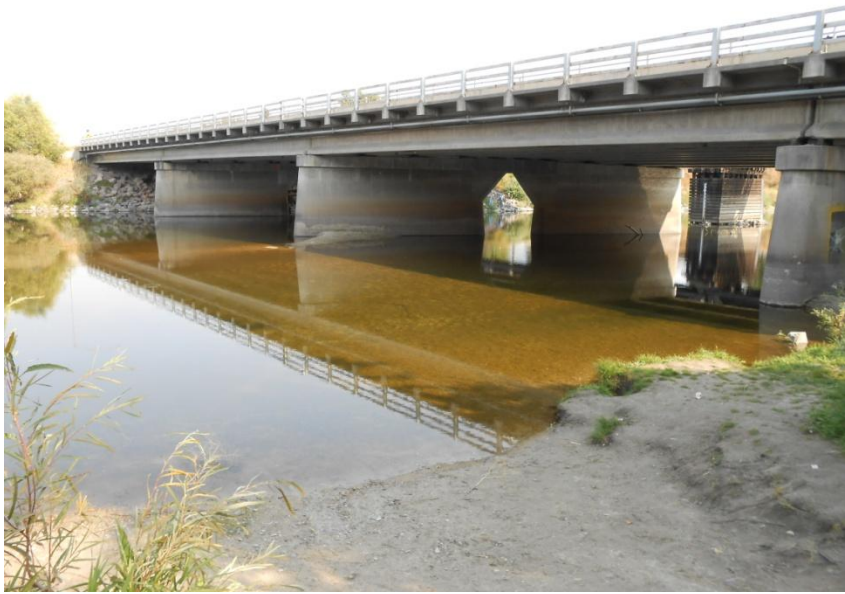
Buckhouse Bridge on the Bitterroot River looking upstream, with a timber-cribbed pier of the old railroad bridge parallel to Buckhouse just visible to the right. There are 3 piers at Buckhouse but they are stream lined and widely spaced and do not appear to be creating a major swimming hole or sandbars.

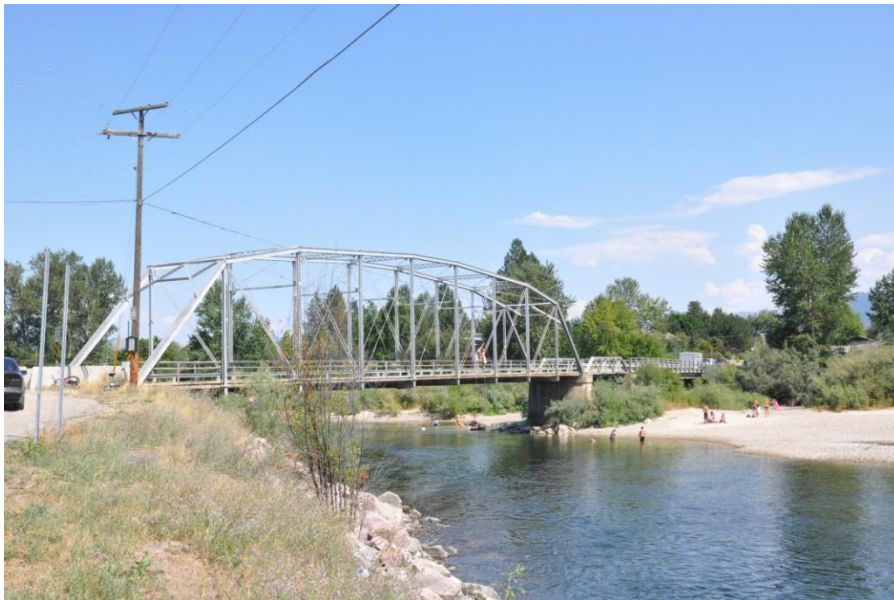
Maclay Bridge on the Bitterroot River looking downstream. The bridge consists of 4 sections with 3 piers close together in the east channel. The west abutment on the left is a prominence that was constructed into the channel, creating a constriction between it and the 3 large cement piers in the east side of the channel where the sand bars and island have developed. The scour hole extends under the truss bridge section where the diver is preparing to jump.

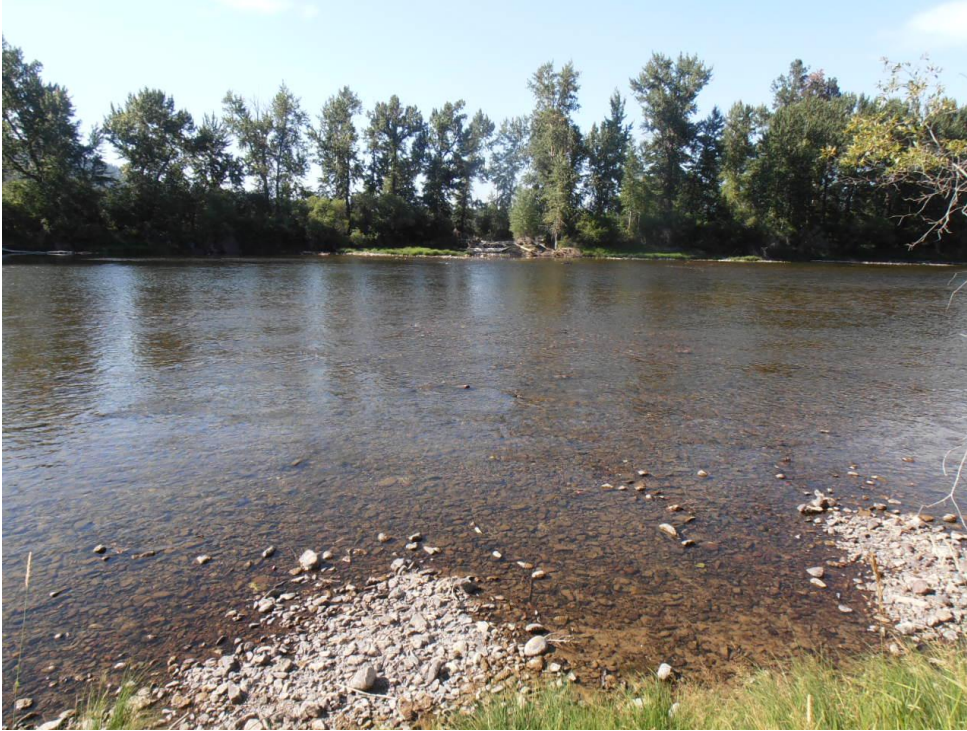
A view to the west of the Bitterroot River in the vicinity of the proposed West South Avenue bridge crossing. The Bitterroot River is straight and relatively shallow here, with no sand or gravel bar development.
