15 July, 2012

Dear County Commissioners,

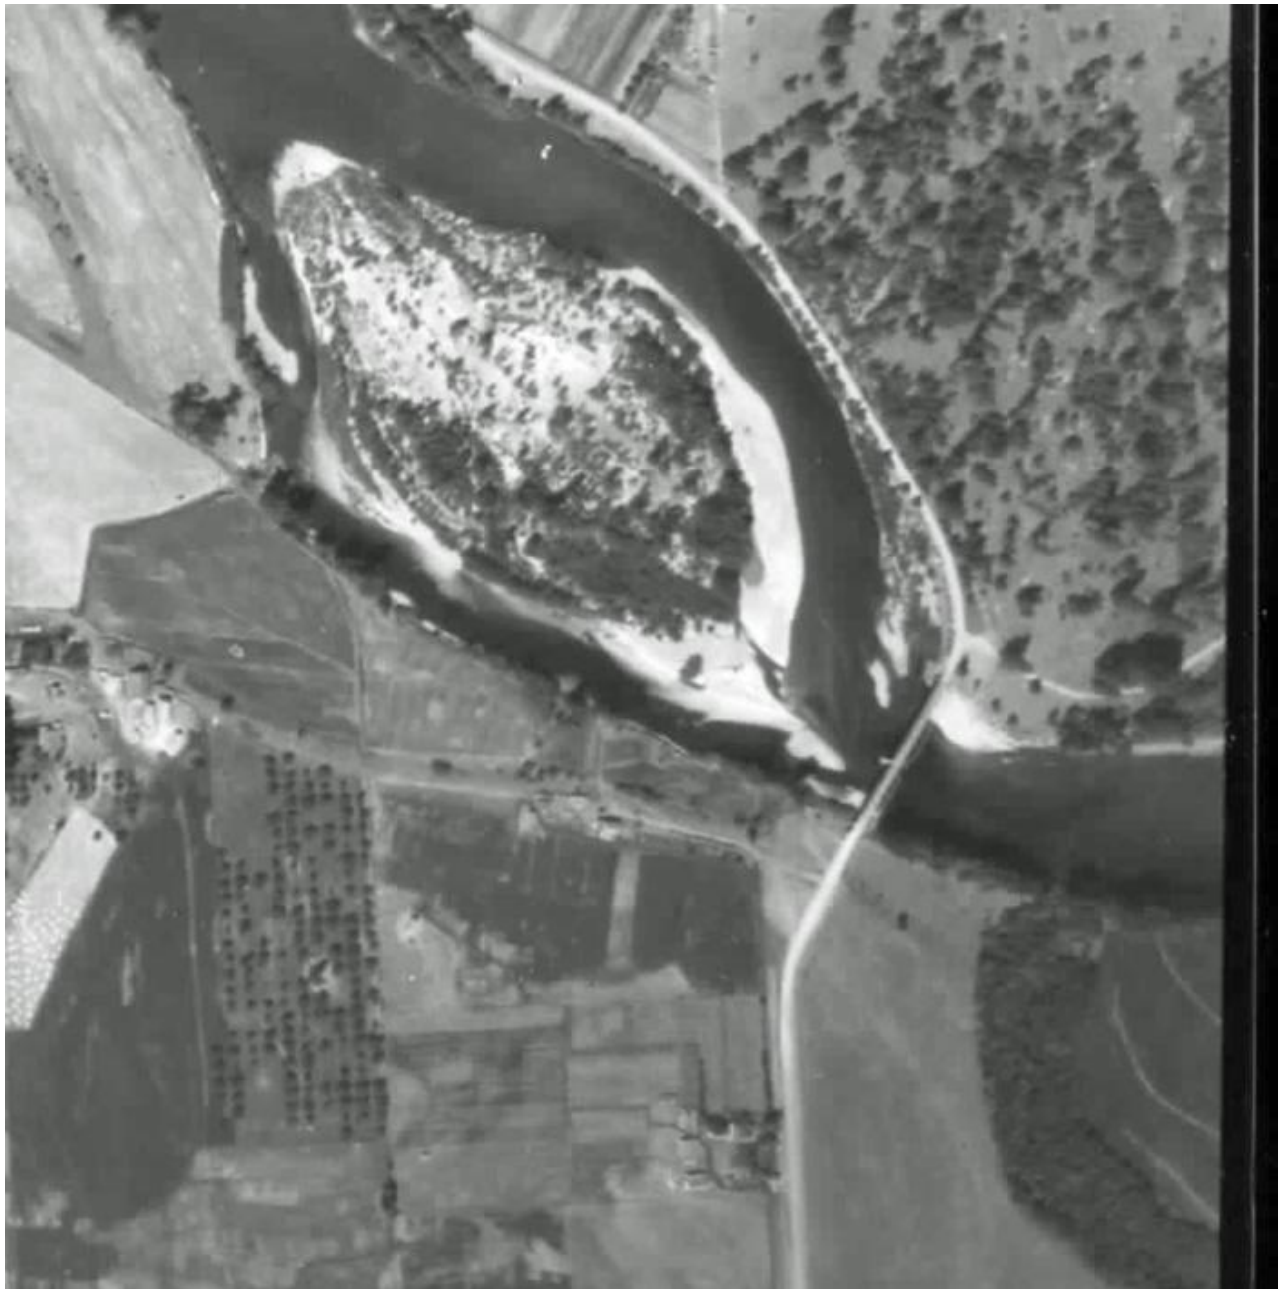
1935 air photo Maclay Bridge (north to right of photo)

The bridge is located on the upstream end of a broad meander in the Bitterroot River, where the river bends to the northwest, with the inside of the bend concave to the west. Typically, when a river "turns a corner" like this, the water slows down on the inside of the corner, has less energy, drops any sediment it is carrying, builds sand and gravel bars, and adds to the river bank. Thus the water should always be shallower and banks should grow on the inside of a river bend. This was clearly occurring at the west bridge abutment in 1935 when the air photo was taken, but is not happening now.

If you compare the 1935 photo to the 2011 photo, you can see just downstream of the west bridge abutment over time there has been significant erosion and loss of bank material for at least 100 to 200 feet. If you visit the site, especially during high flow periods, you can see the bank erosion appears to be related to a large whirlpool that developed under the main bridge span. The whirlpool also has created a deeply-scoured hole in the channel just under and downstream of the bridge.

Due to the fact that these channel changes appear in the photos after the present bridge was installed, it is my opinion the current bridge, with its piers and abutments and west end approach, likely caused or contributed to these unusual changes in the river channel. This is probably due to the fact the west

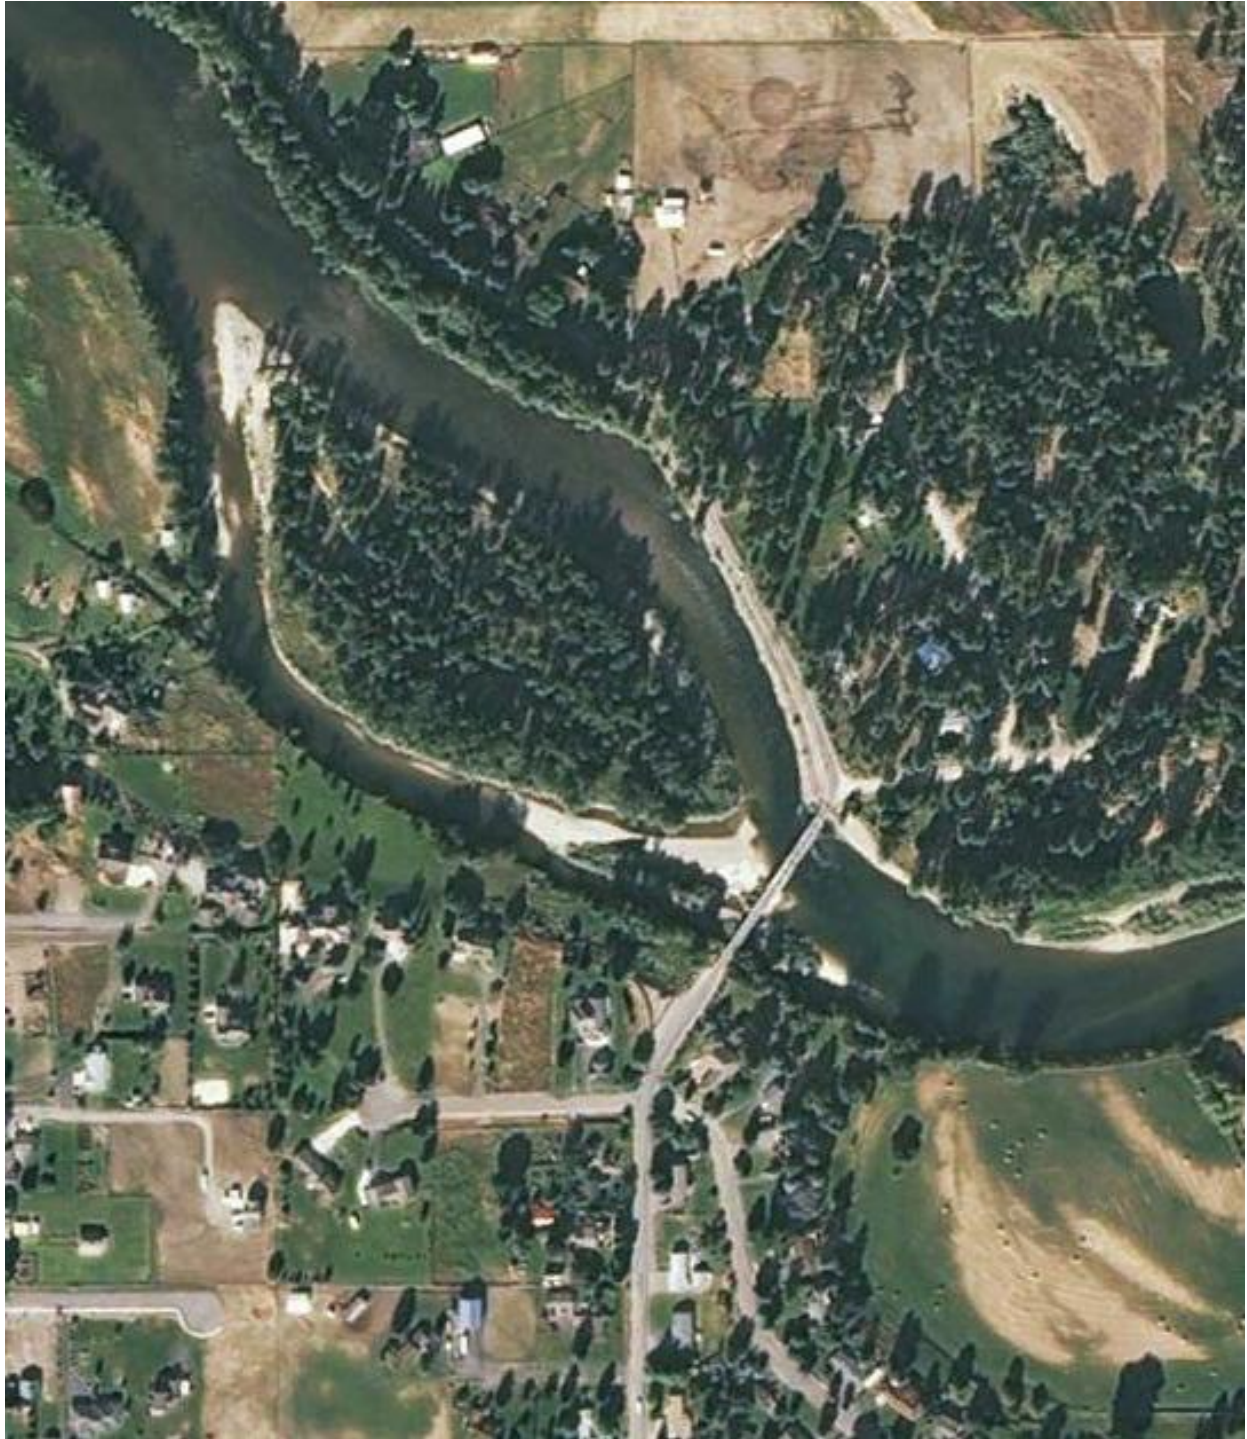
2011 air photo of Maclay Bridge (north to right of photo)

The bridge's constriction of the river has somewhat slowed the water flow upstream of the bridge and may be causing the river to drop sediment there, adding to the sand bars and growth of the large island's north end. Again, a comparison of the 1935 and 2011 photos shows over time since the bridge was installed, the island and sandbars have grown from just upstream of the bridge in 1935, to at present where they extend under the bridge and downstream of it, particularly on the east side of the channel. In 1935, the center pier of the bridge was in the center of the river channel. At present, it is no longer in mid-river, rather now it is mostly surrounded by a long semi-permanent sand bar. The west main channel of the river appears to have been reduced in curvature (ie straightened) by River Pines Rd., which may be directing the river flow like a levee.

In summary, the present bridge since it was installed likely has had significant effects on the Bitterroot River channel and its environment. It was clearly never designed for its present site, and by all accounts, was a used bridge brought in from elsewhere. The bridge probably has caused and is causing loss of private property on the west side and may have expanded beaches and sand bars on the east side. It may have created the large deep scour hole that together with the sand bars invite bridge jumping, swimming, and recreation use, along with all of their public health, safety, and other problems. It should be noted the scouring action could also be undercutting and destabilizing the center bridge pier and west abutment.

These environmental and engineering concerns are significant. They should be studied further and included in the current analysis to assess the drawbacks of any bridge construction or rehabilitation at the present site. Please consider them in reaching your decision on the future of the current bridge. If you would like to obtain copies of the original photos I have referenced or need other information, please contact me.
