Target Range School Board
Target Range School
4095 South Avenue West
Missoula, MT 59804

September 13, 2012

I know your first concern is the welfare and safety of Target Range School children on the school grounds as well as on their way to and from school. Thus I hope you are following the discussion and reports that are resulting from the Maclay Bridge Planning Study being conducted by the Montana Department of Transportation and Missoula County. There is a statement that should be of considerable concern to the School Board, as well as to the students' parents, in the Maclay Bridge Planning Study's Existing and Projected Conditions Report, p. 26:

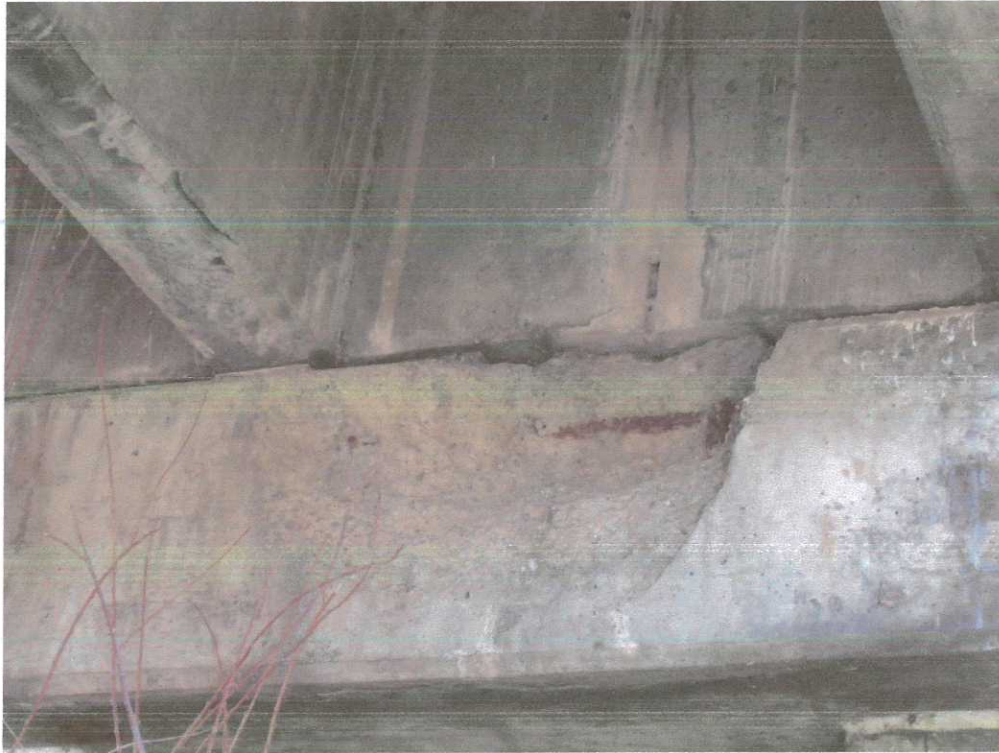
Spalled concrete and exposed rusted rebar in a Maclay Bridge support beam

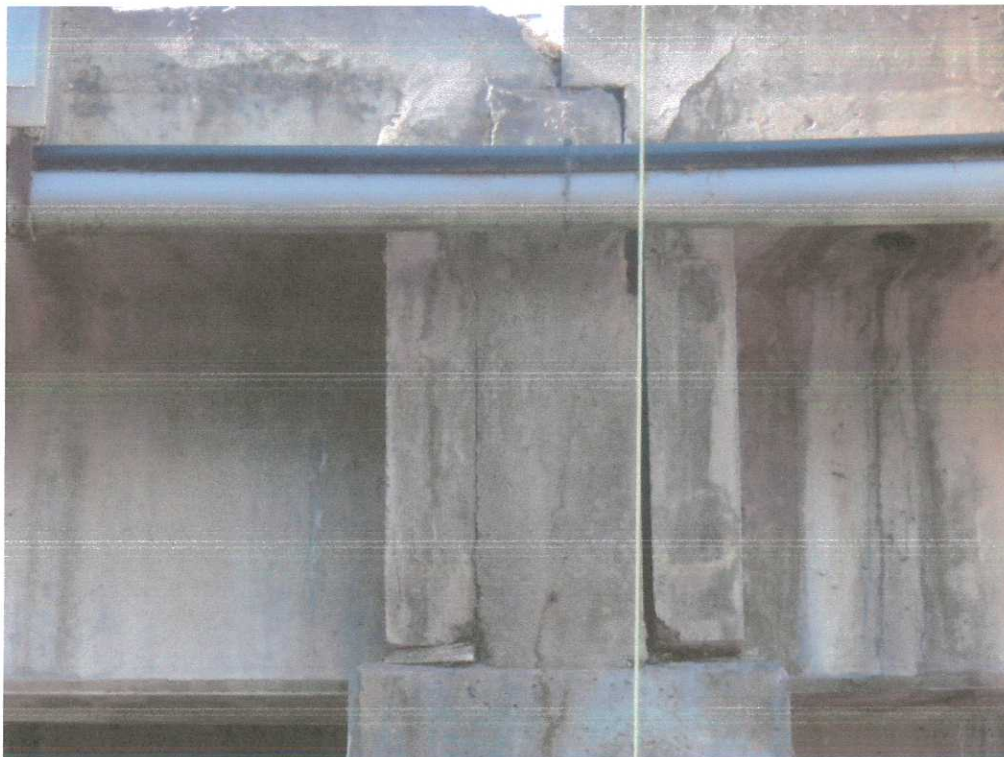
Broken & corroded concrete, exposed rusted rebar, and misaligned joint in bridge support beams

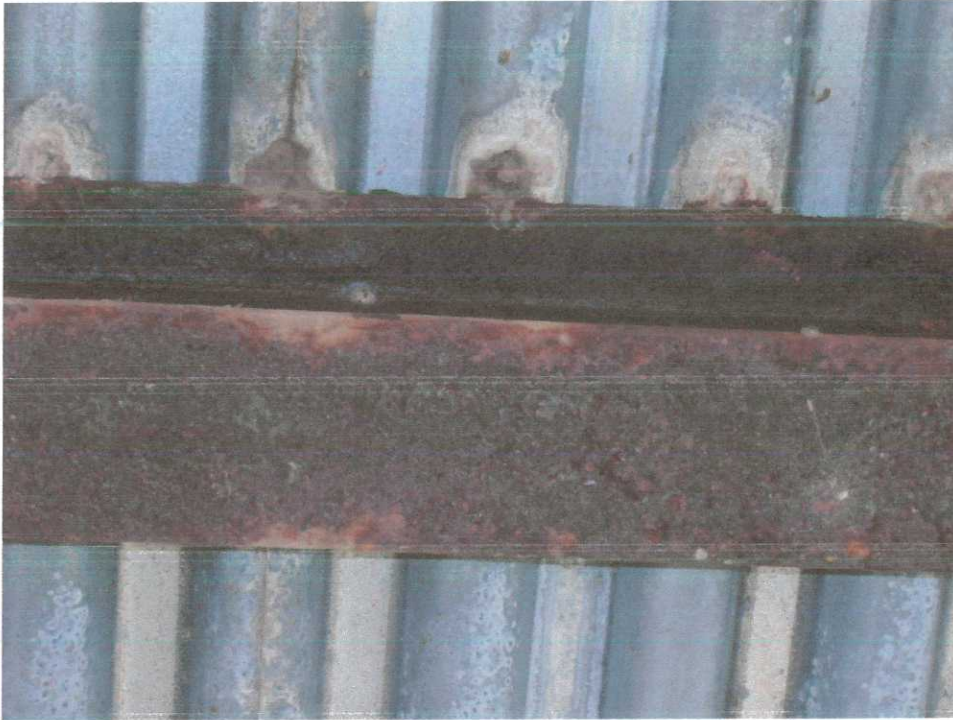
Rusted and pitted steel support beam under the bridge west span with corroded decking bolts

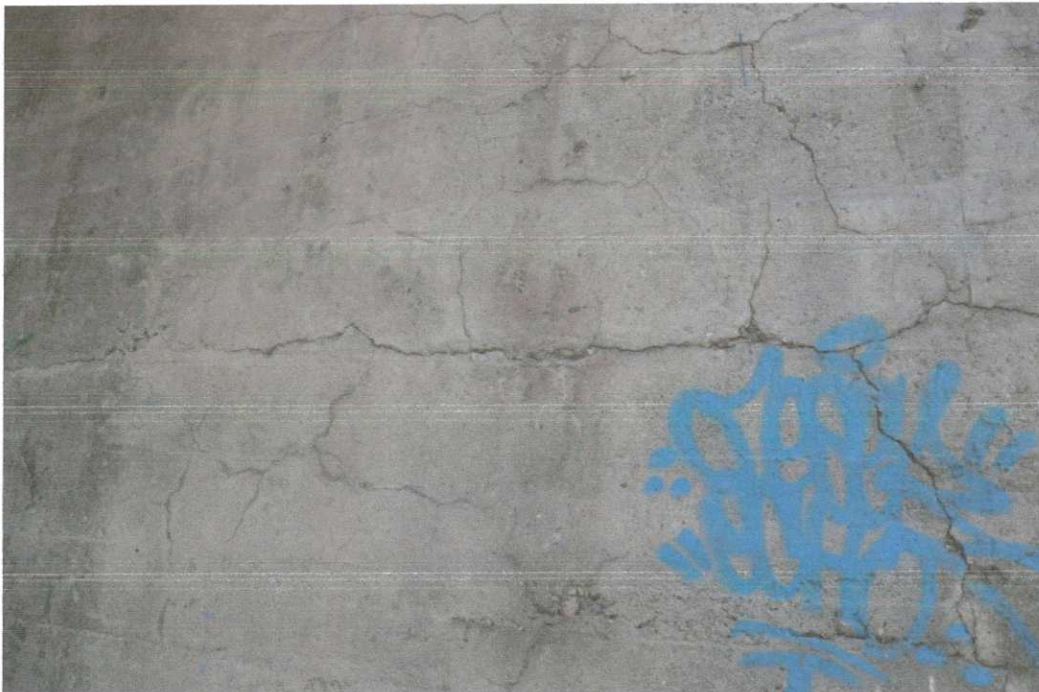
Cracked and corroded concrete in a main bridge support pier

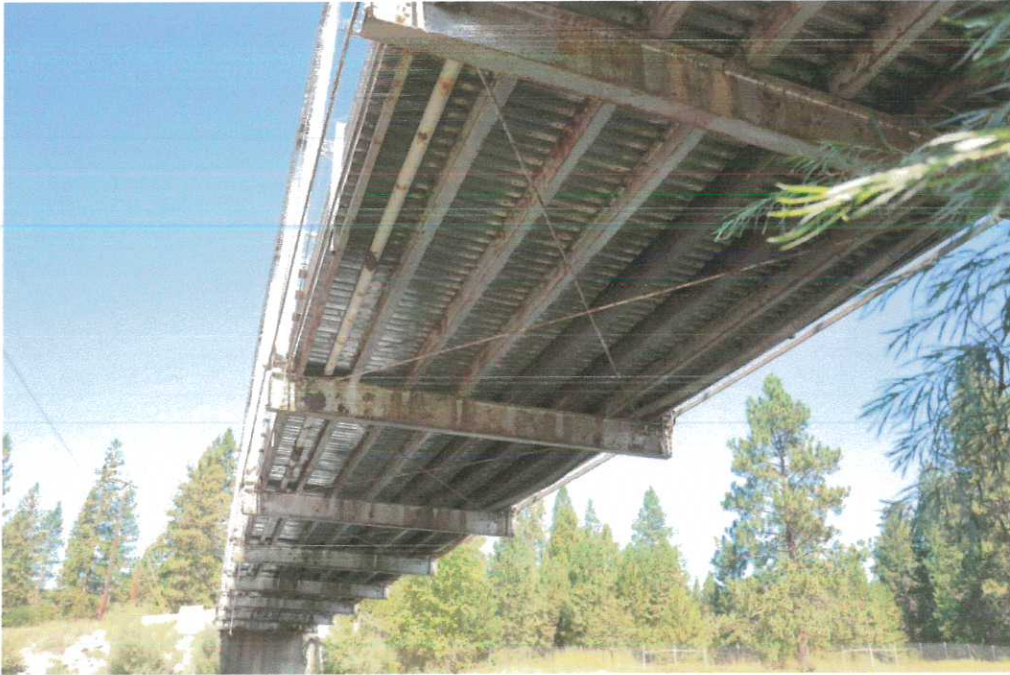
Rusted and deteriorated west bridge span with various patches to the bridge support beams

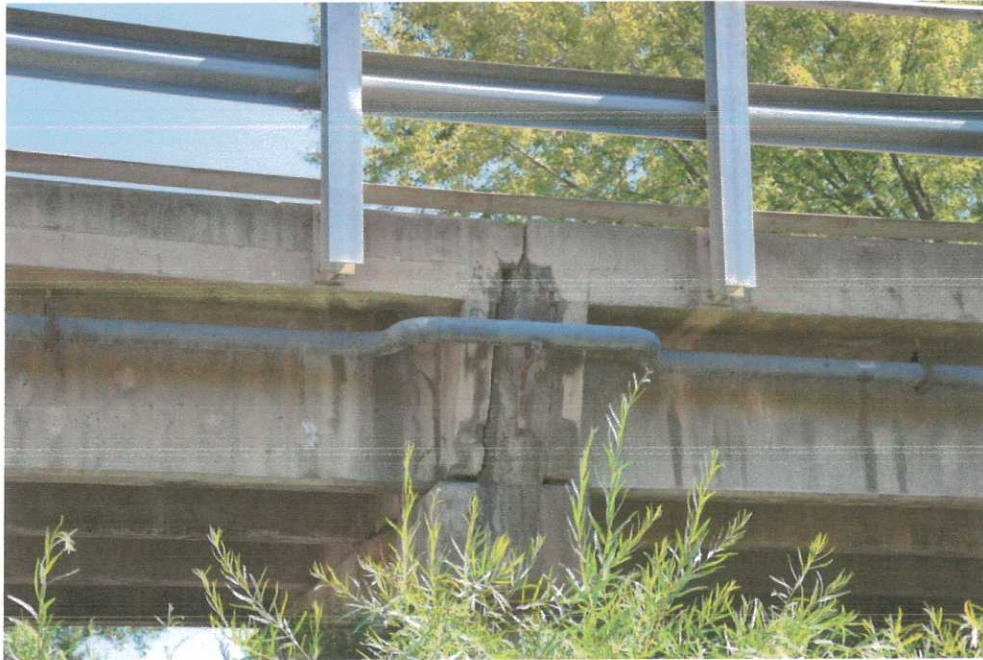
Unshielded and exposed high pressure natural gas line on the bridge where it crosses a deteriorated support joint.
