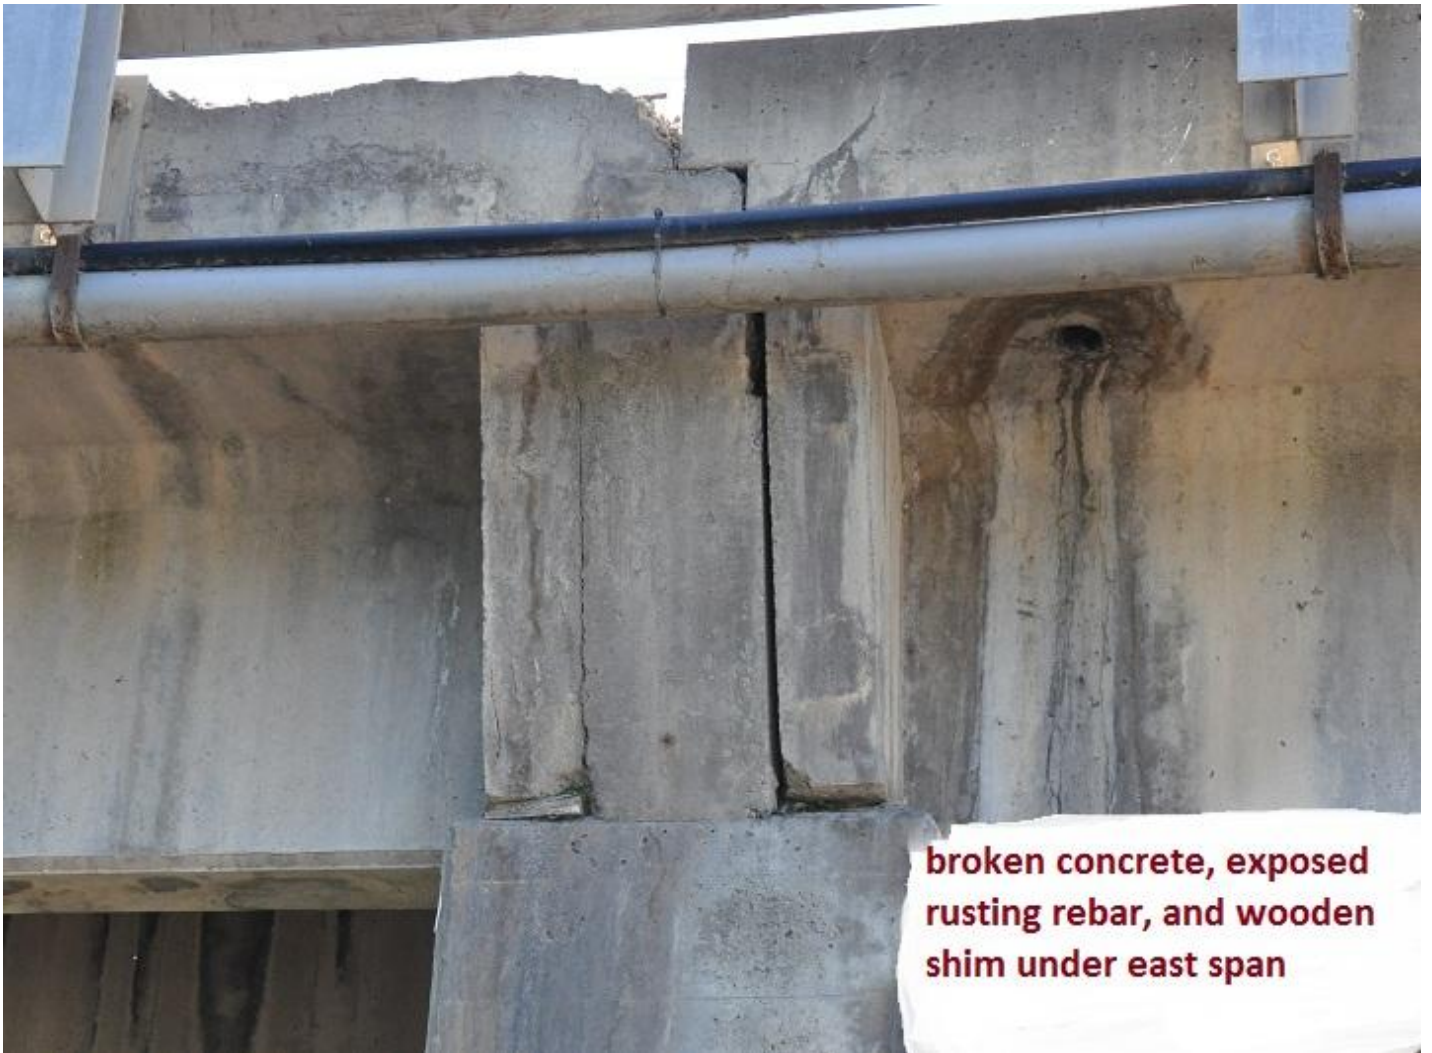
Photo 4

**broken concrete, exposed  
rusting rebar, and wooden  
shim under east span**

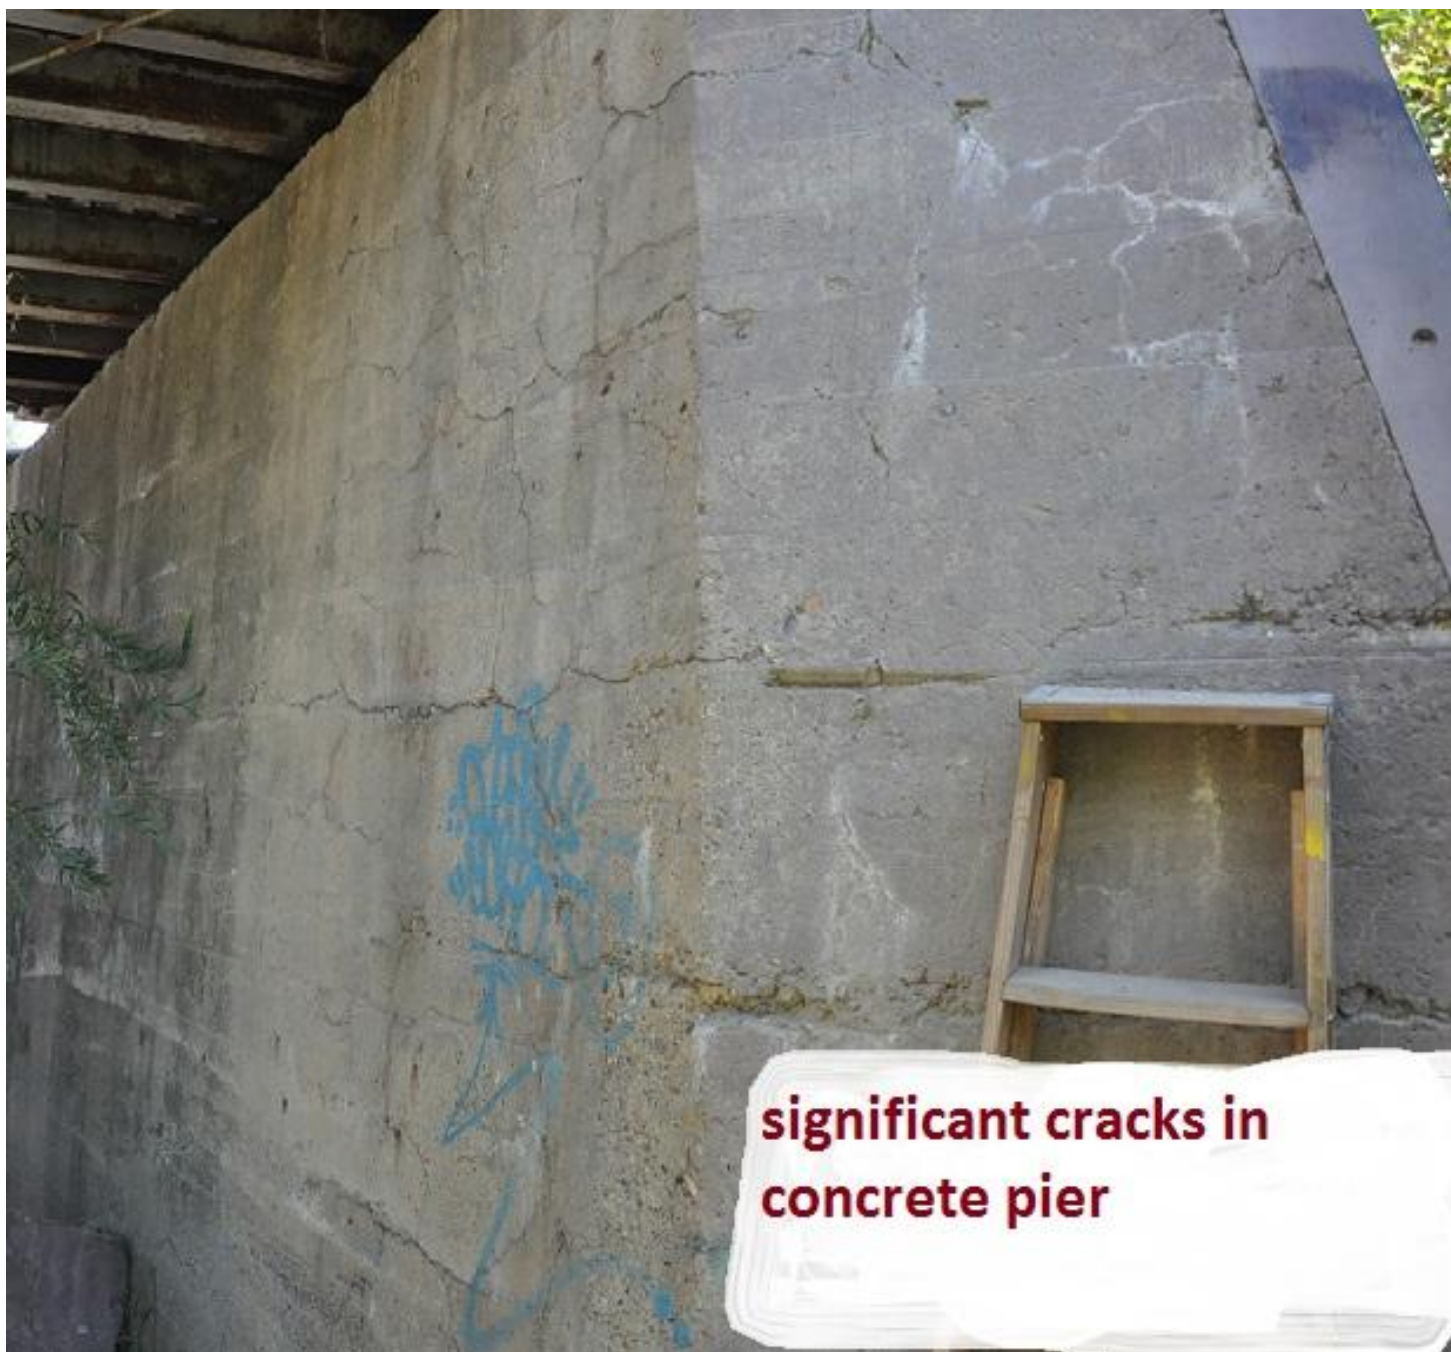
Photo 6

**significant cracks in  
concrete pier**

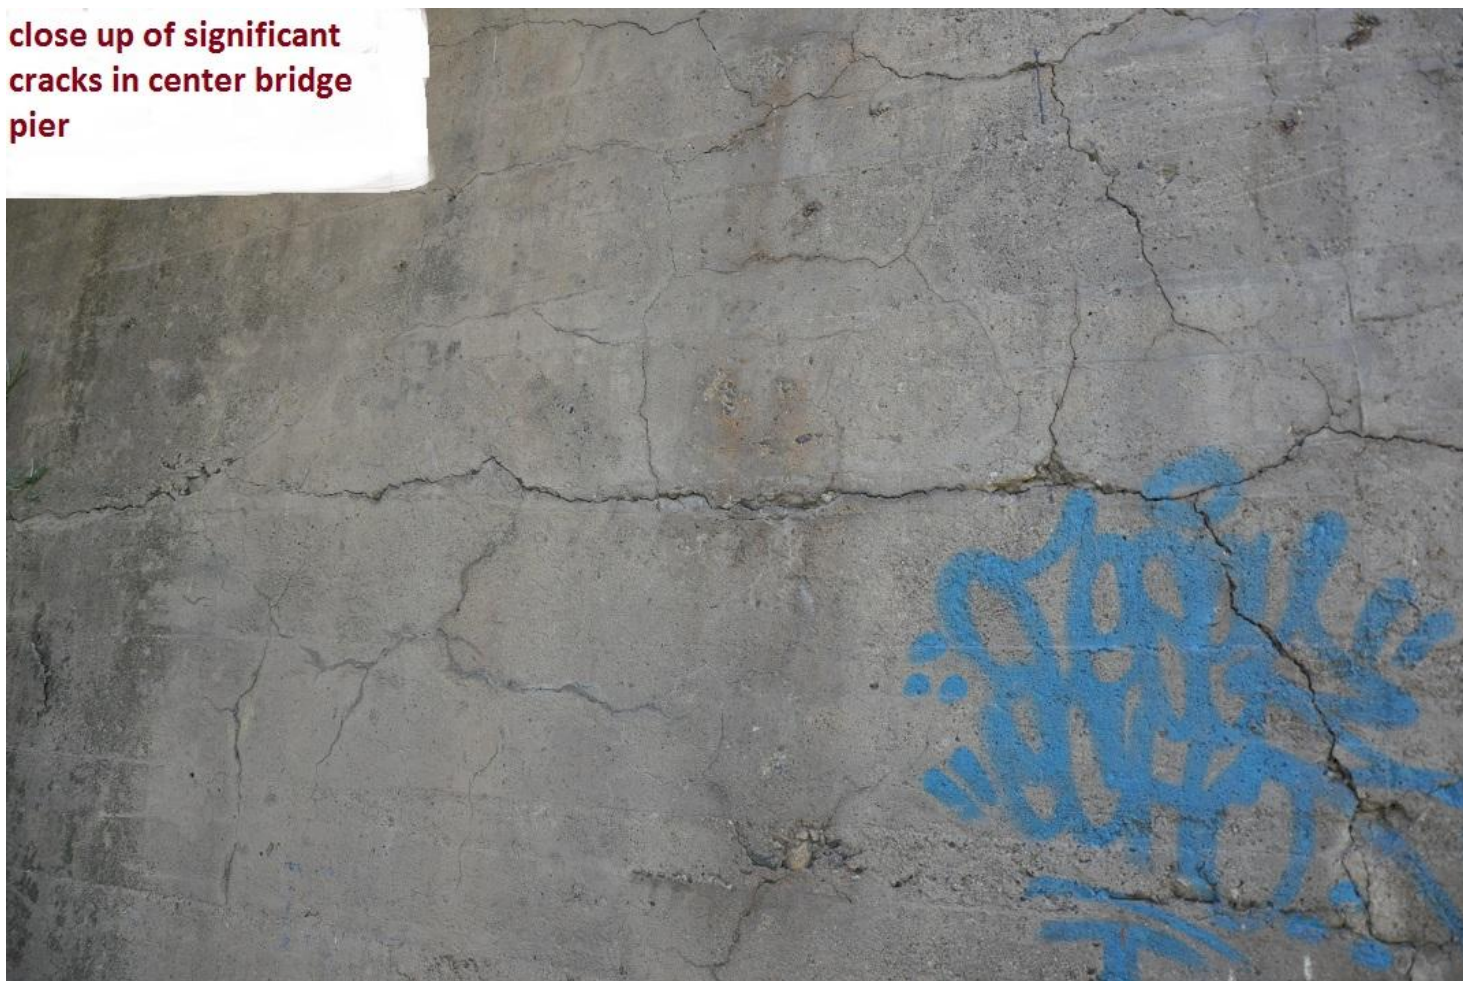
Photo 7

close up of significant  
cracks in center bridge  
pier

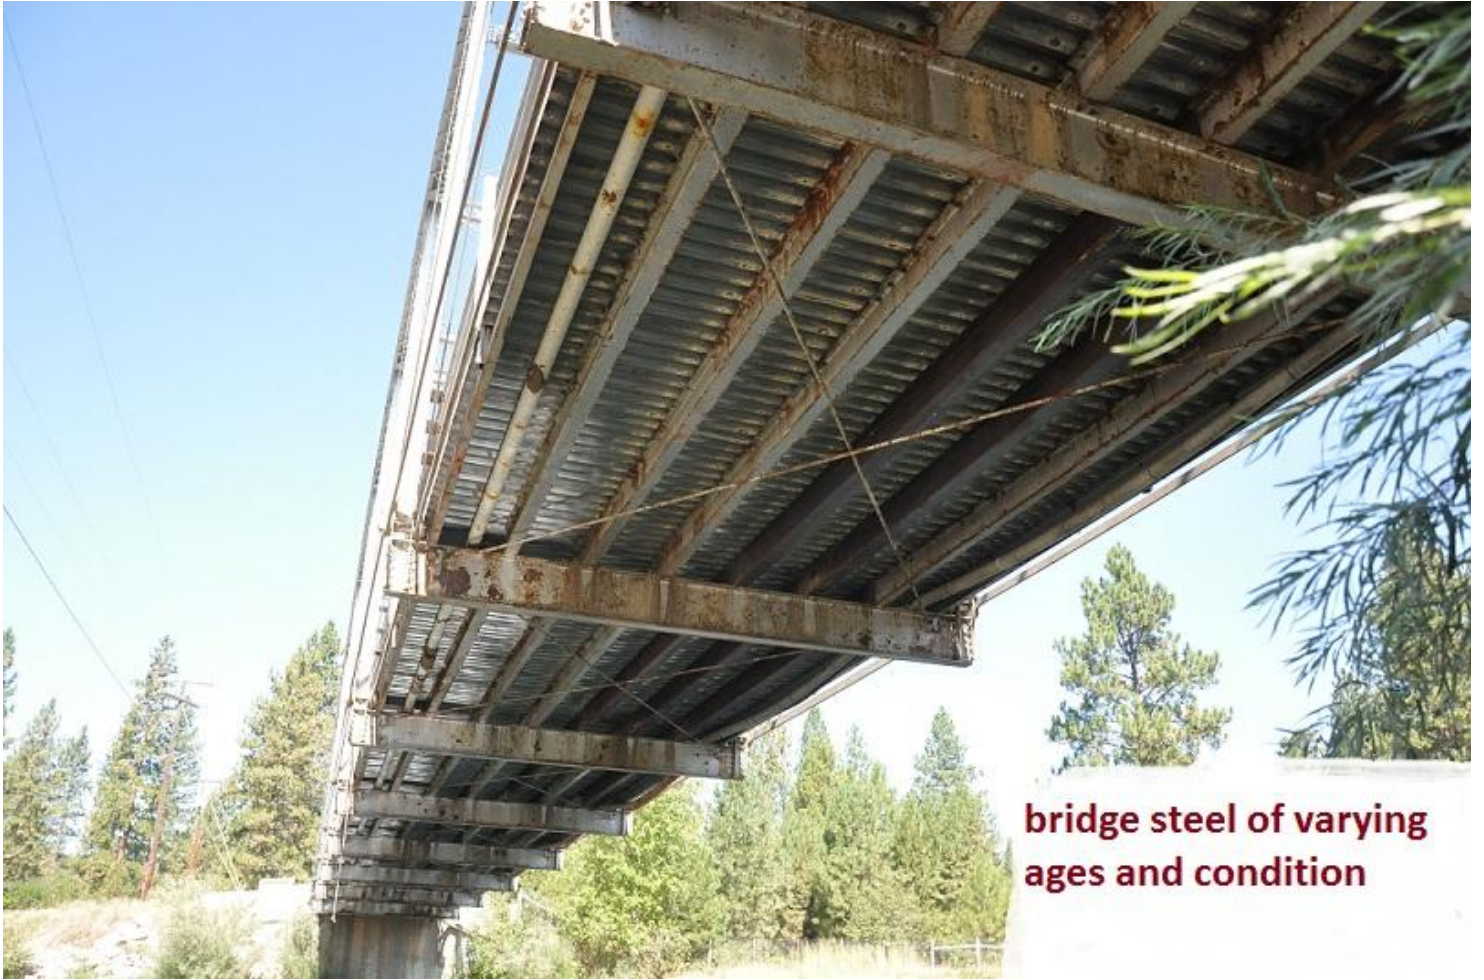
Photo 9

**bridge steel of varying  
ages and condition**
