Majestic Service Company

Multi Line Inspection

Narrative

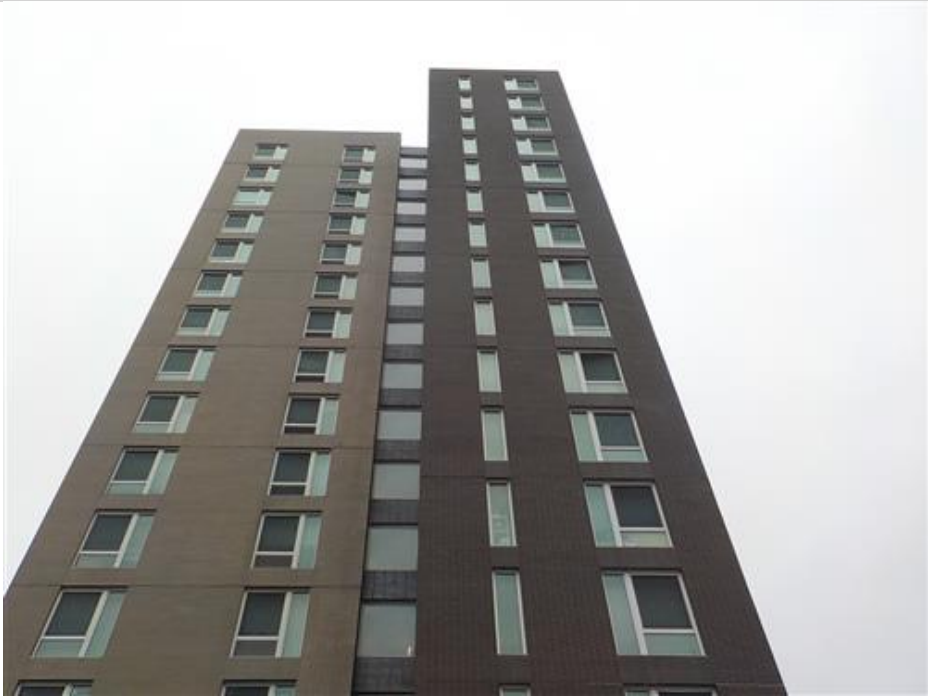
Photograph 1

Front

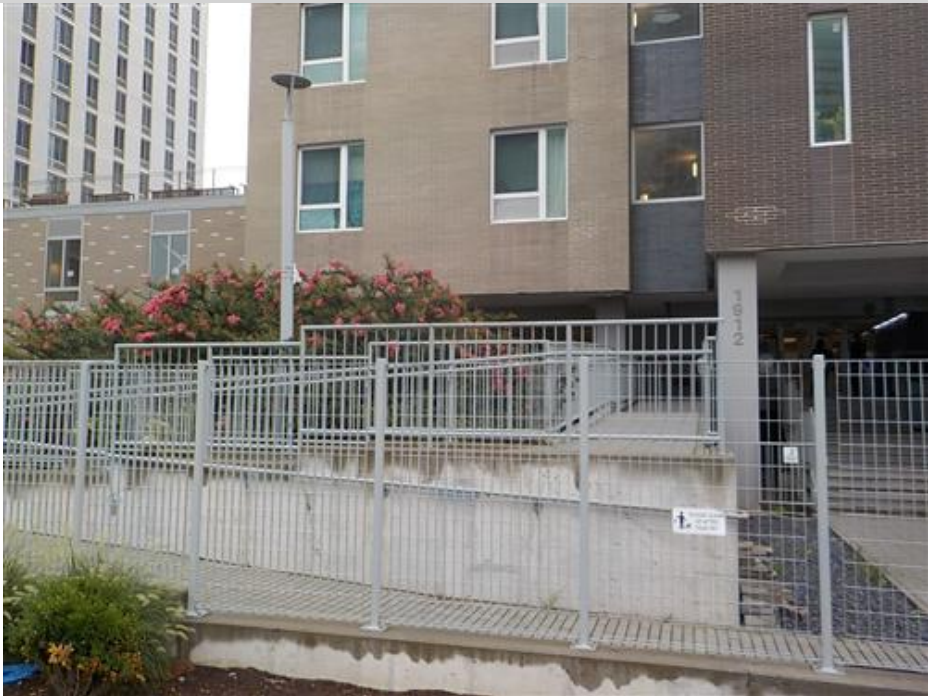
Photograph 2

Front

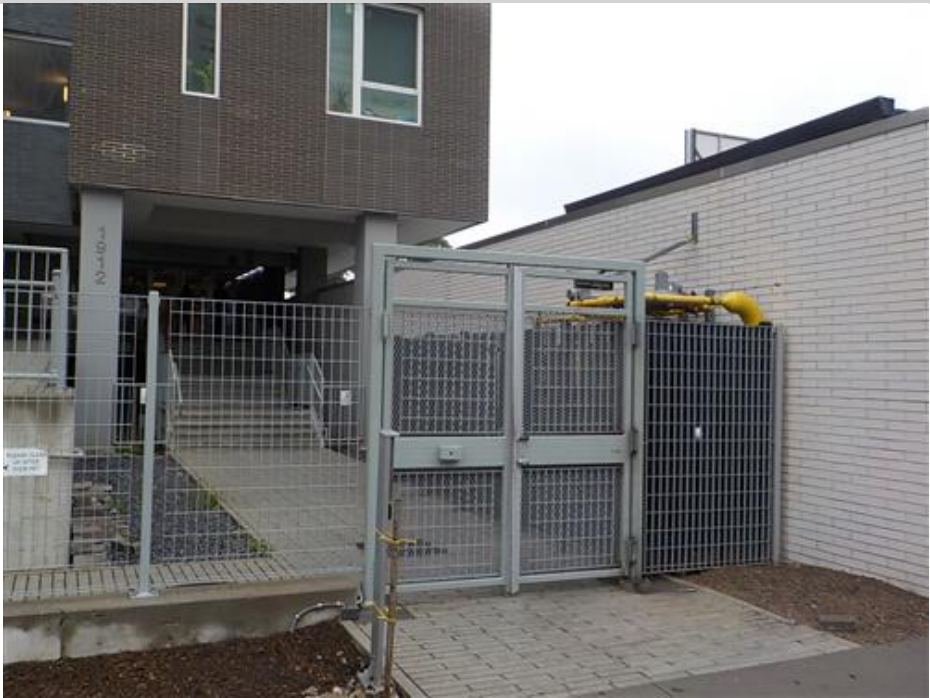
Photograph 3

Entrance

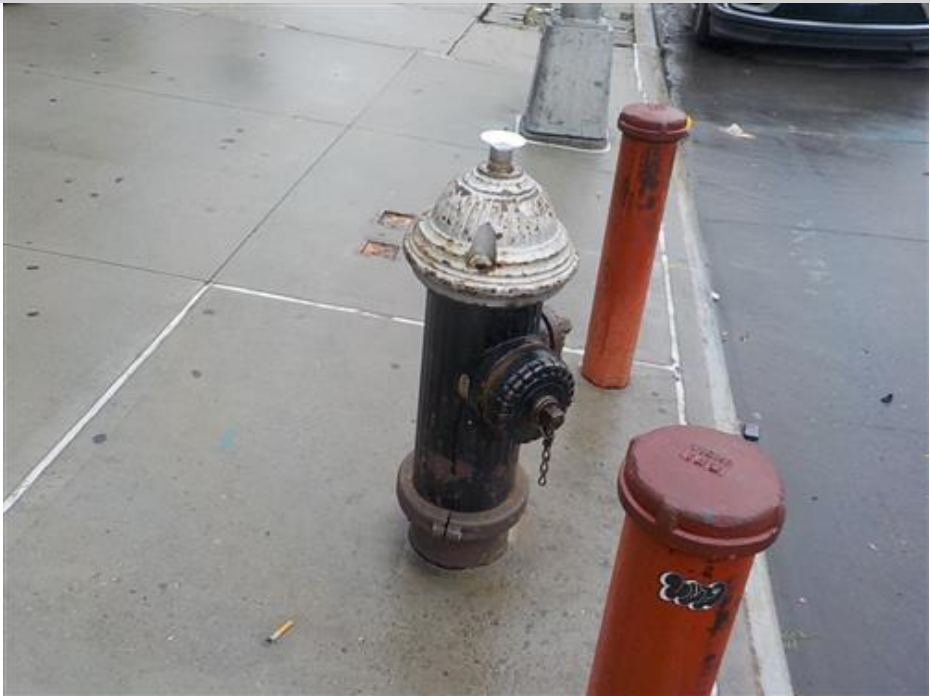
Photograph 4

Sidewalk

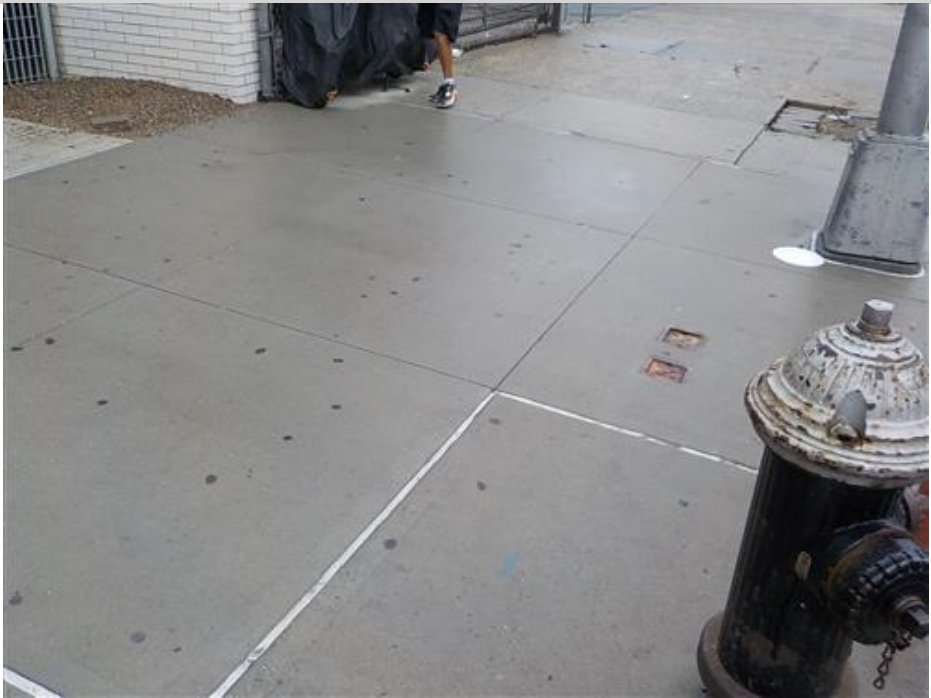
Photograph 5

Sidewalk

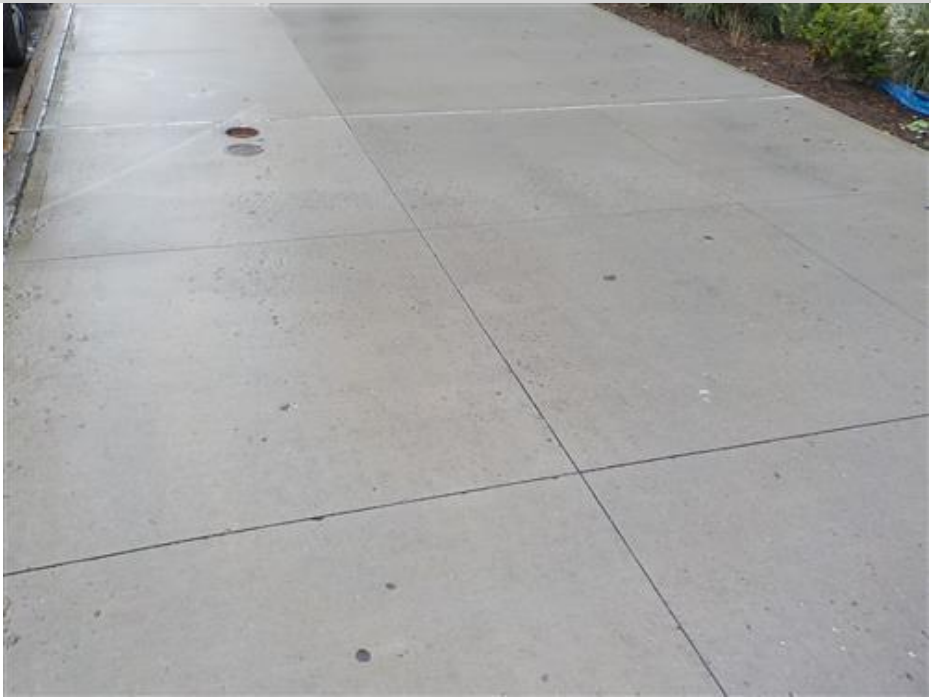
Photograph 6

Sidewalk

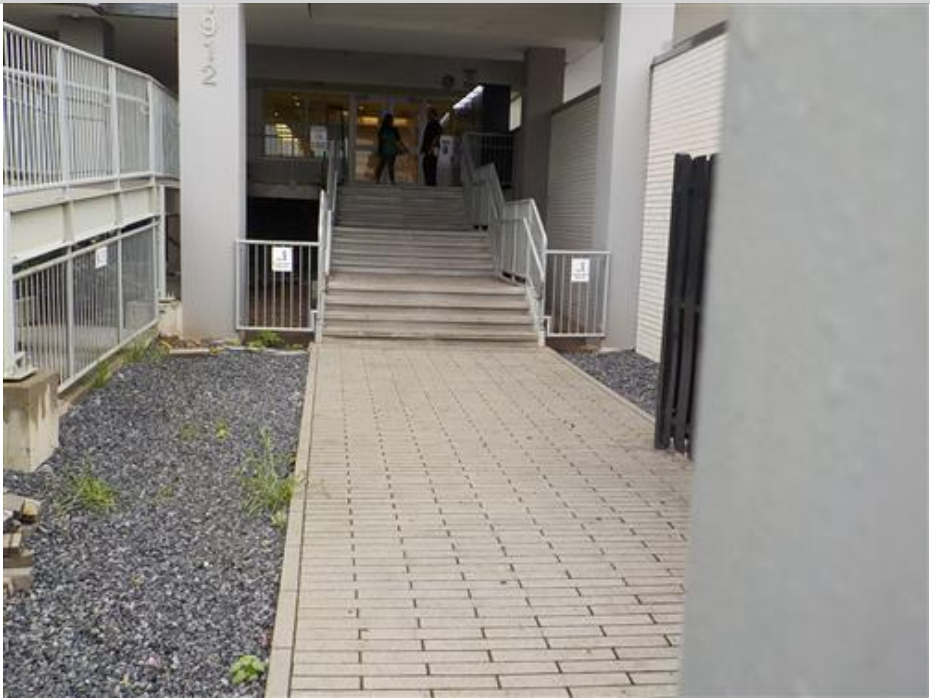
Photograph 7

Entrance

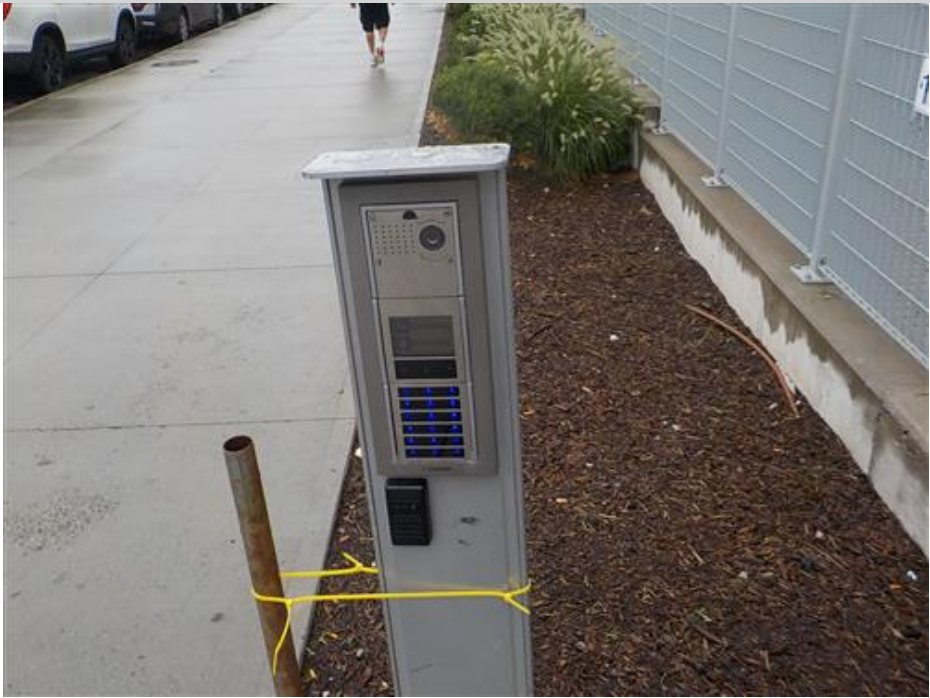
Photograph 8

Smoke detectors, as required, have been installed in this risk as per the contact. This risk is protected by the FDNY fire department, located within .35 mile from this risk. There are 2 fire hydrants within 100 ft. of this risk. The city of New York provides adequate water supply. This risk has an intercom security system, to their locked front entrance door.

Intercom

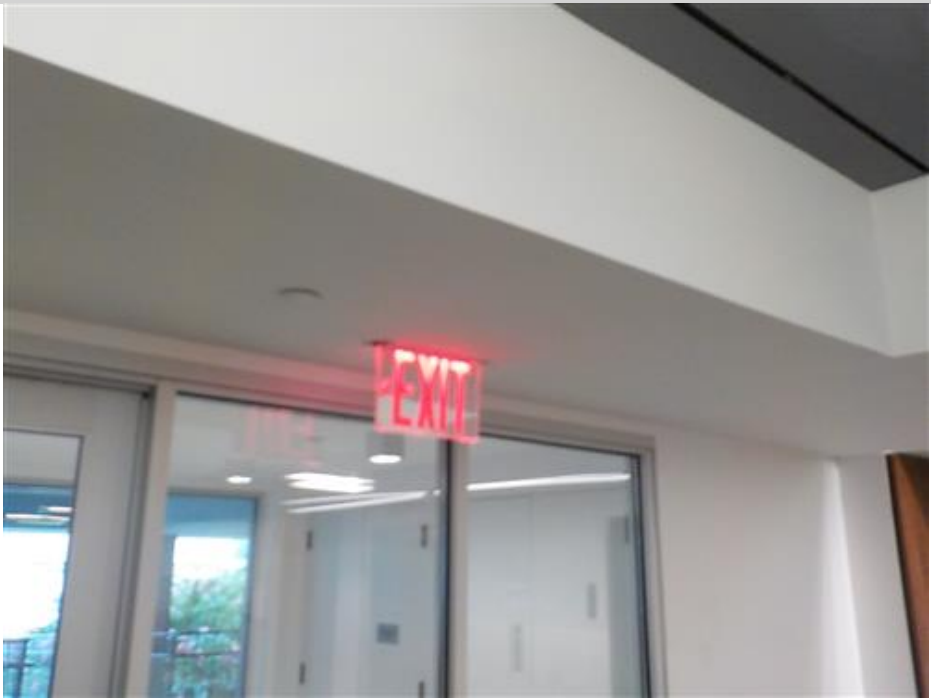
Photograph 9

Exit signage

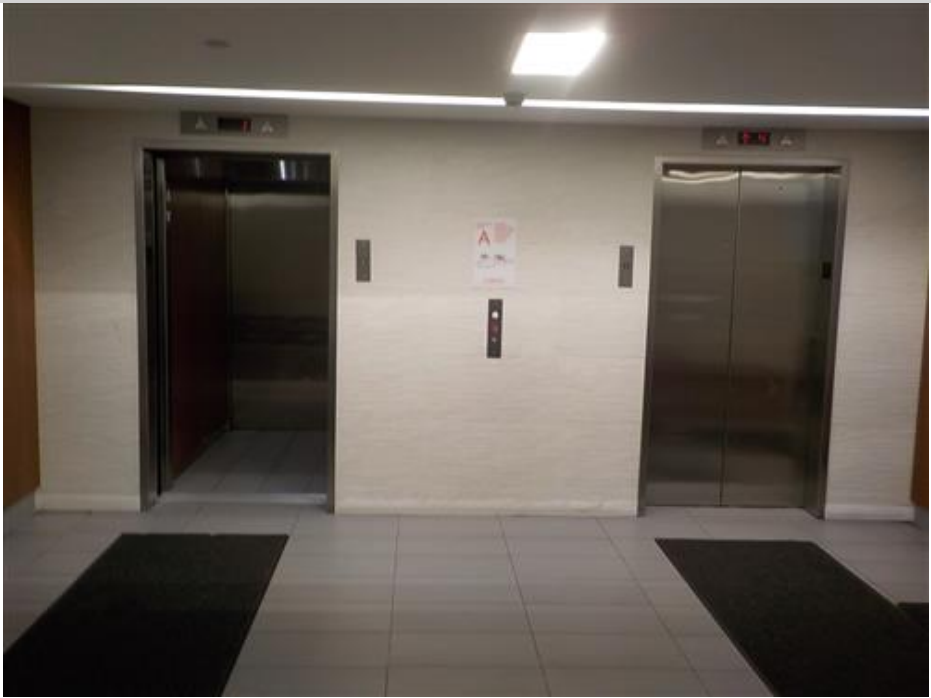
Photograph 10

Elevators

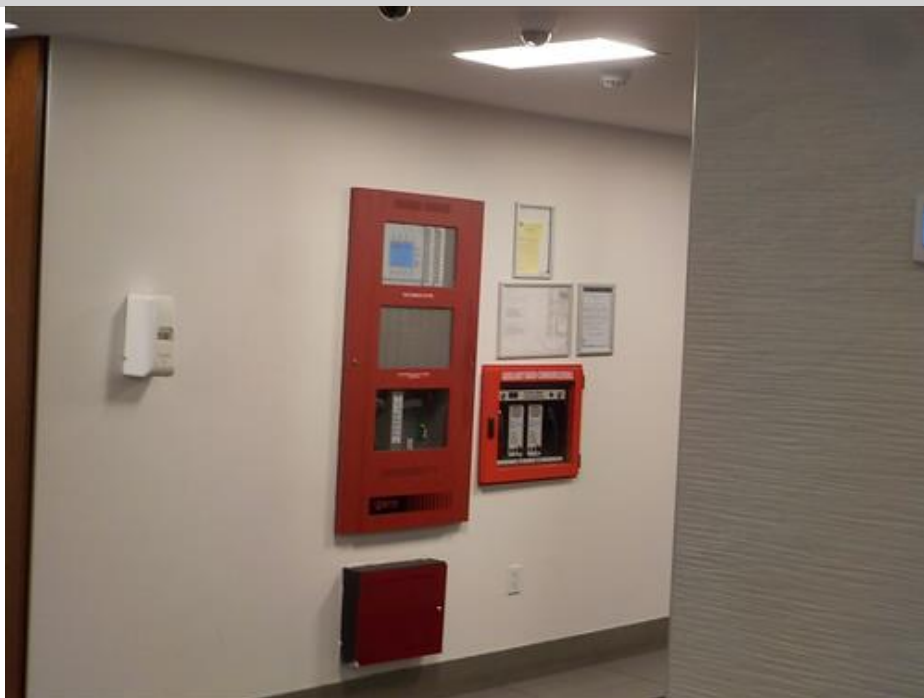
Photograph 11

Alarm panel

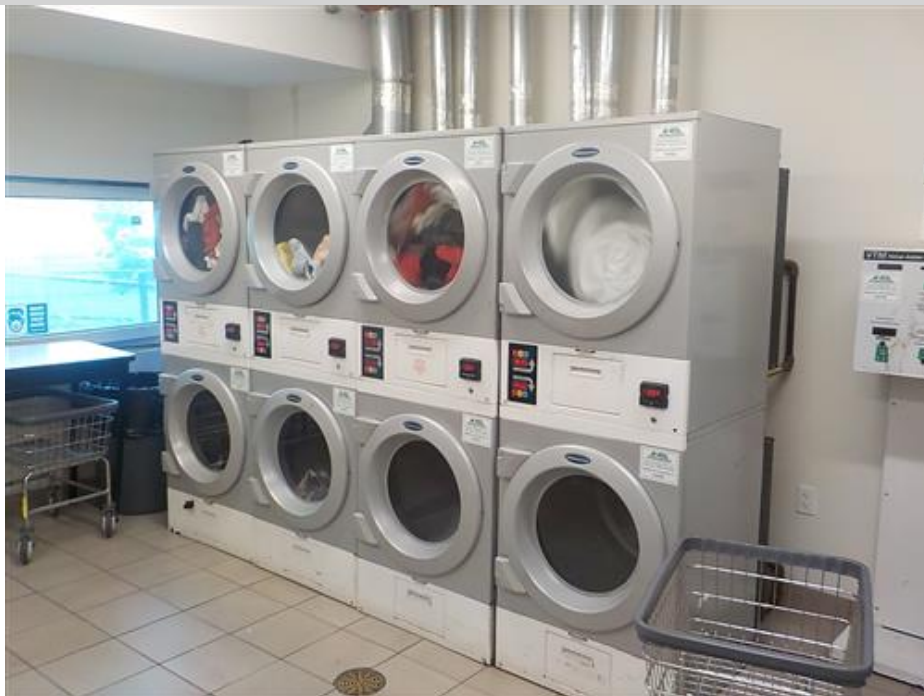
Photograph 12

Laundry room

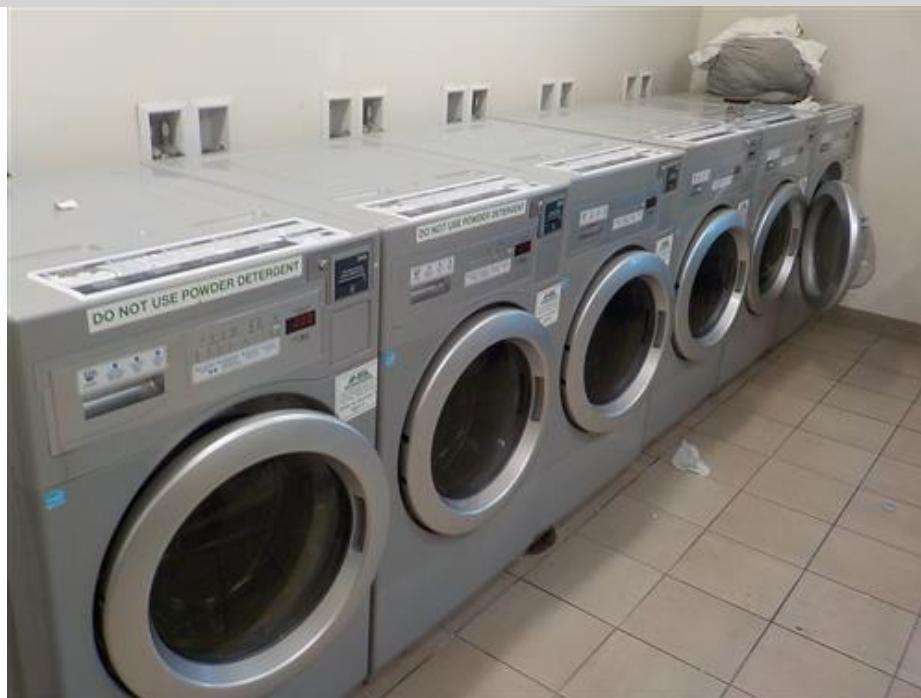
Photograph 13

Laundry room

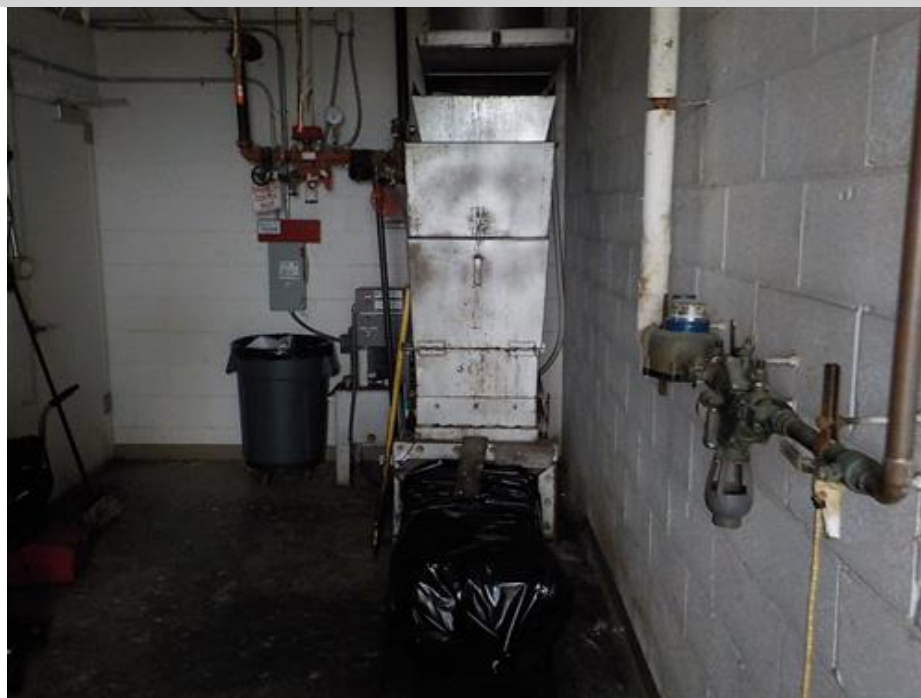
Photograph 14

Compactor

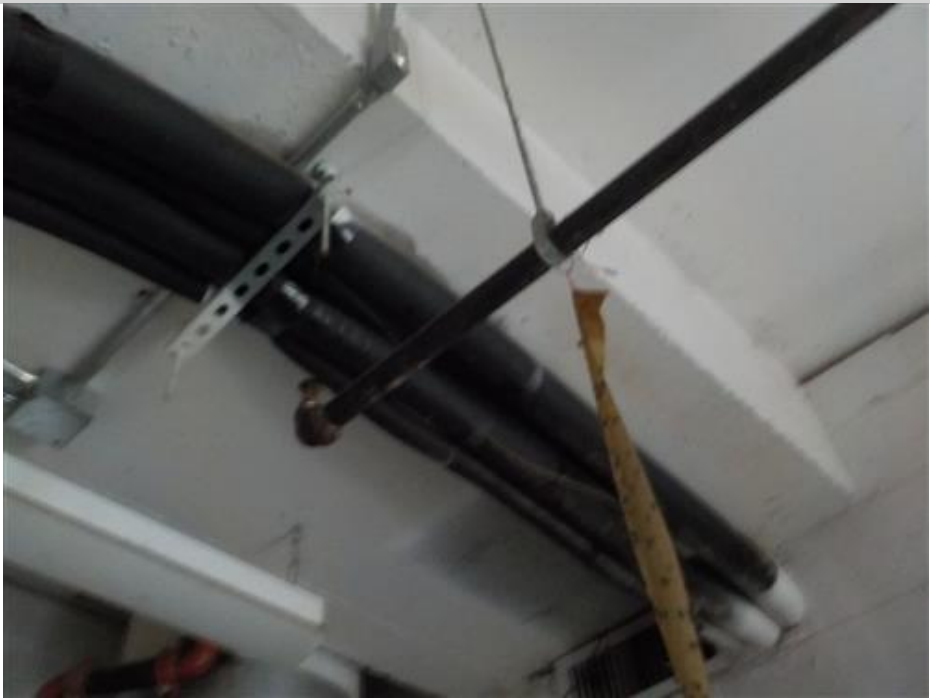
Photograph 15

Compactor room

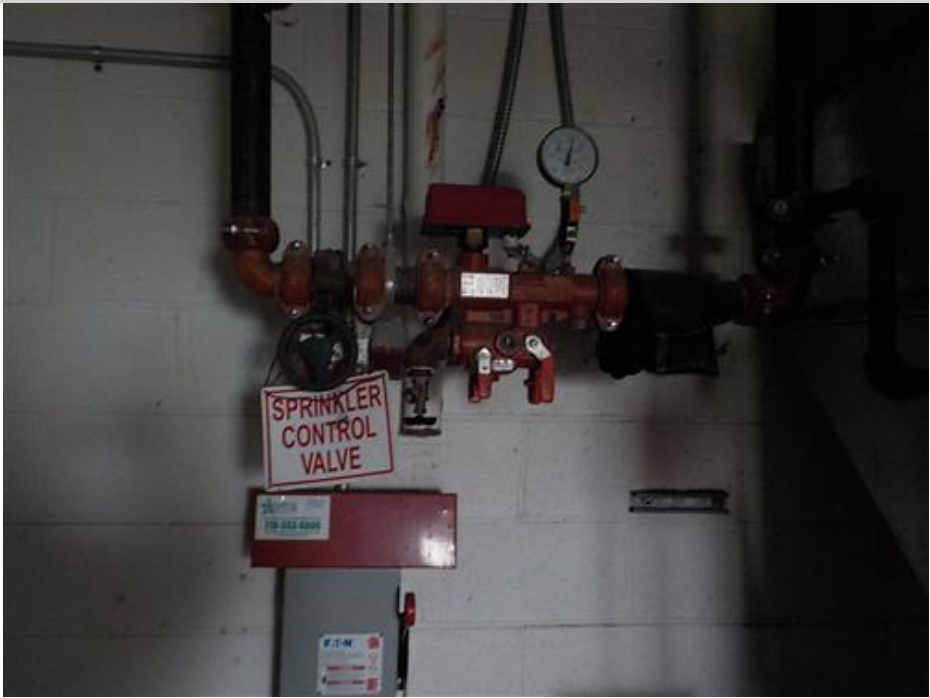
Photograph 16

Interior

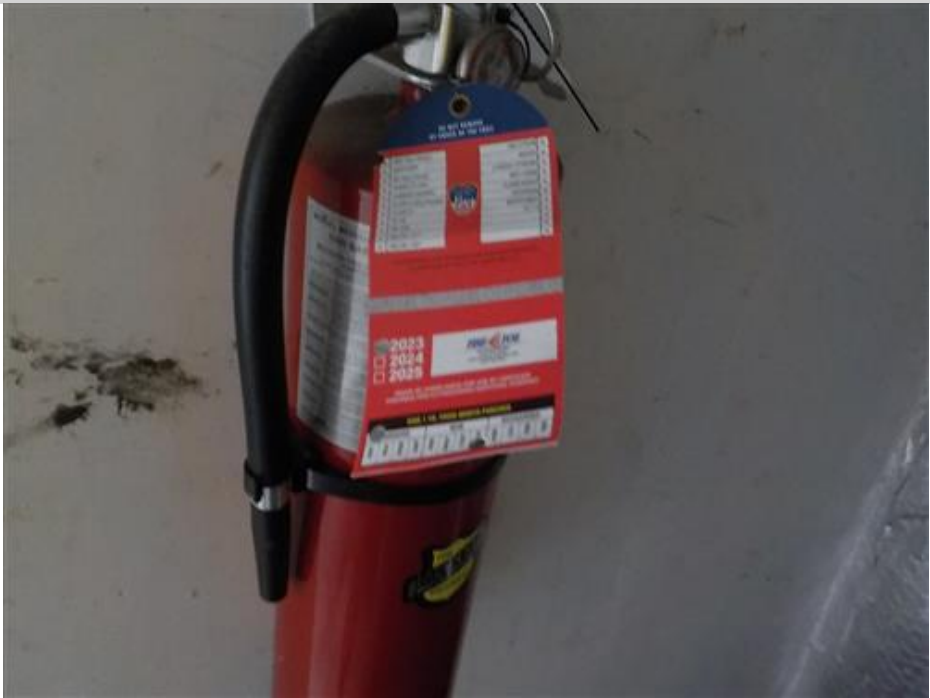
Photograph 17

ABC Extinguisher

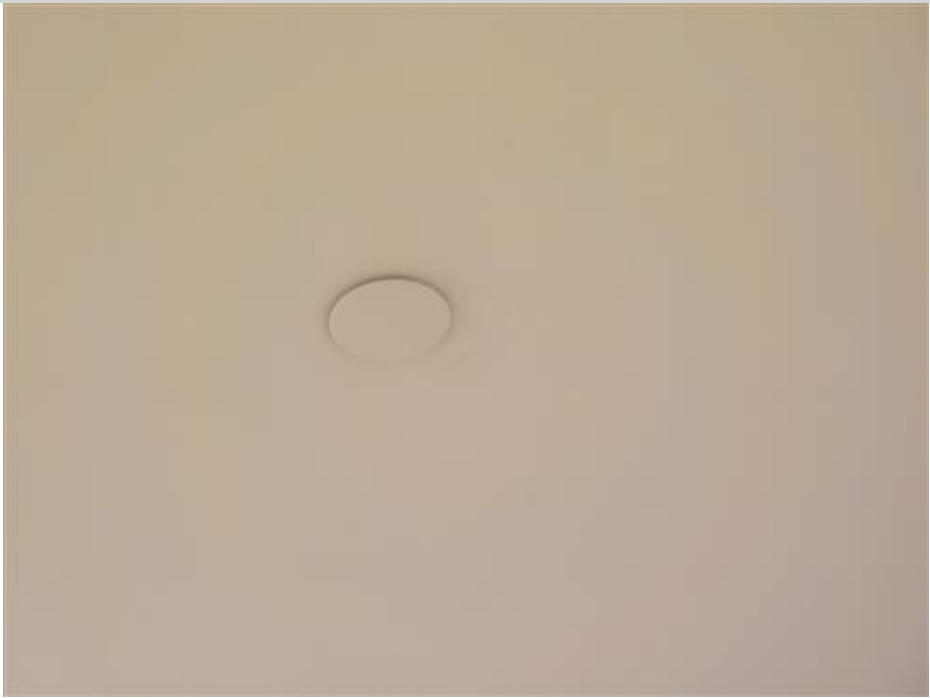
Photograph 18

This risk is protected by a wet sprinkler system to a central station alarm system. The sprinkler system is maintained by Capitol and the last date of inspection is 7/24.

Sprinkler head

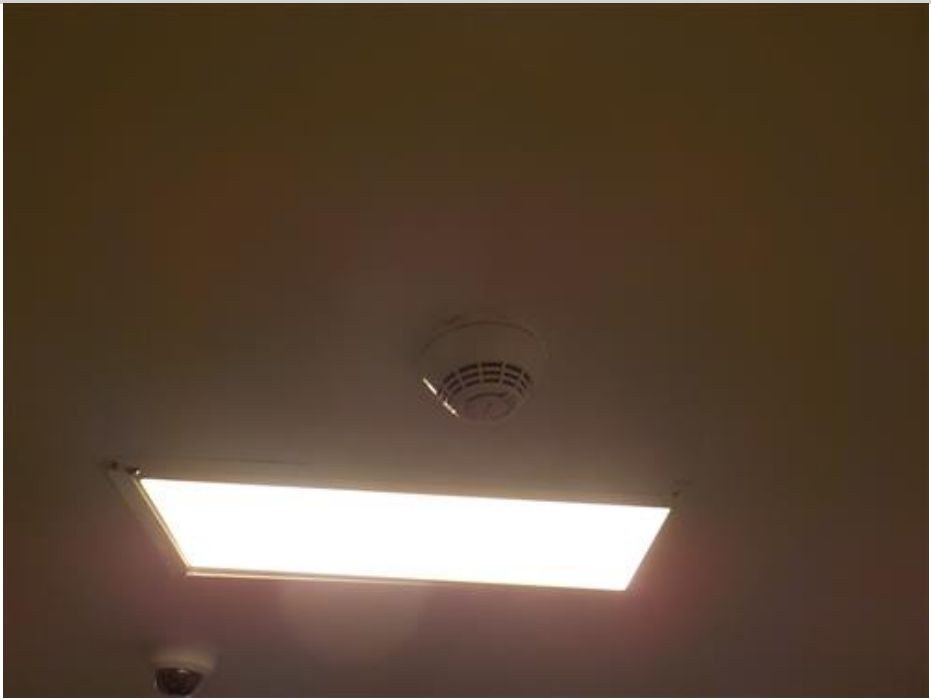
Photograph 19

Smoke detector

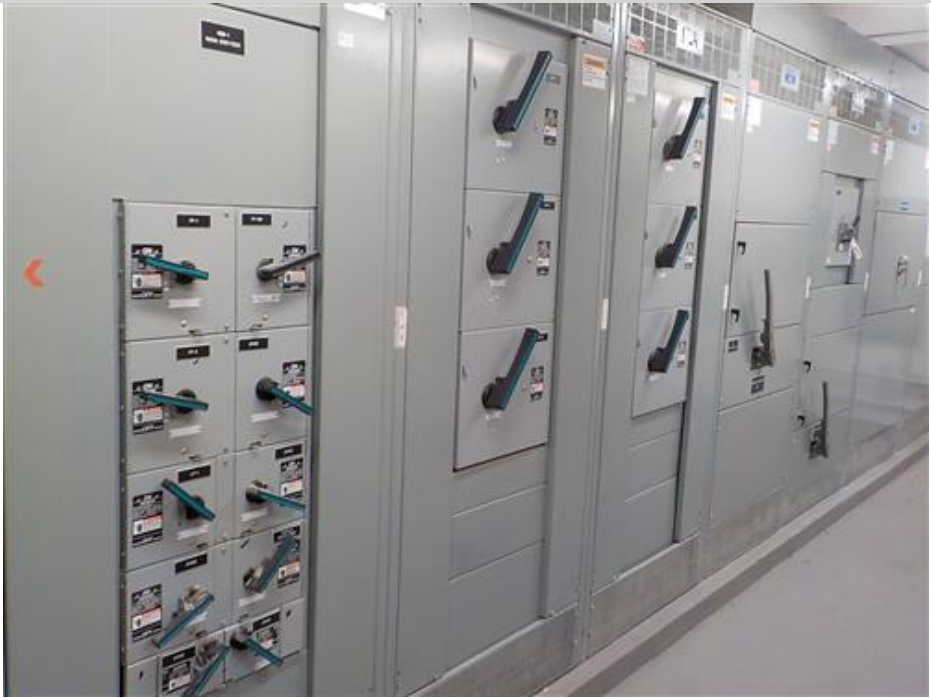
Photograph 20

ELECTRIC- The system is 7 years old and is protected by circuit breakers with BX wiring.

Electric panel

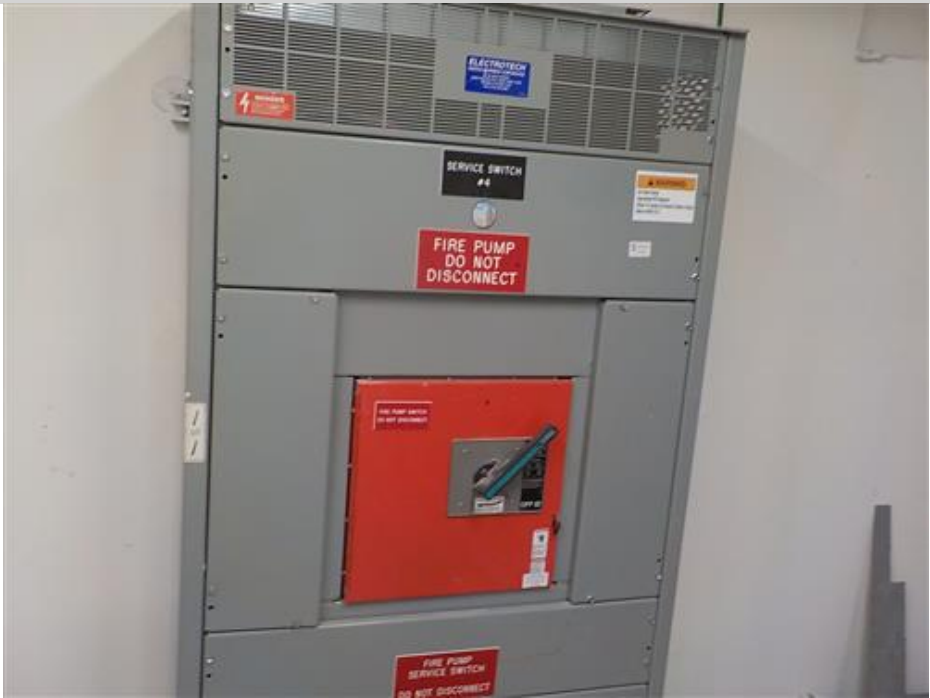
Photograph 21

Electric panel

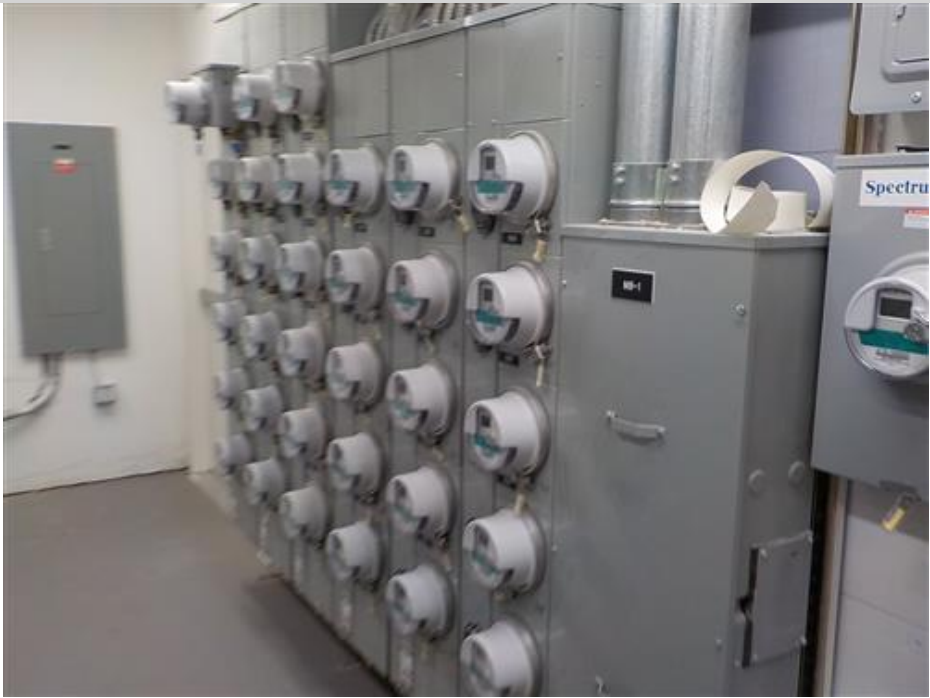
Photograph 22

Electric panel

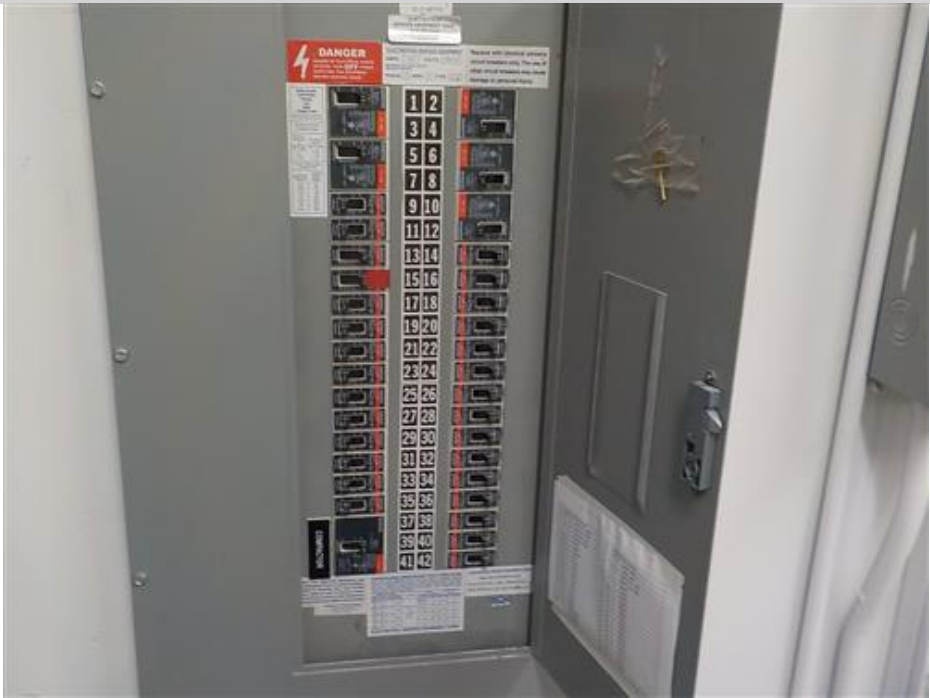
Photograph 23

Electric panel

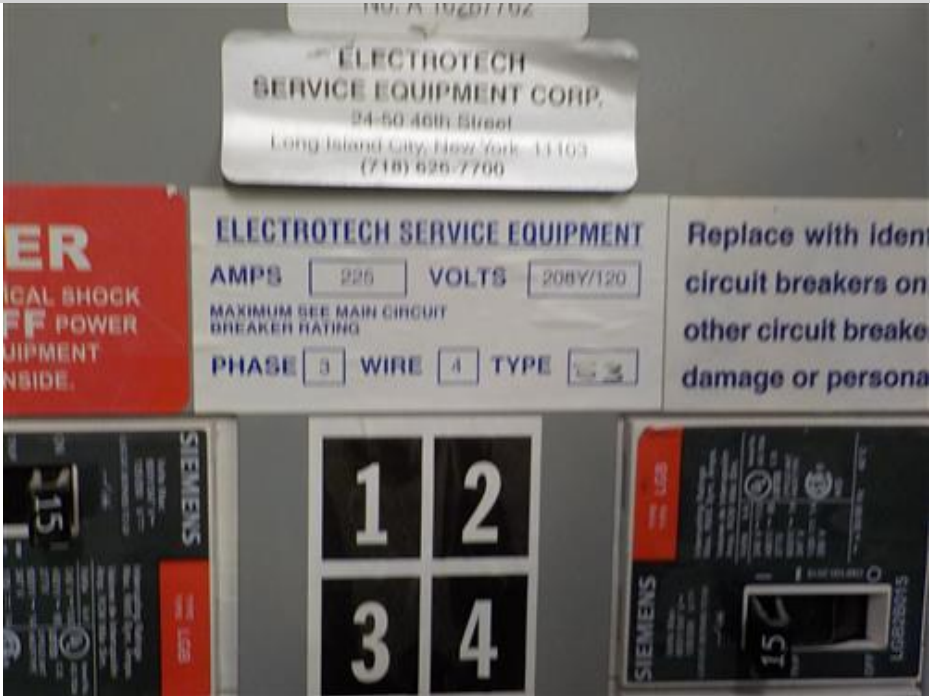
Photograph 24

Electric panel

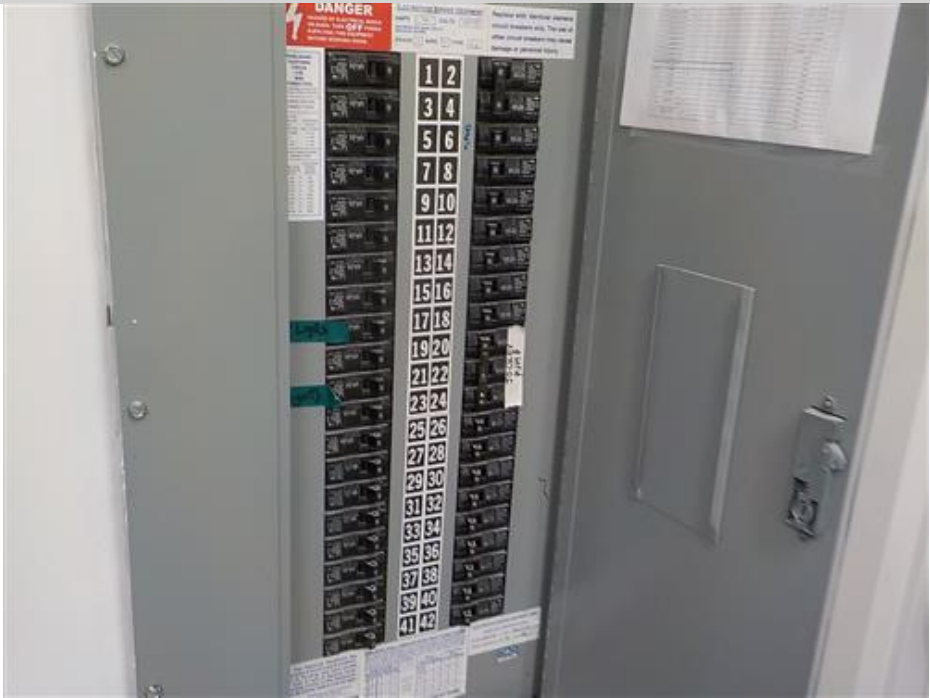
Photograph 25

Electric panel

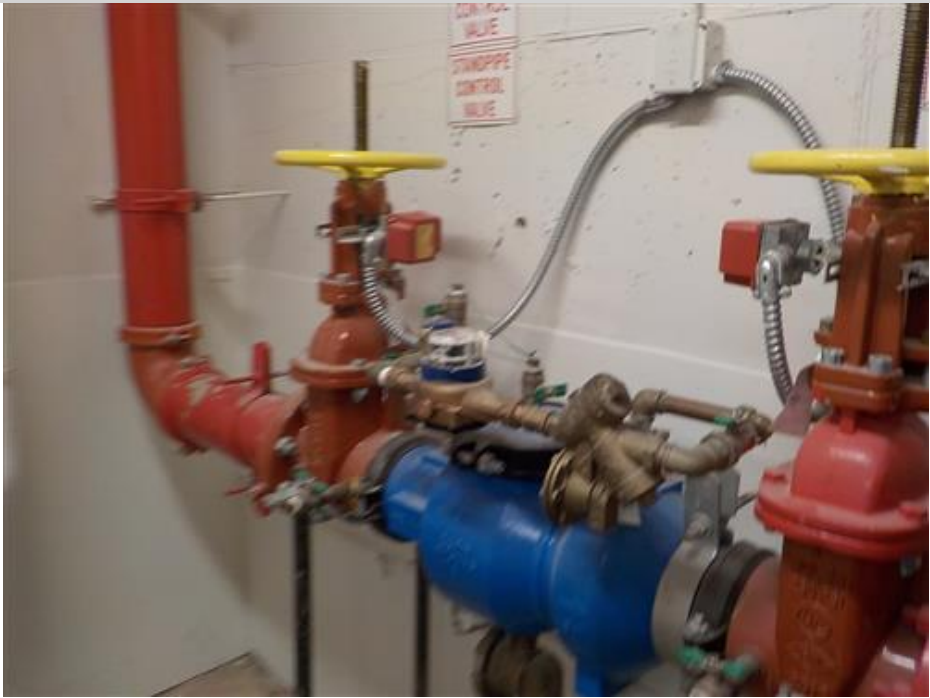
Photograph 26

Sprinkler

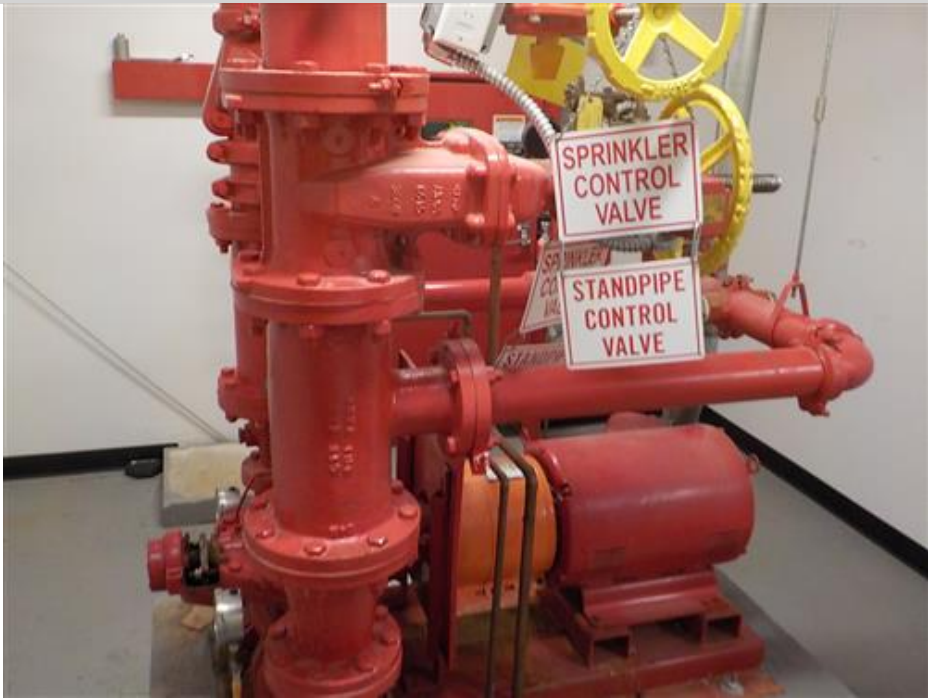
Photograph 27

Sprinkler

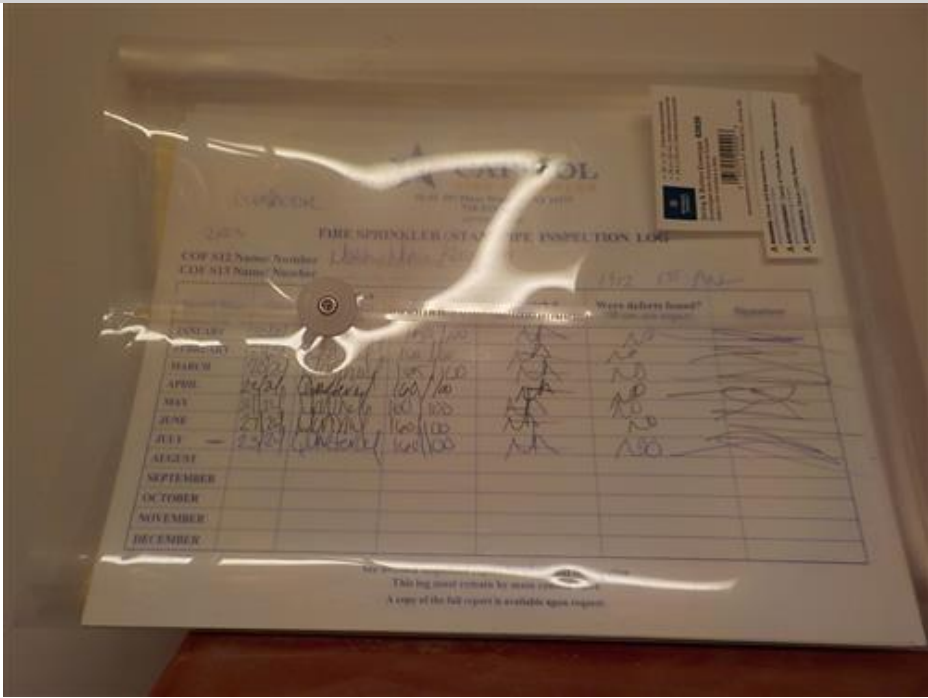
Photograph 28

Sprinkler inspection

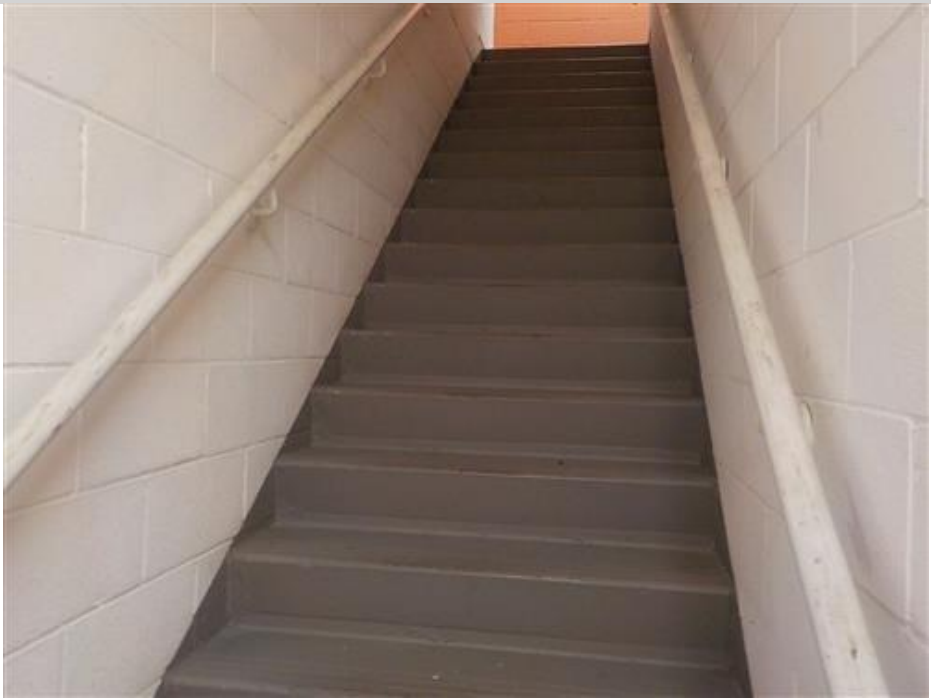
Photograph 29

This risk has 4 interior concrete stairways, located at the front and rear of the building.

Interior stairs

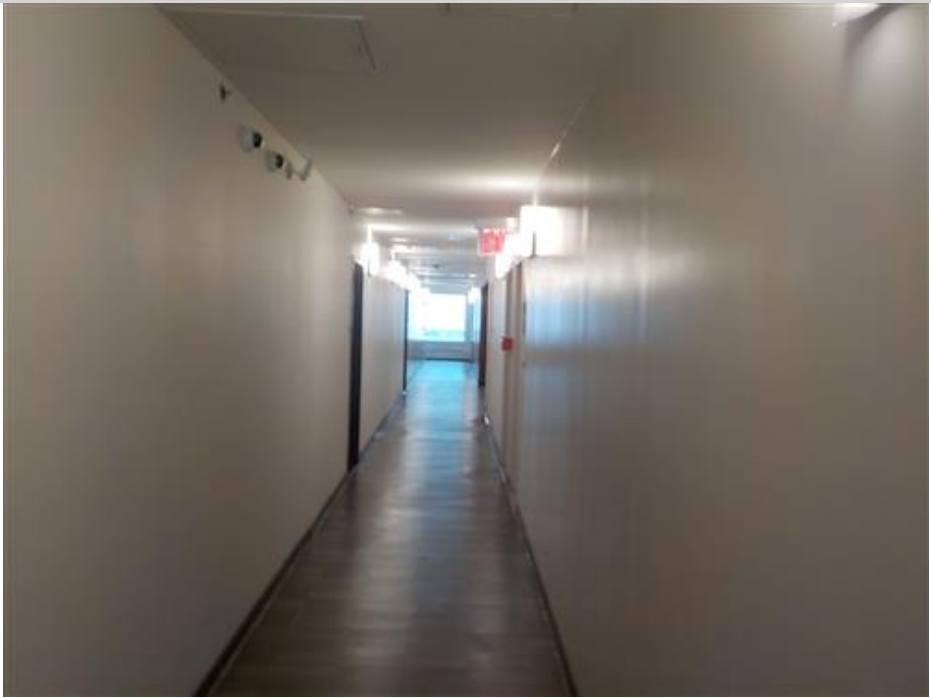
Photograph 30

-Hallway/Stairs doors - We noted that the hallway/stairway doors in this risk are self-closing. Doors noted in halls/stairs are fire doors and appear to be in acceptable/not acceptable condition.

Hallway

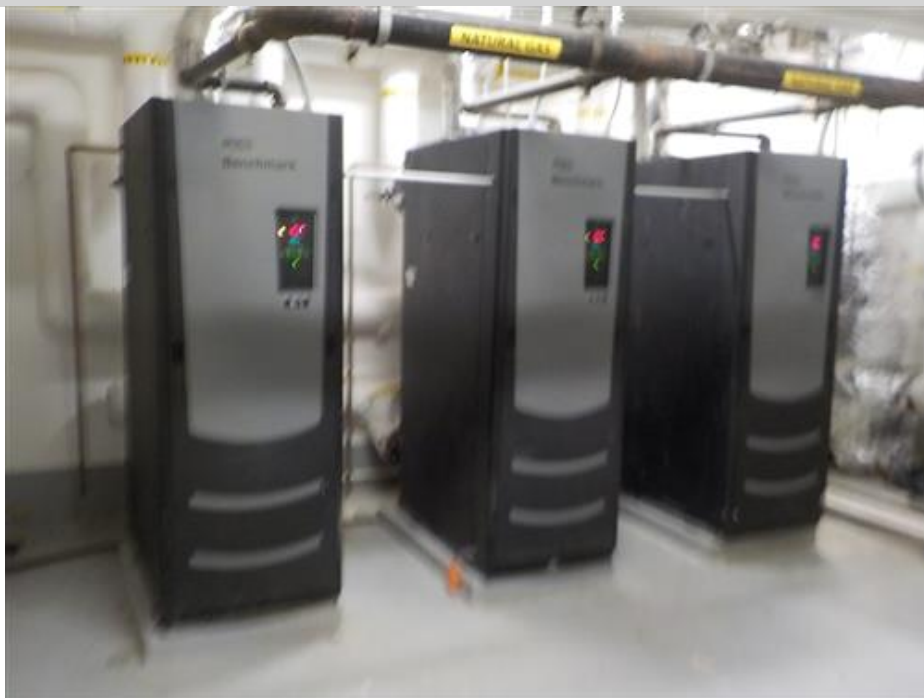
Photograph 31

Water heaters

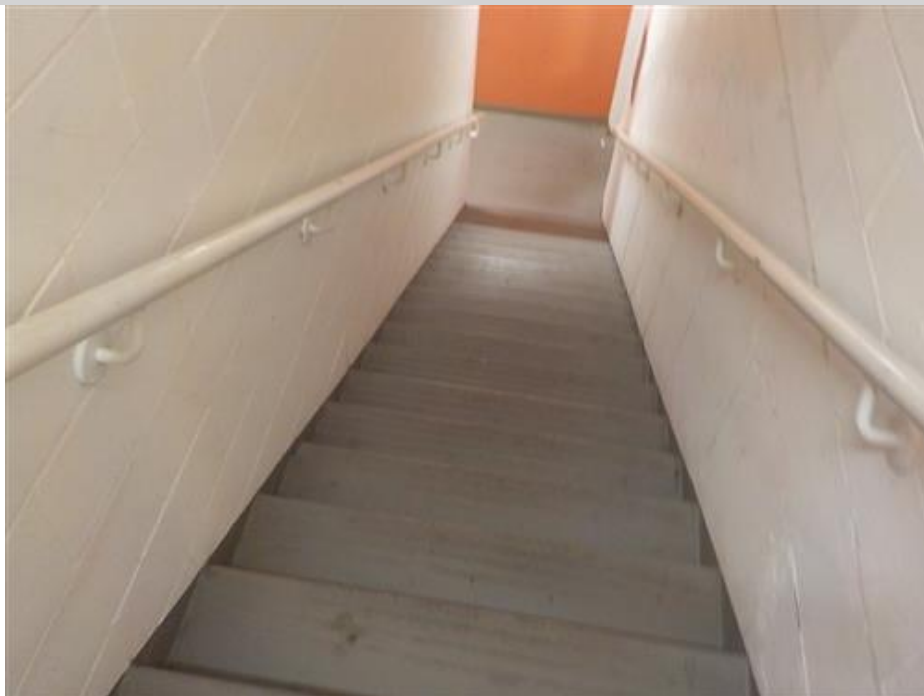
Photograph 32

Interior stairs

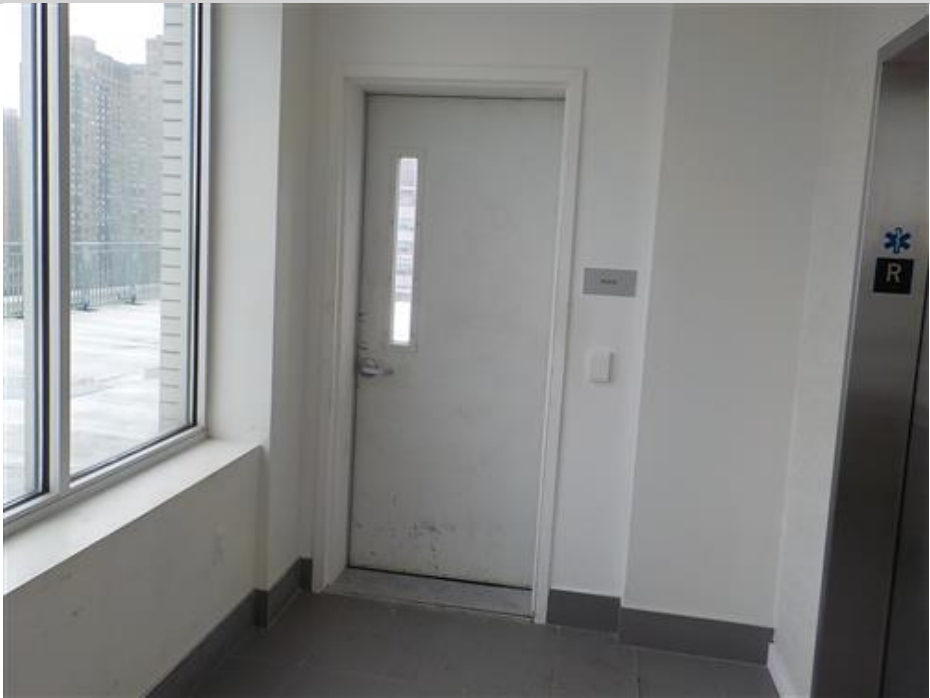
Photograph 33

Roof door

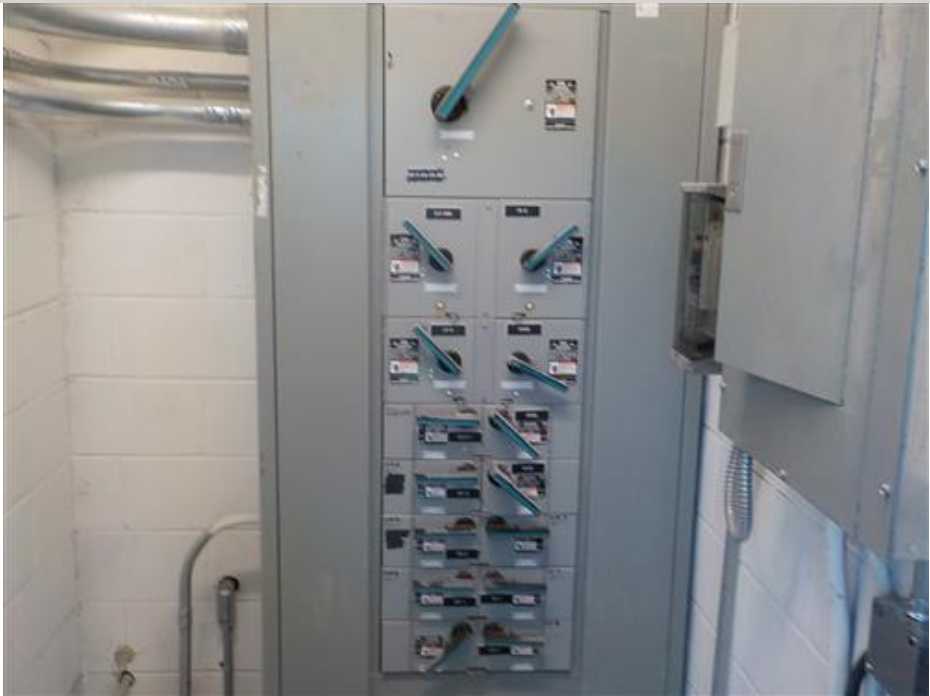
Photograph 34

Electric panel

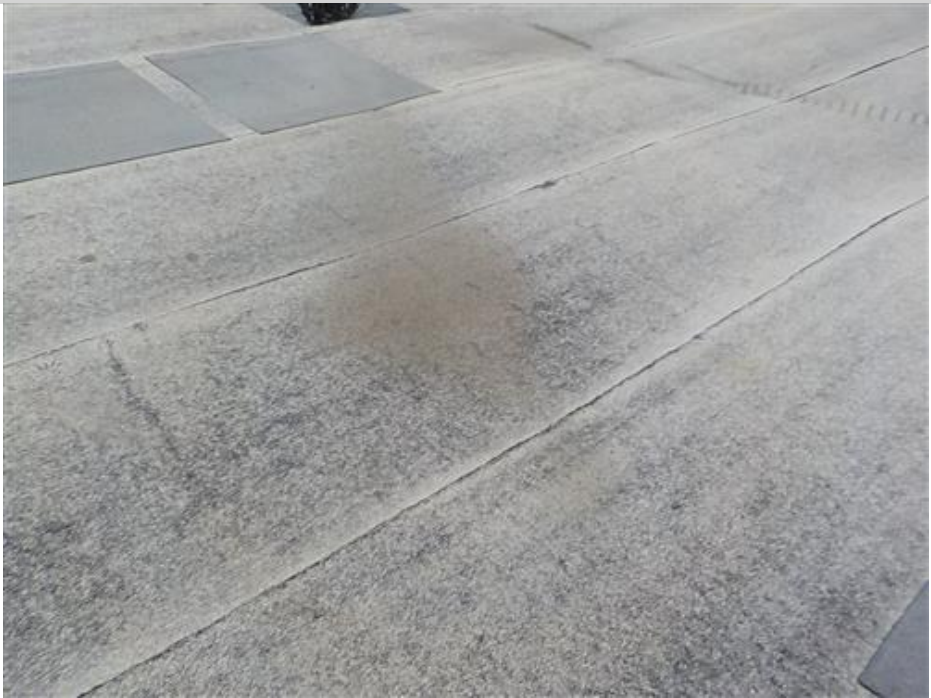
Photograph 35

It was stated that the roof systems were last replaced 7 years ago, and appears satisfactory.

Roof
