Majestic Service Company

Multi Line Inspection

Narrative

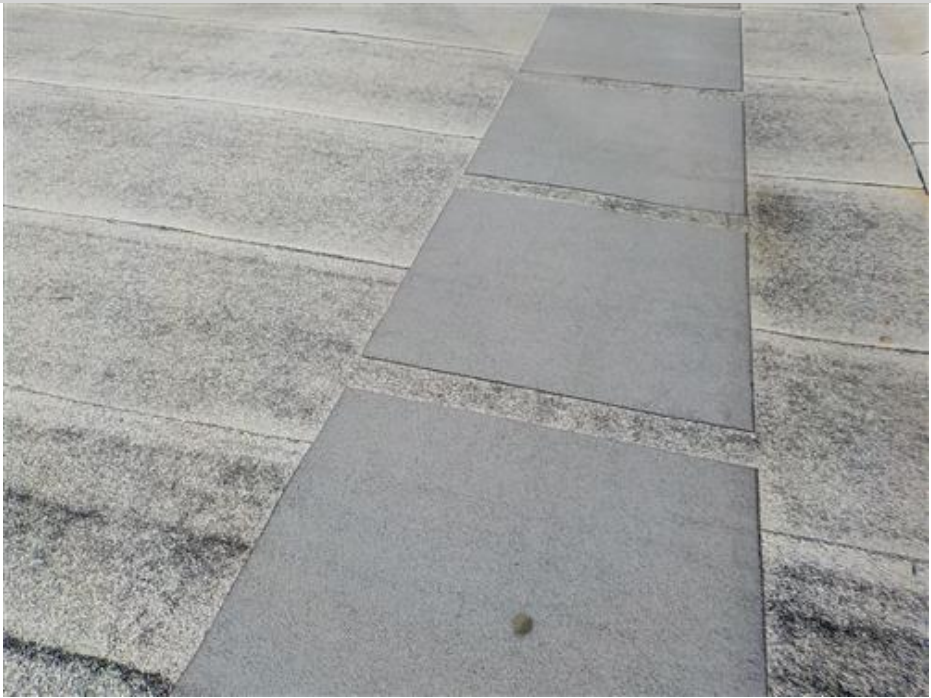
Photograph 36

Roof

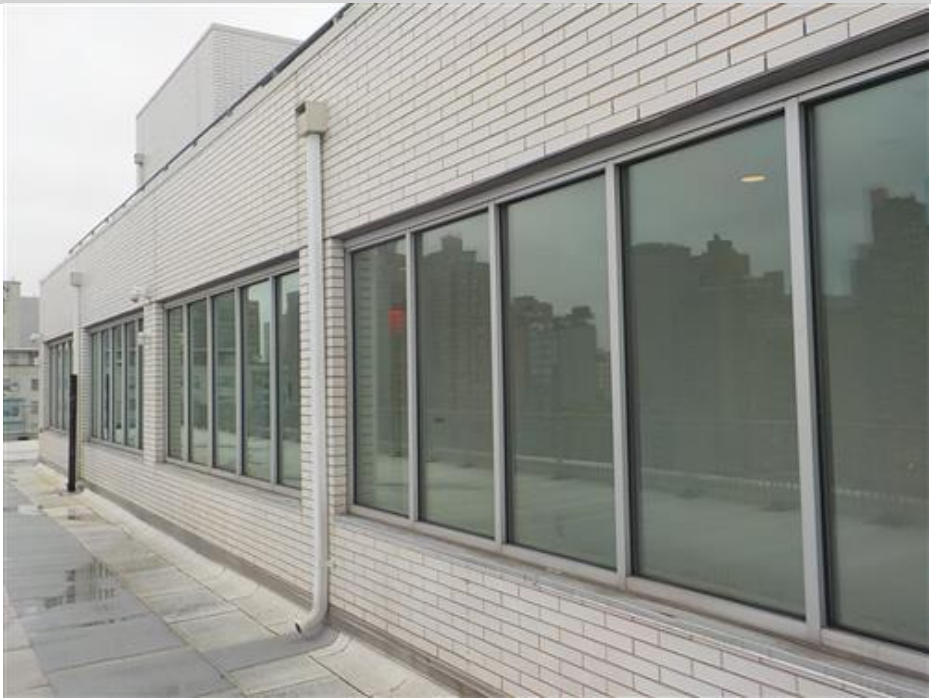
Photograph 37

Roof

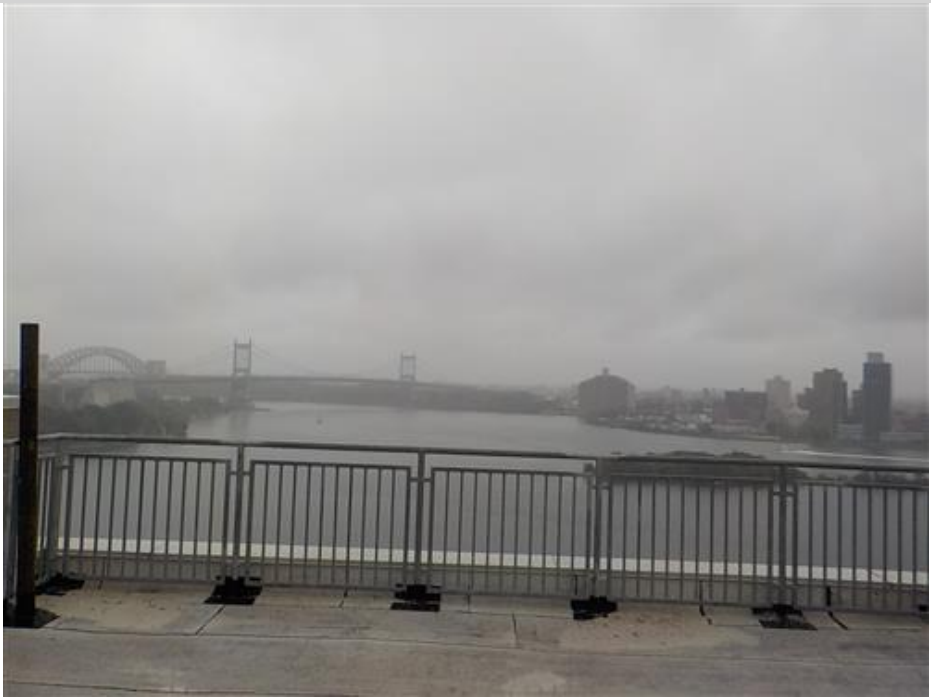
Photograph 38

Roof

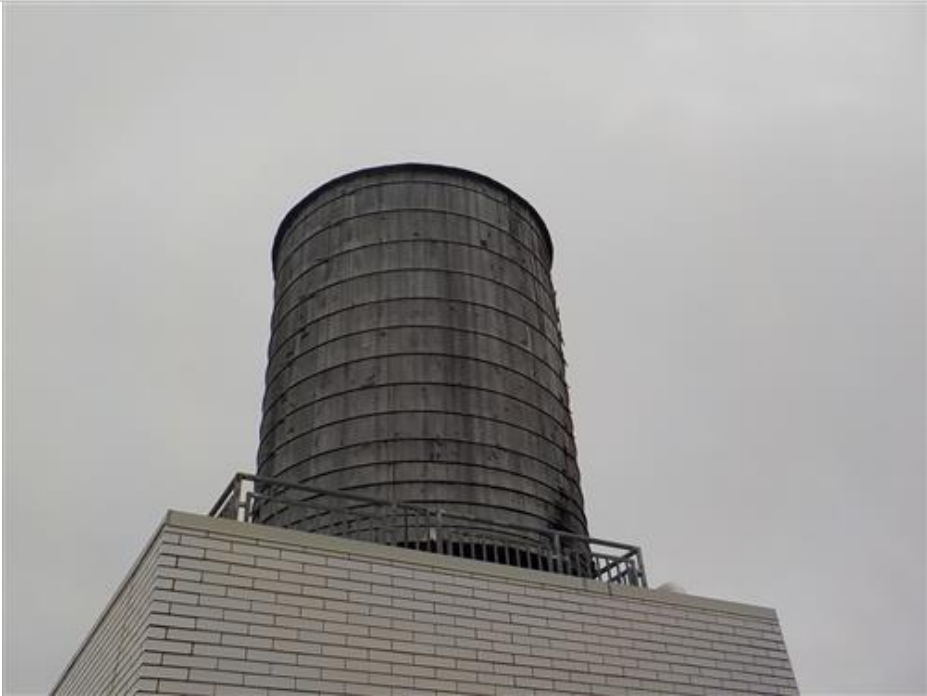
Photograph 39

Roof tank

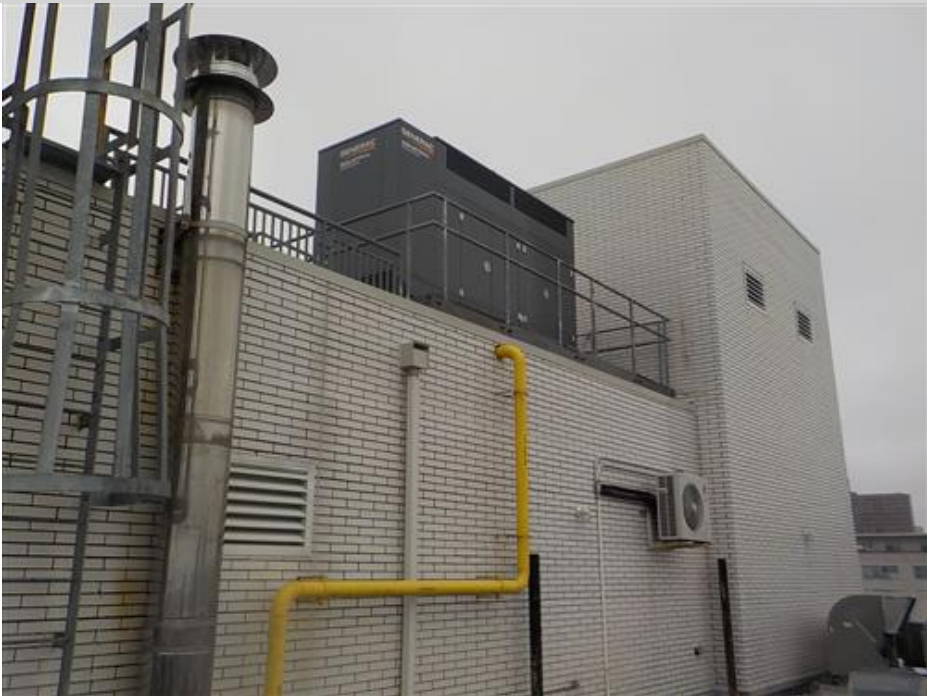
Photograph 40

HVAC Unit

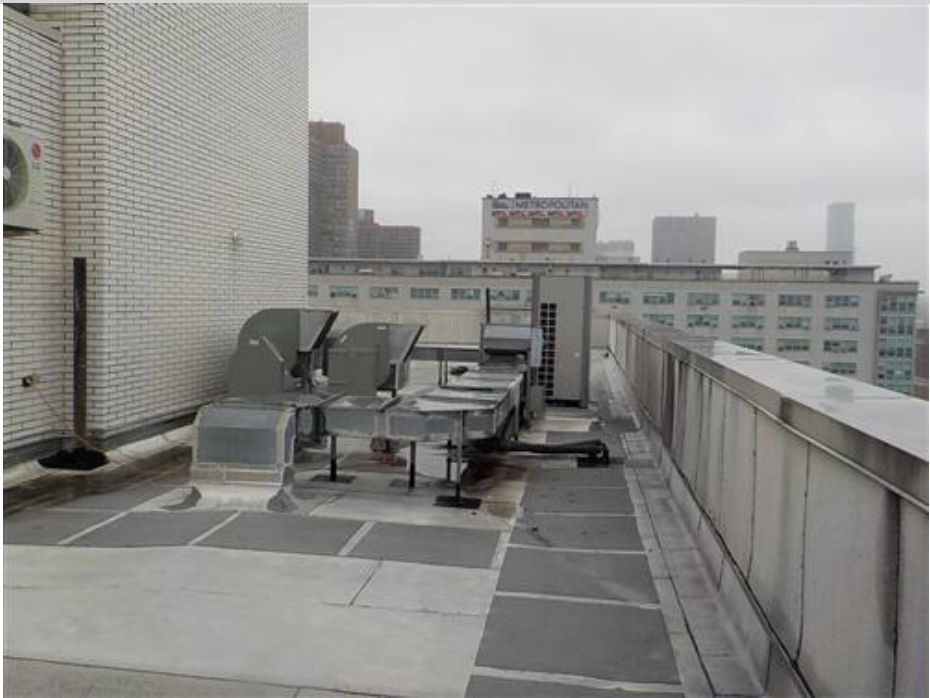
Photograph 41

HVAC Unit

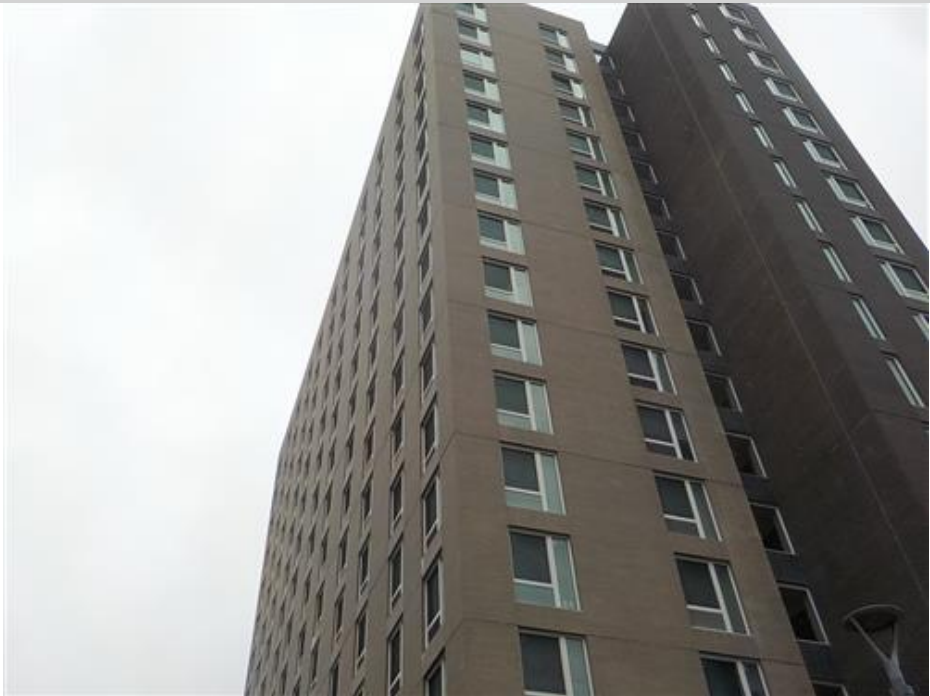
Photograph 42

Left side

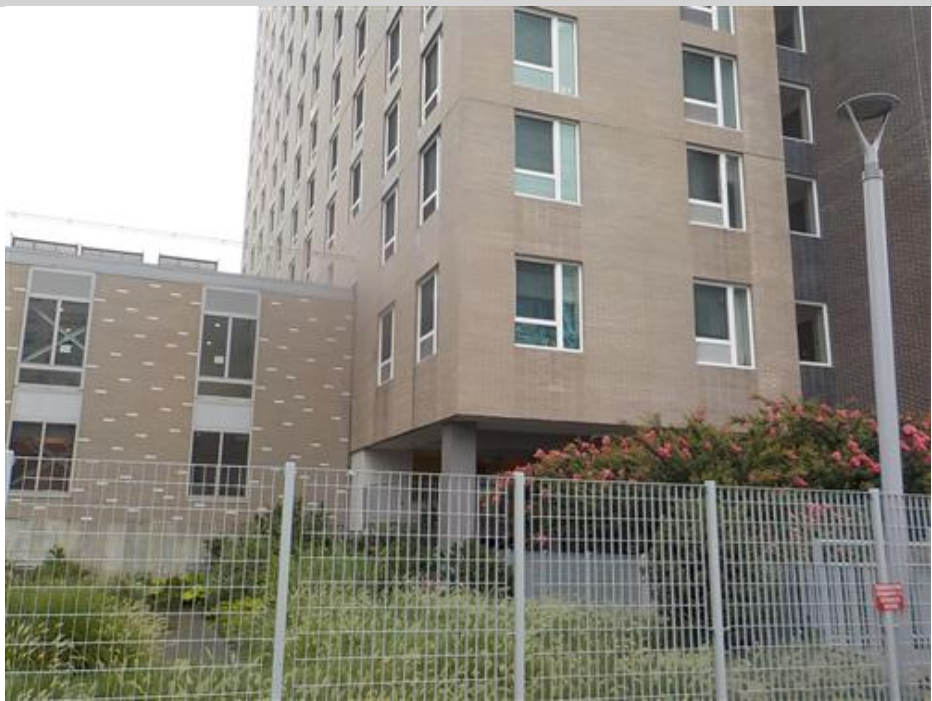
Photograph 43

To the left of this risk, there is an attached, 16 story fire resistive apartment building. To the right of this risk, is a parking lot. This risk is located in a moderate residential mercantile area. We observed no vacant buildings on this street, or in this area. This area has a moderate incidence of crime and VM&M exposures.

Left side
