## Multi Line Inspection

### Insured's Information

## ***Narrative***

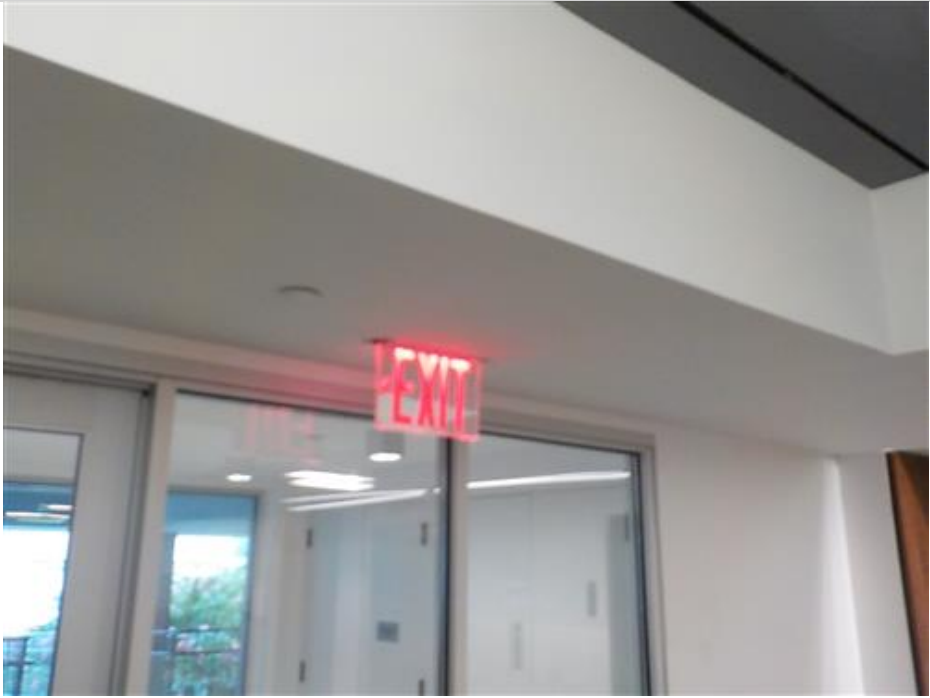
Photograph 9

Exit signage

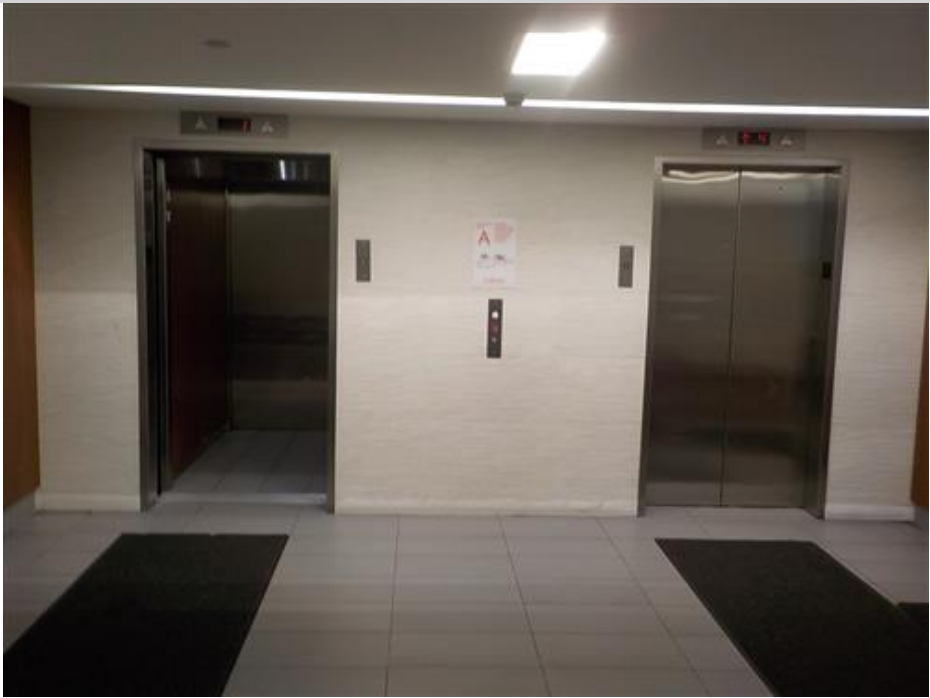
Photograph 10

Elevators

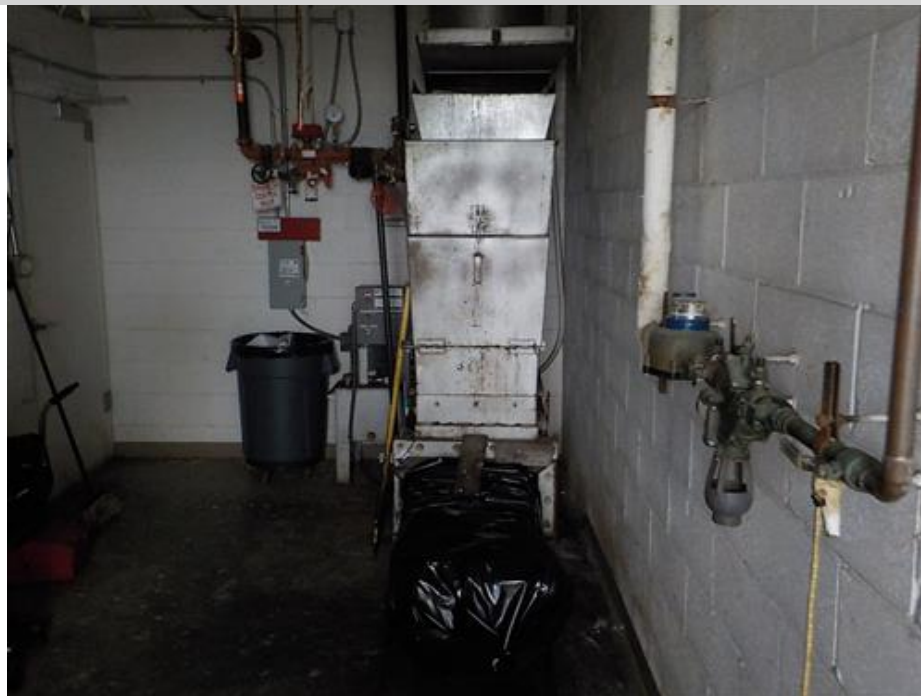
Photograph 14

Compactor

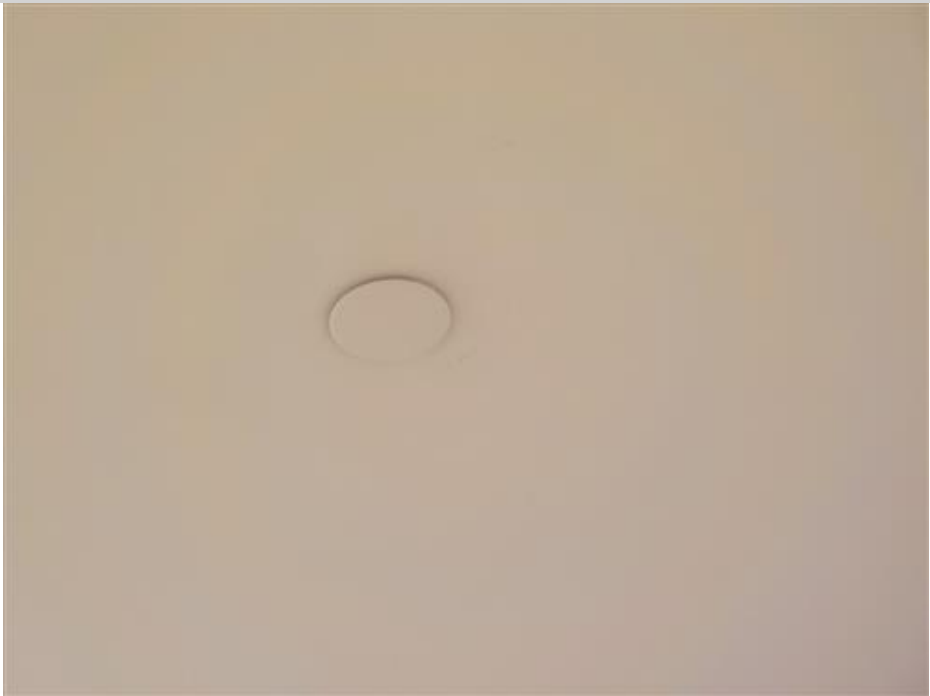
Photograph 18

Sprinkler head

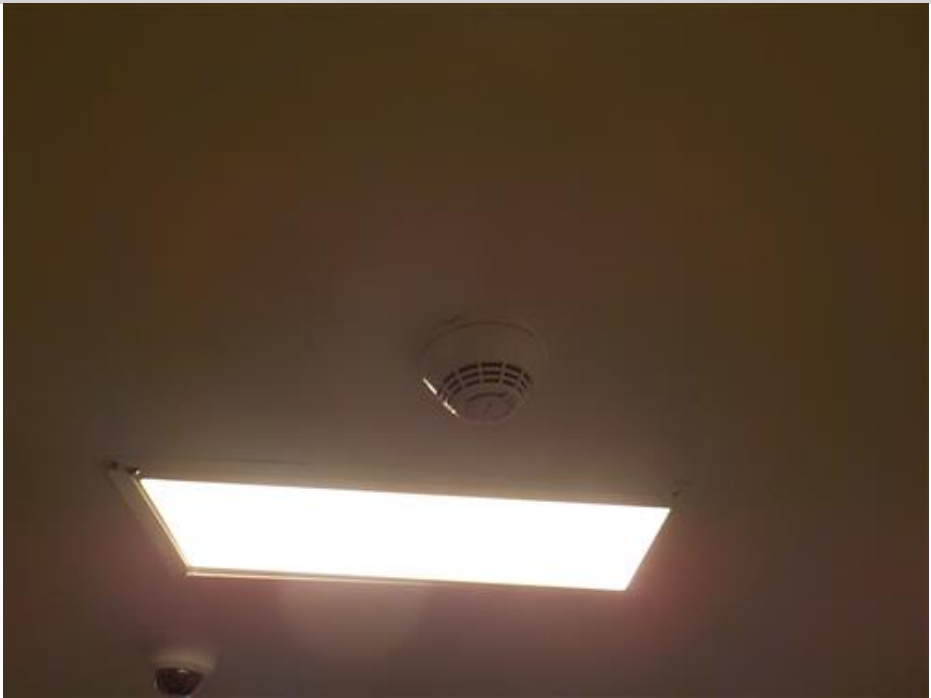
**Photograph 19**

Smoke detector

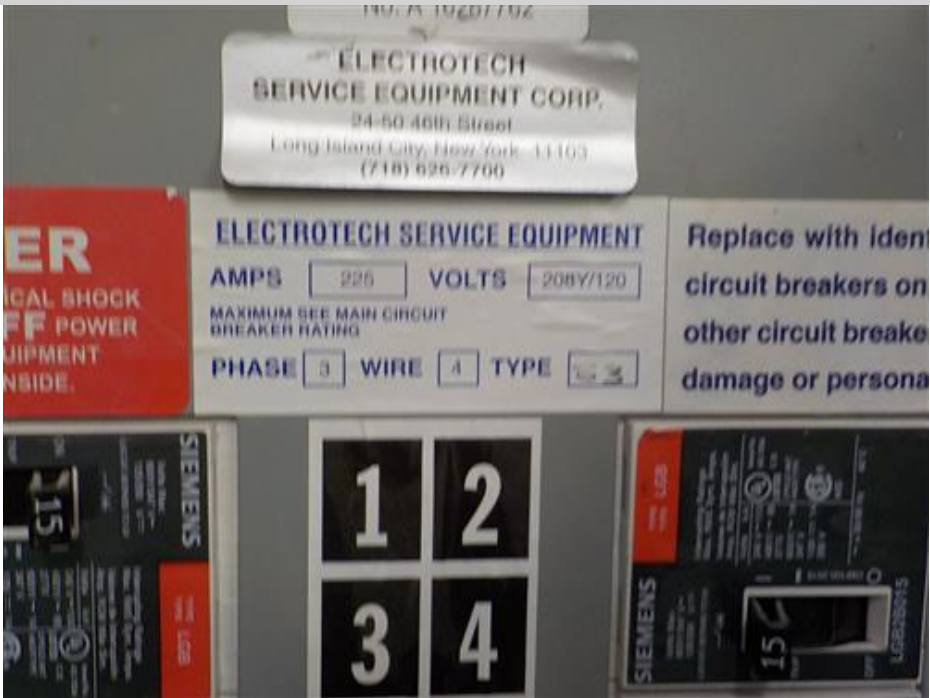
Photograph 24

Electric panel

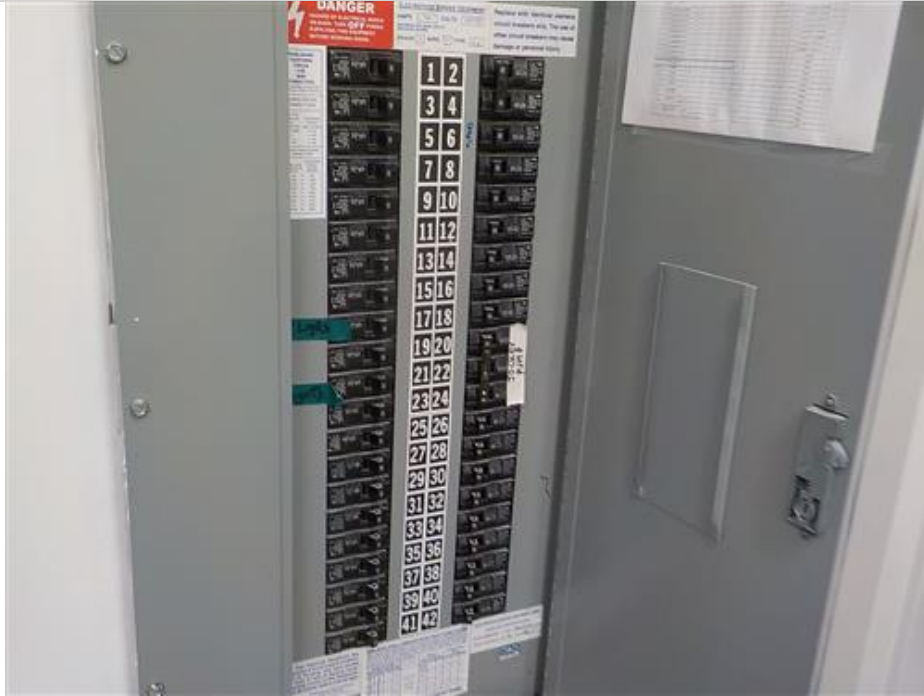
Photograph 25

Electric panel

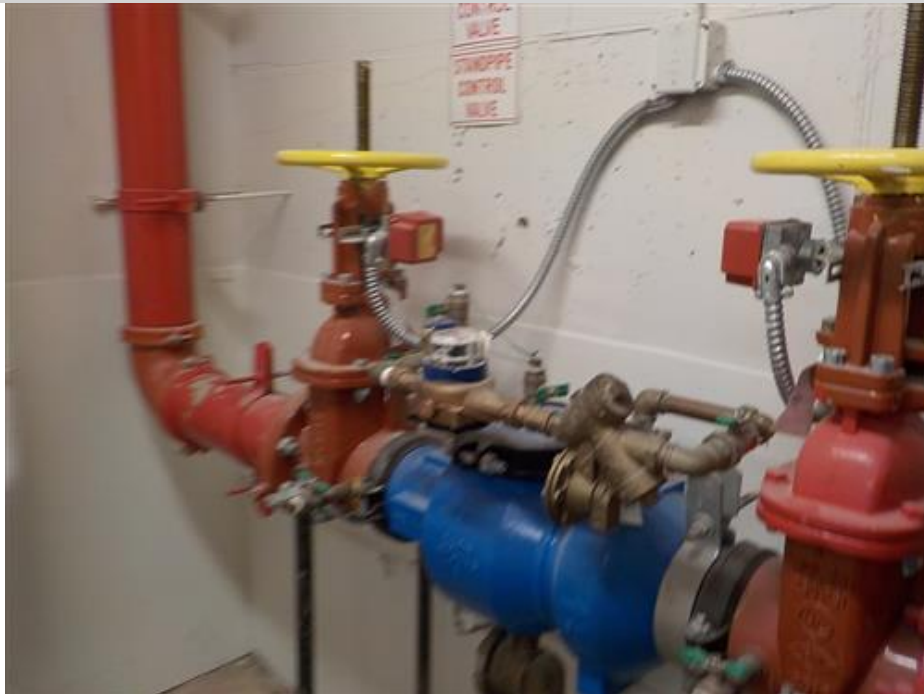
Photograph 26

Sprinkler

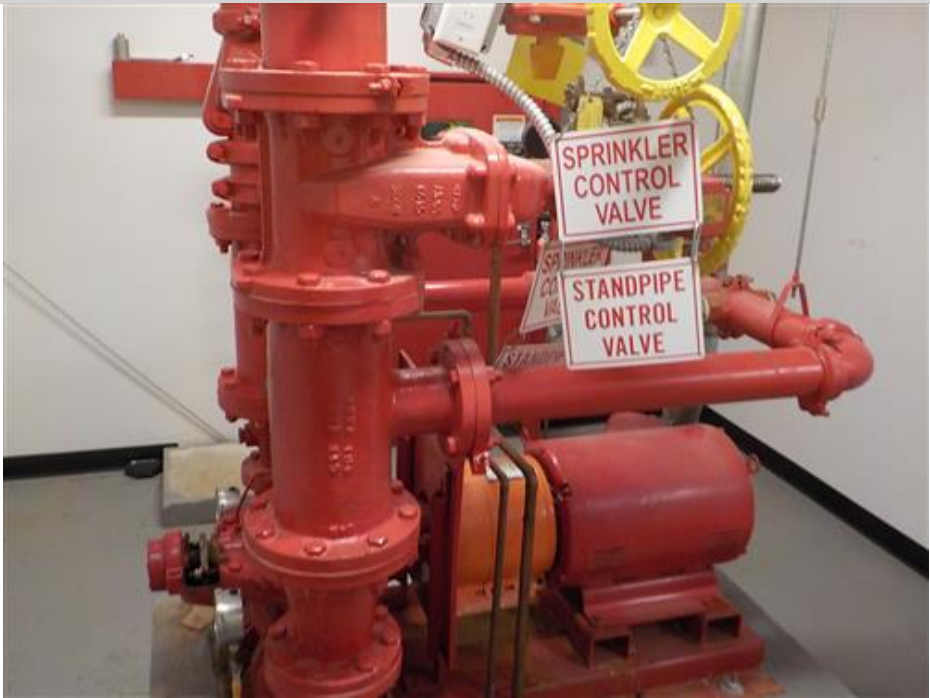
Photograph 27

Sprinkler

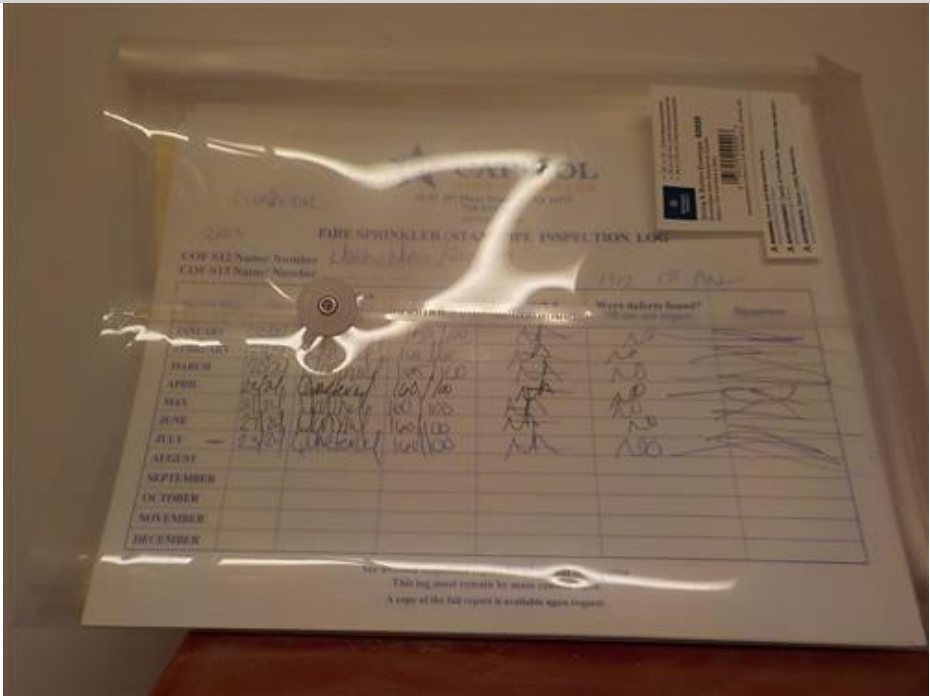
Photograph 28

Sprinkler inspection

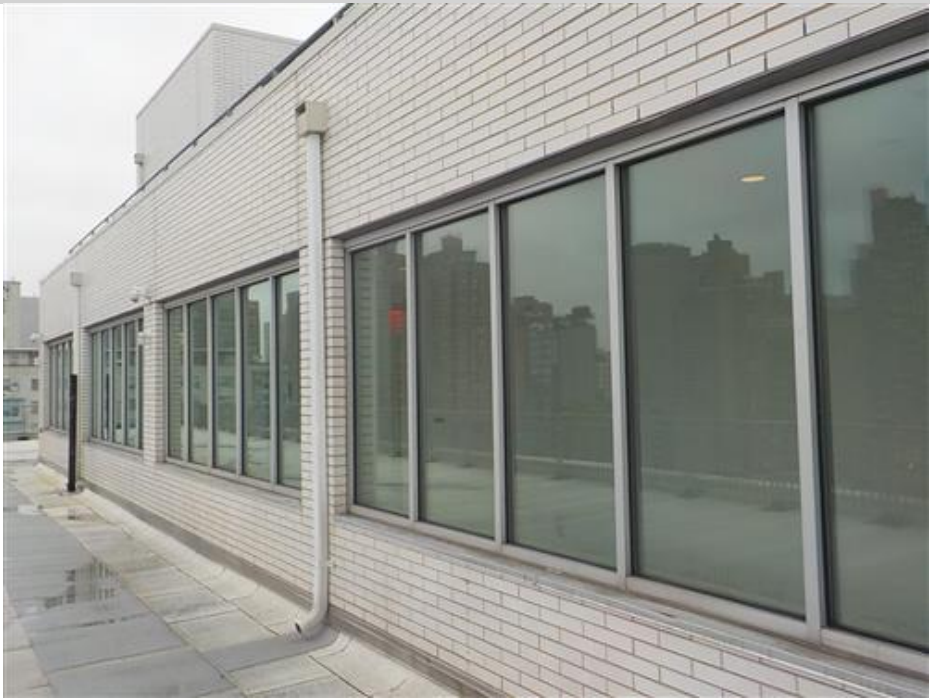
**Photograph 37**

Roof

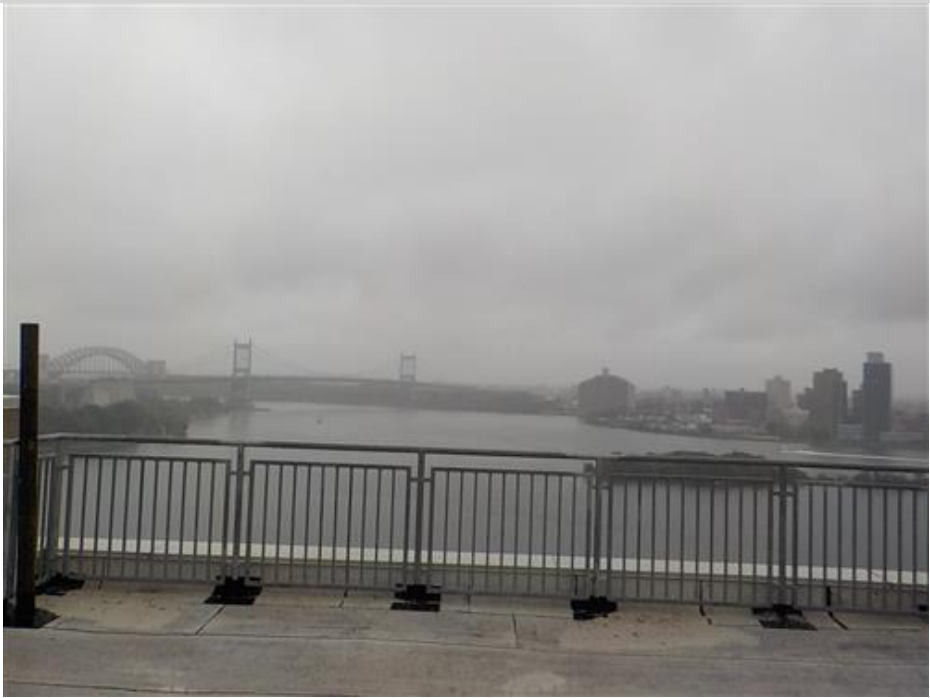
**Photograph 38**

Roof

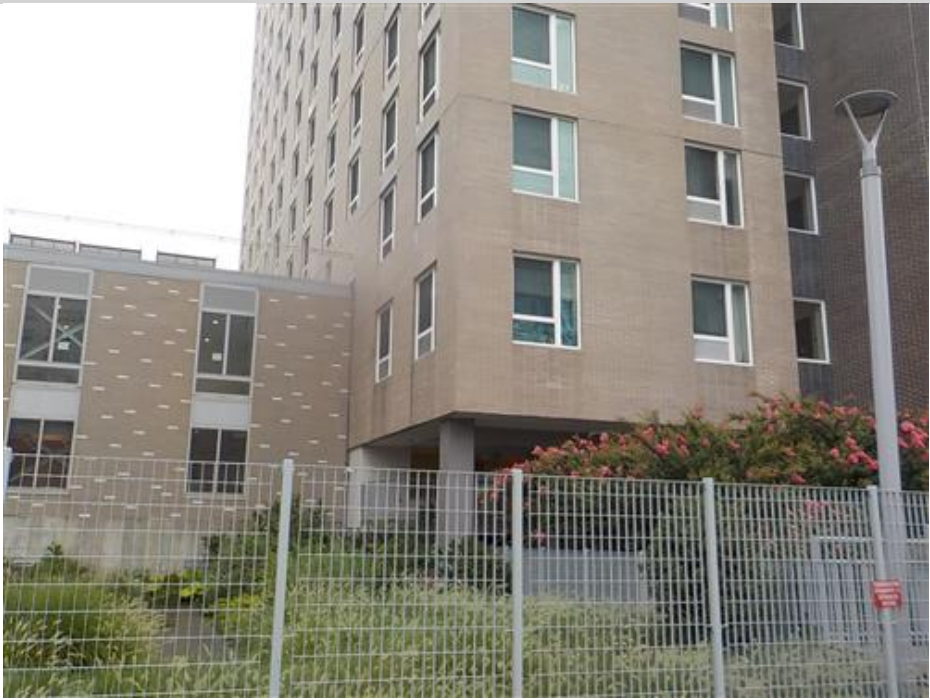
**Photograph 43**

Left side
