PDMS Microfluidic Chip Inspection

Manuel Robert Handta
Microfluidics Lab / Hochschule RheinMain

July 19, 2025

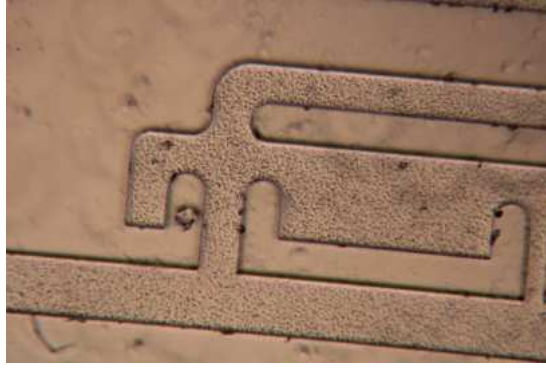
Particulate Contamination is shown in figure 1. A small particle is trapped in the channel, potentially causing partial blockage and disturbed laminar flow.

Figure 1: Particle trapped in channel.

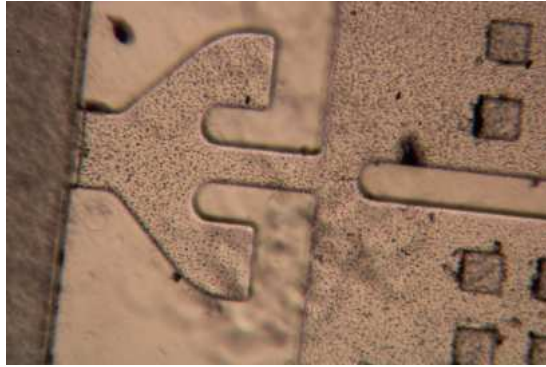
Figure 2 shows smearing on the microfluidic chip. Visible smear on the PDMS indicates a residue that might lead to uneven plasma bonding.

Figure 2: Smeared PDMS surface along channel wall.

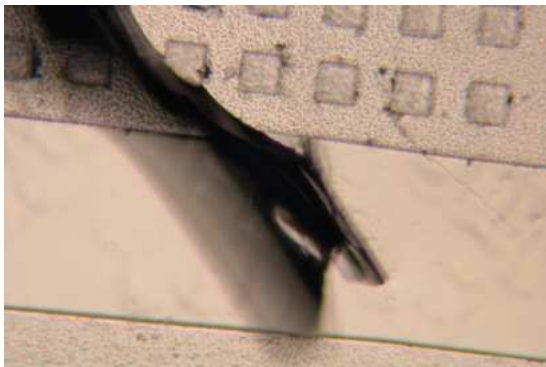
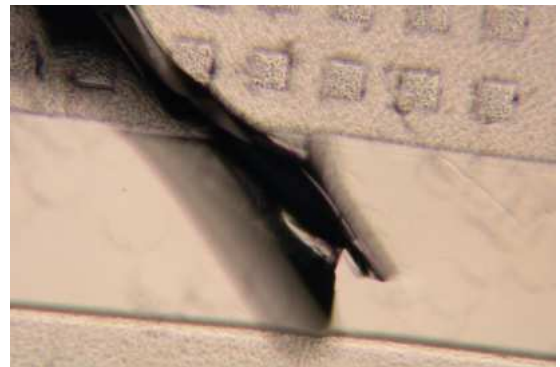
A Crack is shown in figure 3. The images portray the end of the crack that was caused by uncarefull extraction of the PDMS chip from the SU-8 mold. This would definitely cause leakage of the chip therefore making it unusable, except for inspection purposes. The figure also features a channel with elevated cubed structures: (left) focus at the channel floor and (right) with the cubes surface in focus.

Figure 3: Longitudinal crack imaged at the floor (left) and top of cubes (right) of the channel.

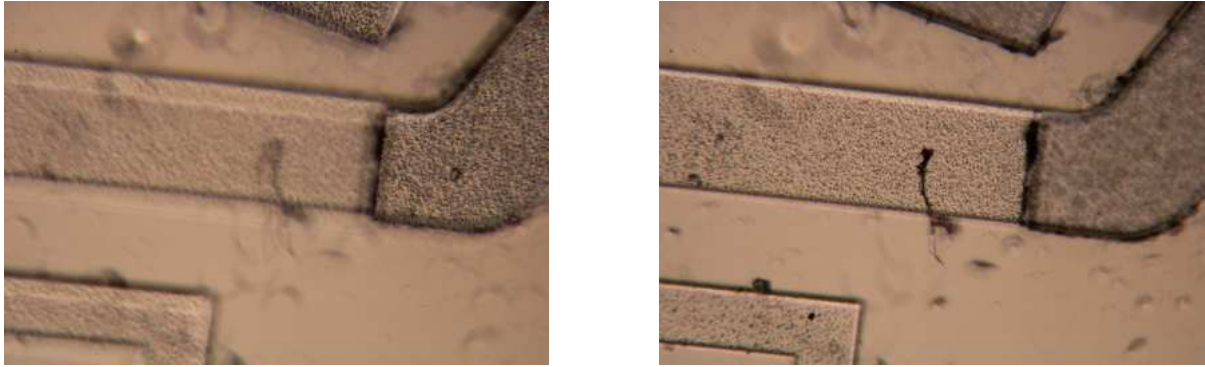
The last figures (Fig. 3) show a channel with a depth step. A region where channel depth abruptly changes. Left: focus on shallow section; right: focus on deep section. This abrupt change in height might create dead volumes.

Figure 4: Channel depth transition, shallow (left) versus deep (right) focus.
