FIELD REVIEW REPORT - #R003

Project No: 2021-0448-12 Date: December 16, 2025

Project: University of Waterloo –Math 4

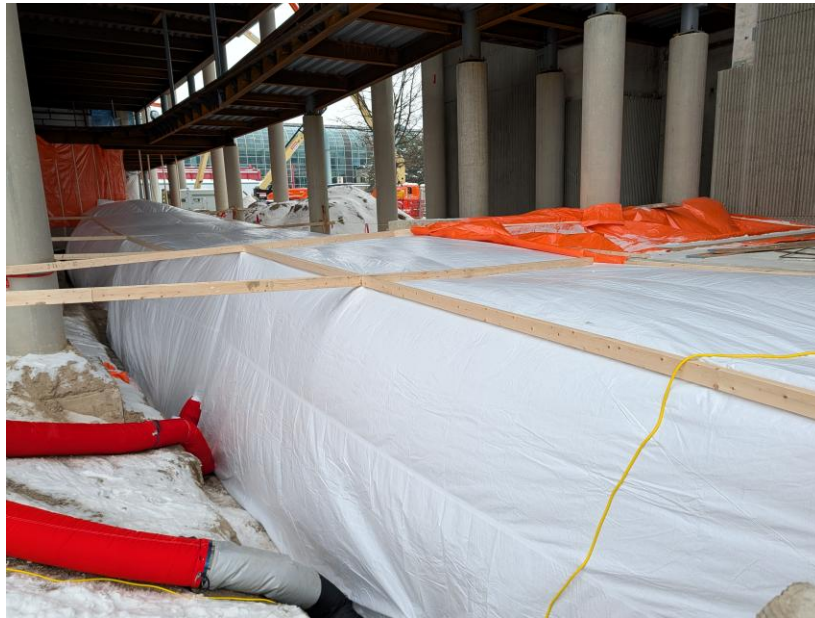
- R003-1 Tunnel extending south from Davis Centre has been backfilled.
- R003-2 Tunnels extending west to MC and north to GSC have been excavated. Existing waterproofing removed, concrete repairs in progress. Temporary enclosure for heating installed, see **Photo 1**.
- R003-3 Concrete beam over stair at MC installed.
- R003-4 The purpose of this visit was to review concrete surface preparation prior to next waterproofing application.

Photo 1: Enclosure for tunnel between M4 and MC

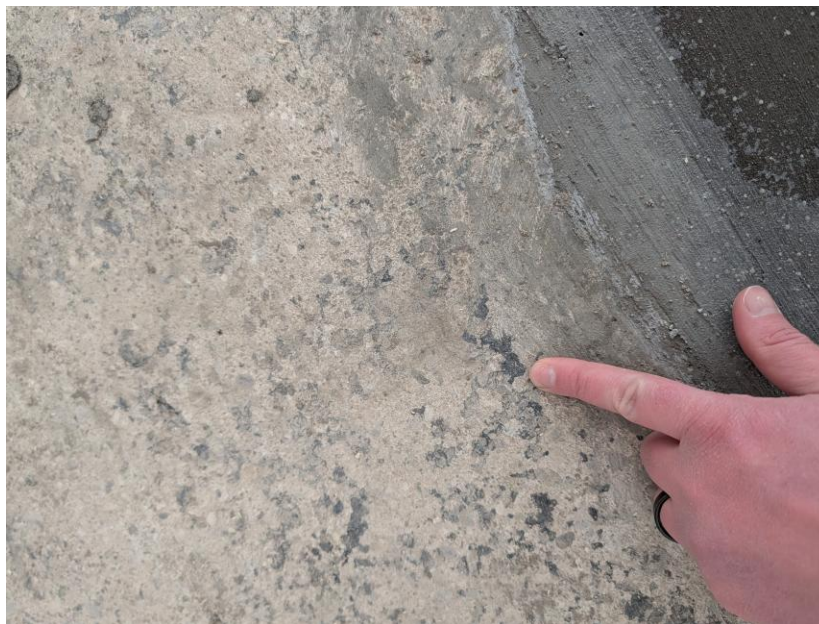
- R003-6 In general, the existing waterproofing is at least 95% removed (or better) for the first 20-30ft abutting the MC building with some additional grinding work required in localized areas. Elsewhere removals were considered poor. See **Photo 2-5** for examples of poor removals.

Photo 2: Example of waterproofing not fully removed (Minor spot, M4 side)

- R003-5 Tunnel observed with remnants of original waterproofing materials. Continue grinding in areas where remnants remain, see photos for examples of poor versus acceptable waterproofing (R003—5&6).

- R003-13 Removals sub indicated that the preparation is the result of float grinder in the area abutting M4. The waterproofing at MC was a different product and came off much easier. Sub indicated that removals went well at the removable hatch because this was done with a hand grinder. WF indicated that if going over the poor areas again with a float grinder doesn't improve removals, hand grinding may be required.
- R003-14 WalterFedy indicated to Gillam that many of the concrete repairs performed appeared to be poor quality, were cracked and/or unsound, and are not suitable for waterproofing application.

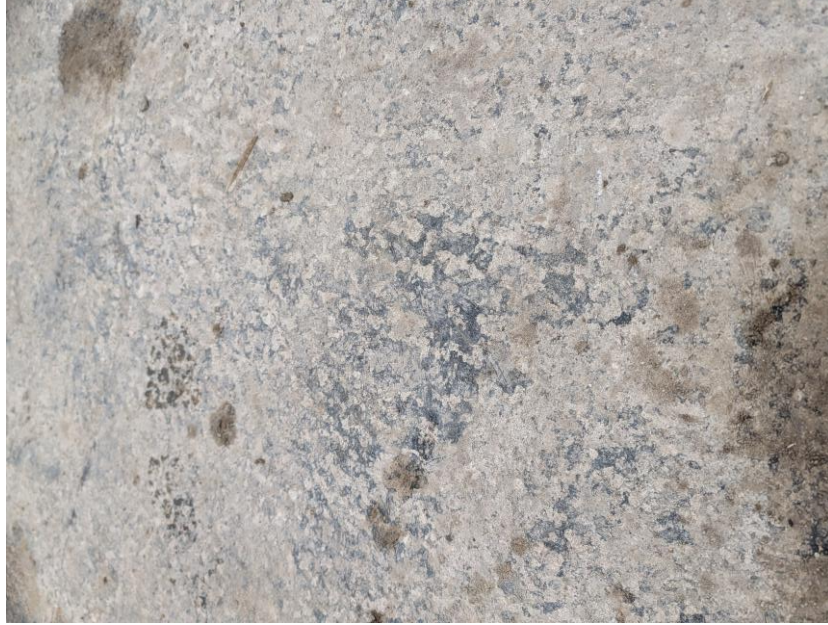
Photo 3: Example of waterproofing not fully removed (Many spots all over this photo, M4 side)

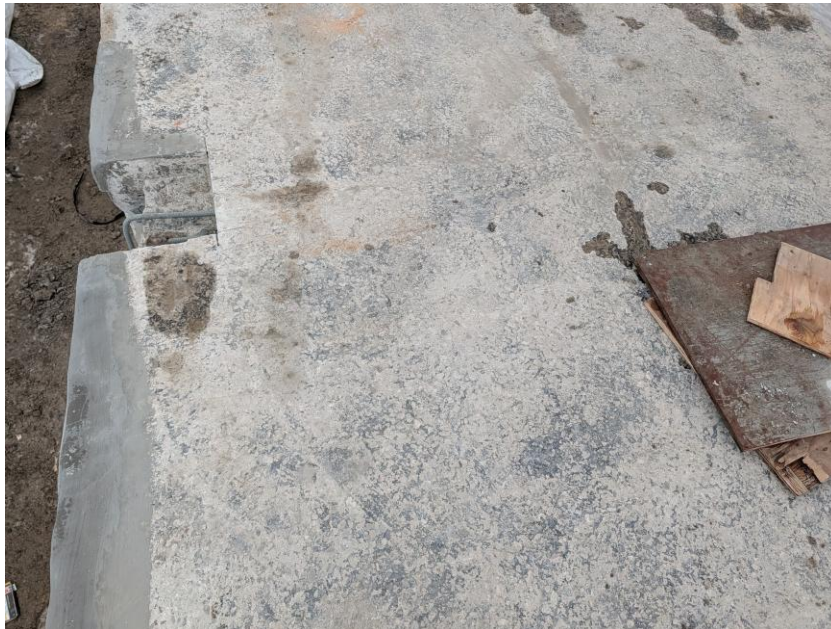
Photo 4: Example of waterproofing not fully removed (Many spots all over this photo, M4 side)

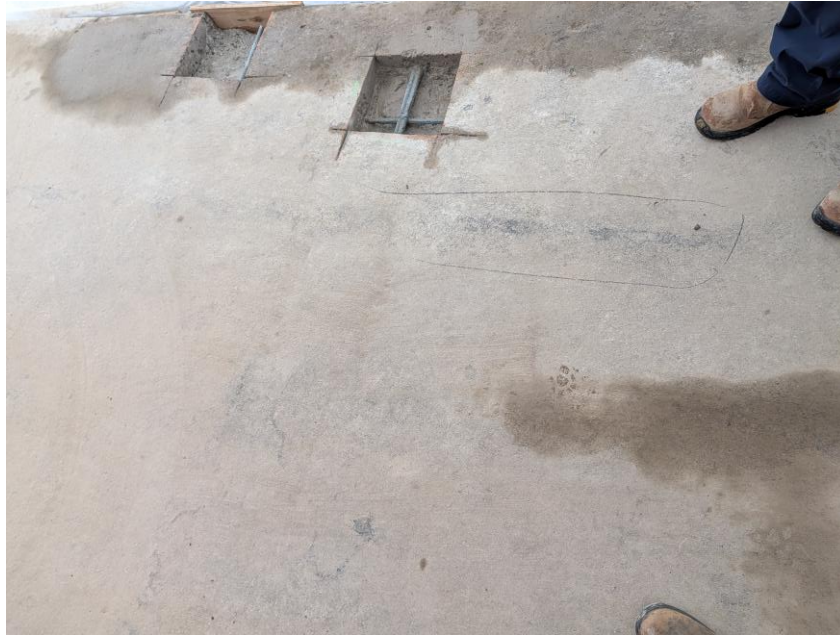
Photo 5: Example of waterproofing not fully removed (Stripe circled adjacent to concrete repair, MC side)

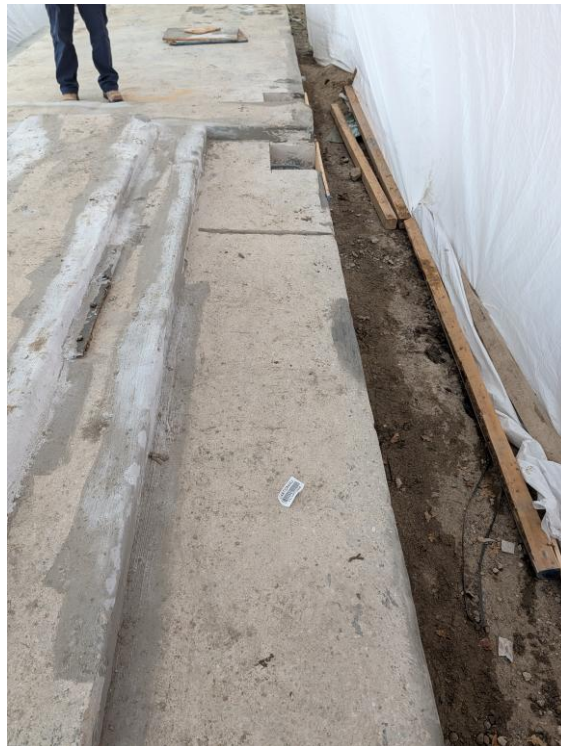
- R003-7 Removals around the removable hatch abutting M4 were considered acceptable (see **Photo 6** for example). The quality of waterproofing removals shown in **Photo 6** is to be used as a mock-up for removals in all other areas of tunnel.

Photo 6: Example of acceptable waterproofing removals (Removable hatch, M4 side)

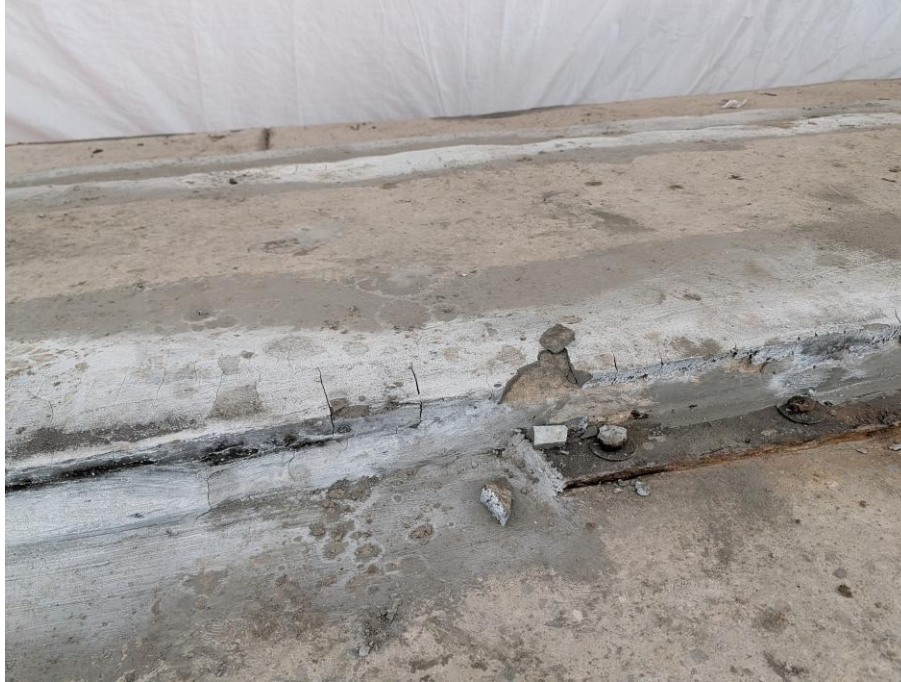
- R003-8 Many concrete repair appeared unsound and were cracked. The concrete was crumbling and falling apart in some areas, cracked in others. See **Photo 7-10**. Section 07 14 16 for cold-fluid waterproofing requires that surface patching shall have a bond of at least 1.5 MPa, which will not be achieved by the repairs performed.

Photo 7: Unsound concrete repair at removable hatch

- R003-15 Contractor to obtain direction from MTE on how to proceed with concrete patching in order to achieve 1.5 MPa bond to existing substrate. MTE to perform a 100% review of repairs performed in order provide sound concrete repairs for waterproofing.
- R003-16 After the concrete surface is ground again and 100% removals achieved, allow for follow-up inspection by WalterFedy to review waterproofing removals and surface preparation again prior to waterproofing.

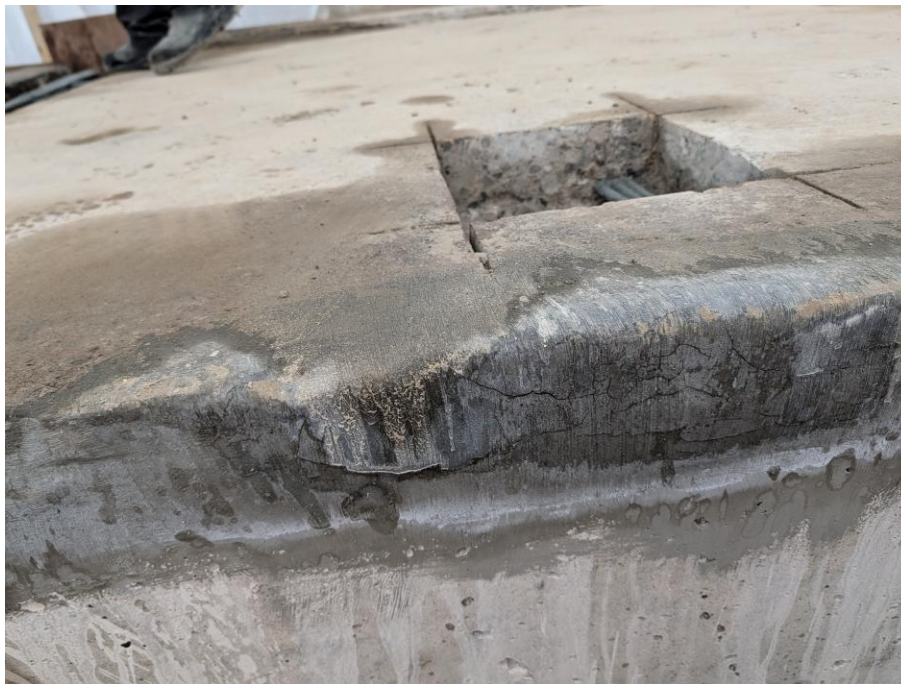
Photo 8: Unsound concrete repair at corner, MC side

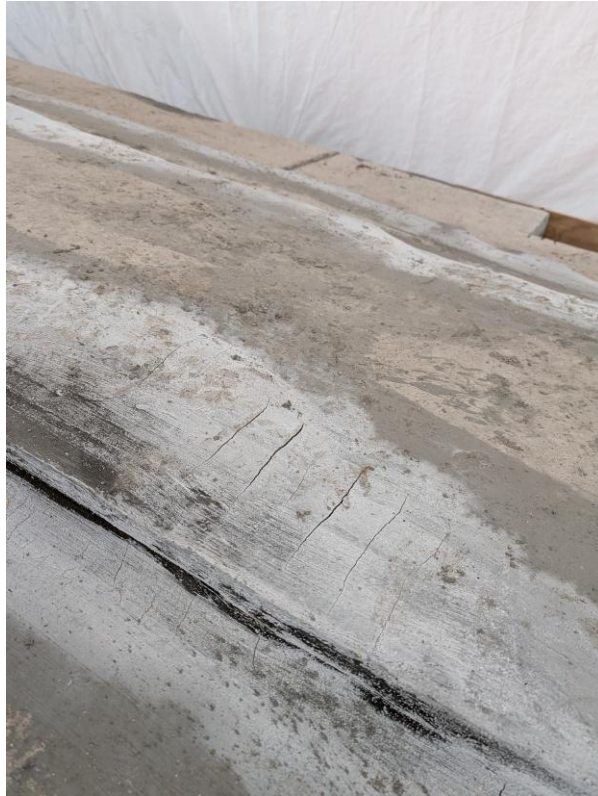
Photo 9: Cracked concrete in new repair, MC side

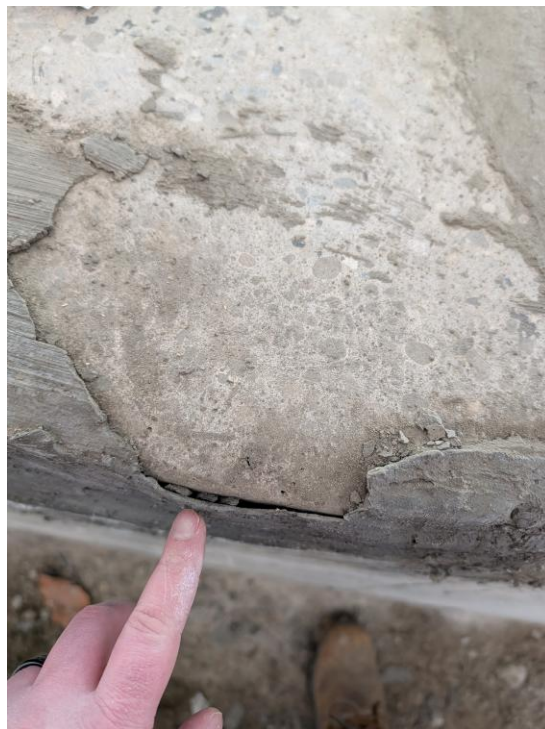
Photo 10: Concrete repair skimmed over existing tunnel

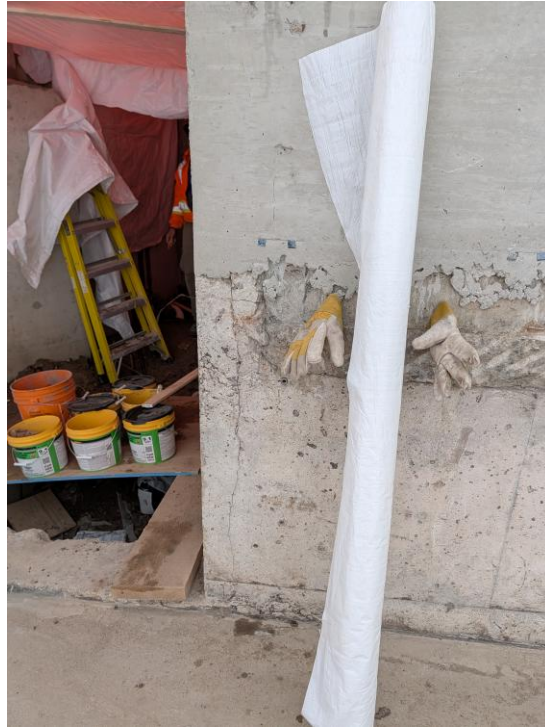
Photo 11: Foundation wall crack to be routed sealed, honeycombing to be repaired or filled with sealant

- R003-9 Cracks and honeycombing were observed in concrete. Ensure cracks are routed and sealed and honeycombs filled with sealant prior to waterproofing. See **Photo 11-12**.

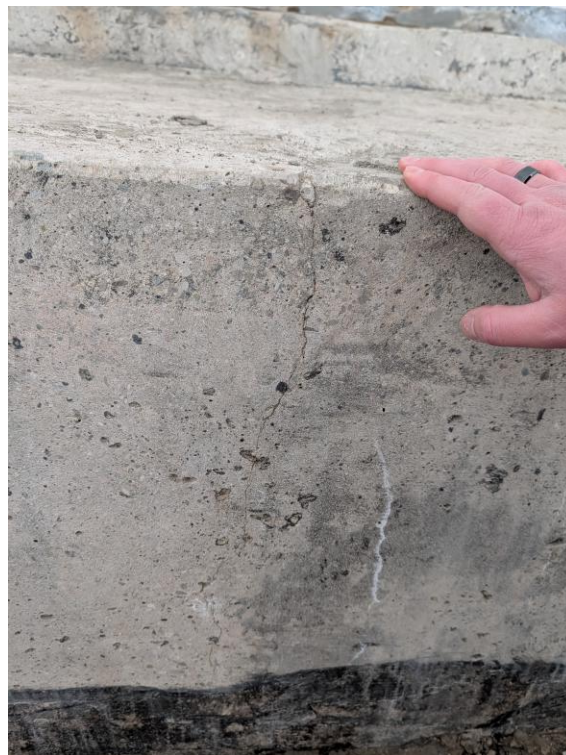
Photo 12: Tunnel wall/roof crack to be routed sealed

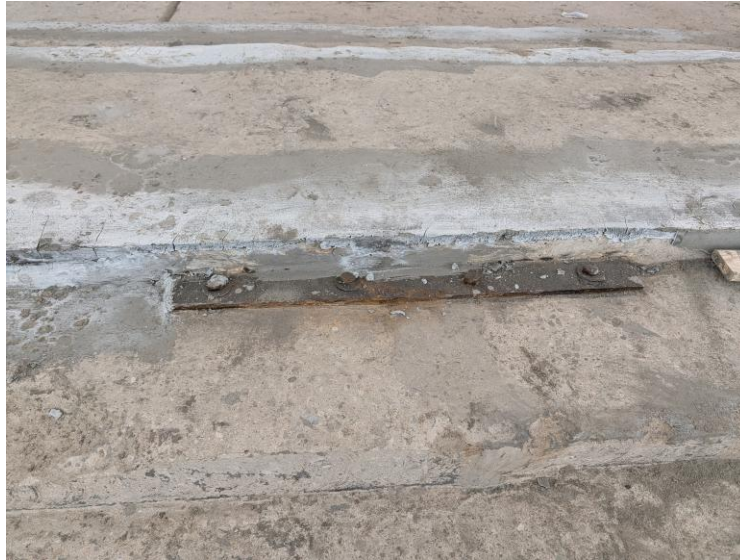
Photo 13: Steel plate each side of removable hatch

- R003-10 Steel connection observed at removable hatch, each side. Contractor to remove corrosion by grinding, apply sealant cants around edges of plate and around bolt heads prior to waterproofing. See **Photo 13**.

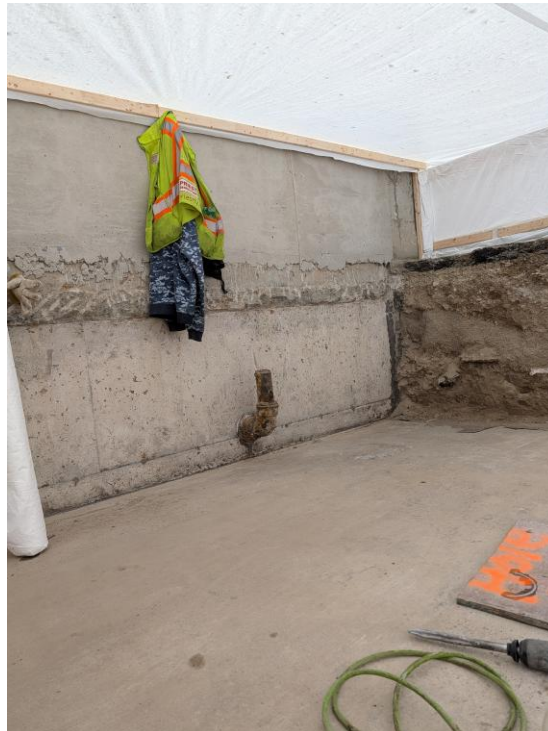
Photo 14: Sleeve through existing foundation wall

- R003-11 Sleeve observed through existing foundation wall at MC. Clean off corrosion and detail penetration as per the typical details. See **Photo 14**.

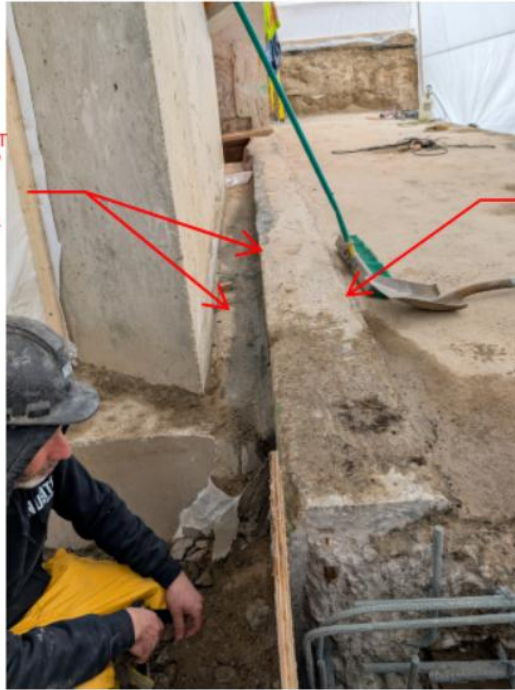
- R003-12 Stair foundation at MC prevents 24" waterproofing downturn. See **Photo 15**, provide waterproofing on existing footing and upturn at least 12" onto foundation wall.

Photo 15: Waterproofing detail at stair foundation

PROVIDE SEALANT CANT
E.S., WATERPROOF TOP
OF FOOTING, UPTURN
WATERPROOFING ON
FOUNDATION WALL MIN.
12" ABOVE FOOTING

GRIND CORNER,
PROVIDE SEALANT CANT
ALONG THIS EDGE
