FIELD REVIEW REPORT - #R001

Project No: 2021-0448-12 Date: November 20, 2025

Project: University of Waterloo –Math 4

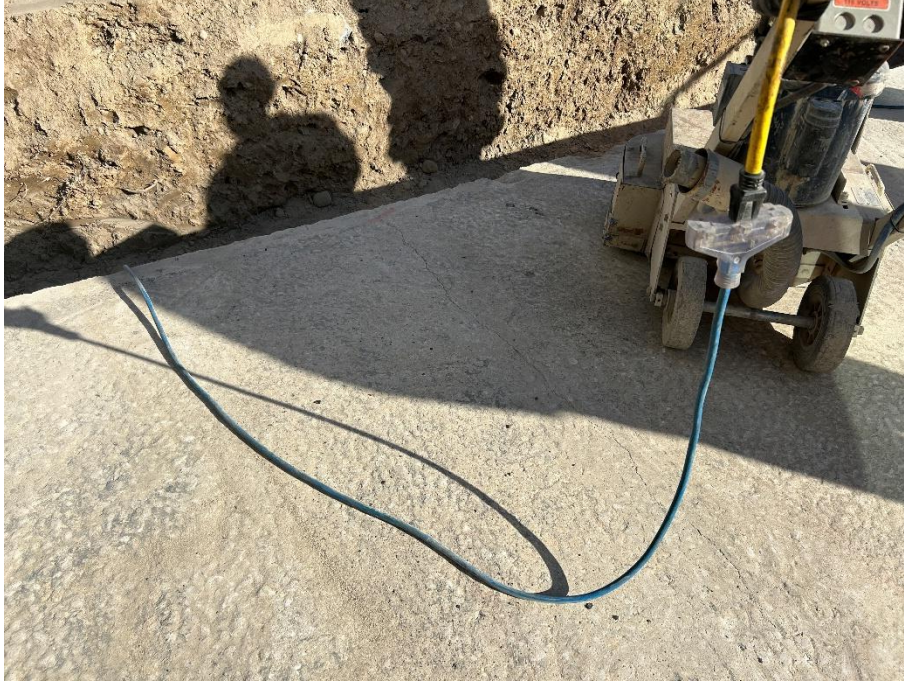
- R001-1 The South and West tunnels have been excavated and the south tunnel had mostly completed surface preparation at time of review.
- R001-2 WF noted that there were multiple minor cracks along the surface of the south tunnel. As per specifications, all cracks larger than 1/16" are to be routed a minimum of 1/4" wide and 1/2" deep then caulked with a compatible sealant as per the waterproofing manufacturer's guidelines.

Photo 1: Example of cracking along the South tunnel roof surface

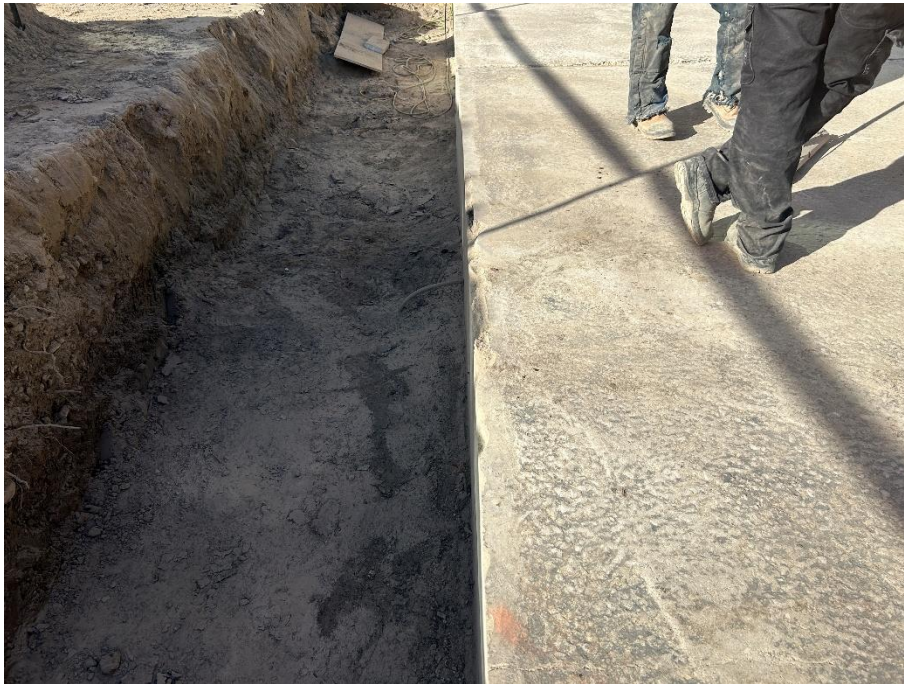
Photo 2: Condition of some South tunnel downturn corners

- R001-3 Some of the south tunnel corners were rough and irregular. Rough edges are to be ground smooth with downturns receiving a 1" chamfer such that no sharp protrusions remain.

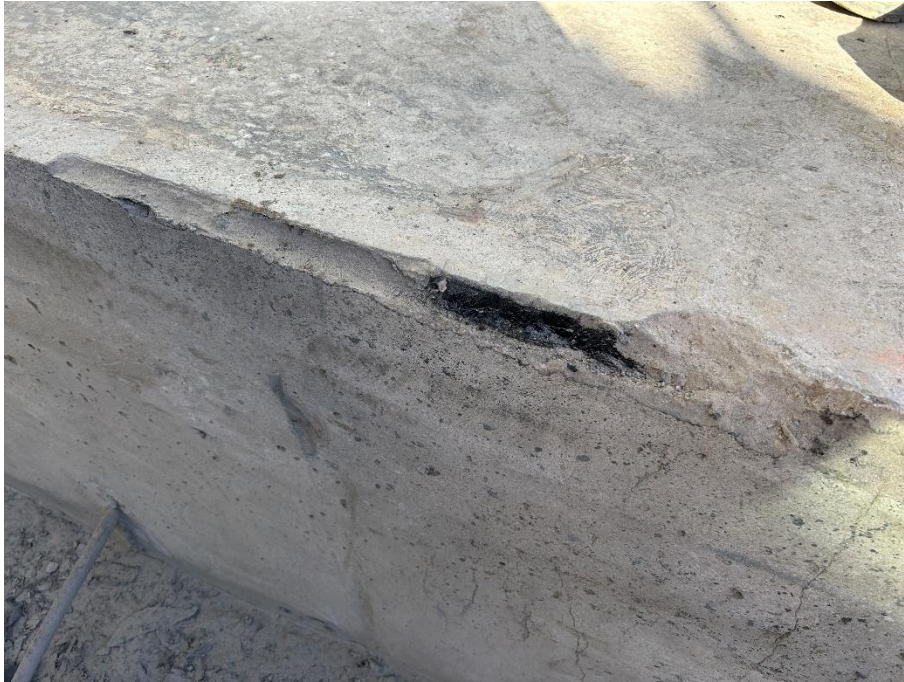
Photo 3: Small portion of original waterproofing remaining at South tunnel (to be ground off)

- R001-4 One area was noted on the south tunnel where a small portion of the original waterproofing remained. All areas of waterproofing are to be ground off to 100% removal.

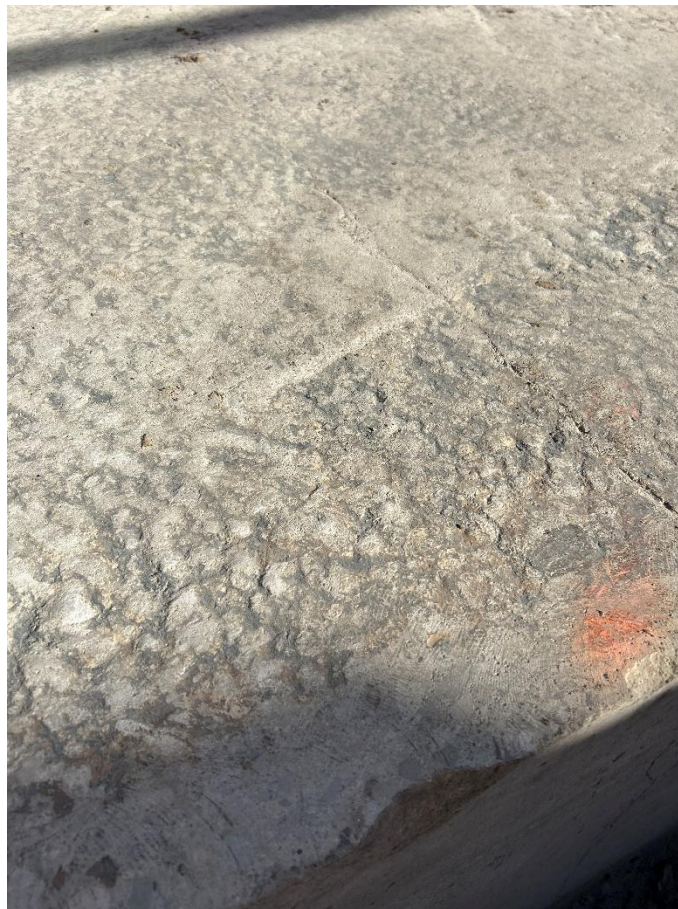
Photo 4: Rough surface condition of some areas at South tunnel (divots to be filled in, detail coat provided)

- R001-5 WF noted that in some areas of the South tunnel, the concrete surface was rougher than the specified CSP 3. Local divots should be filled with specified compatible sealant and a 60mil detail coat over top. Otherwise, the slightly rough area is acceptable.

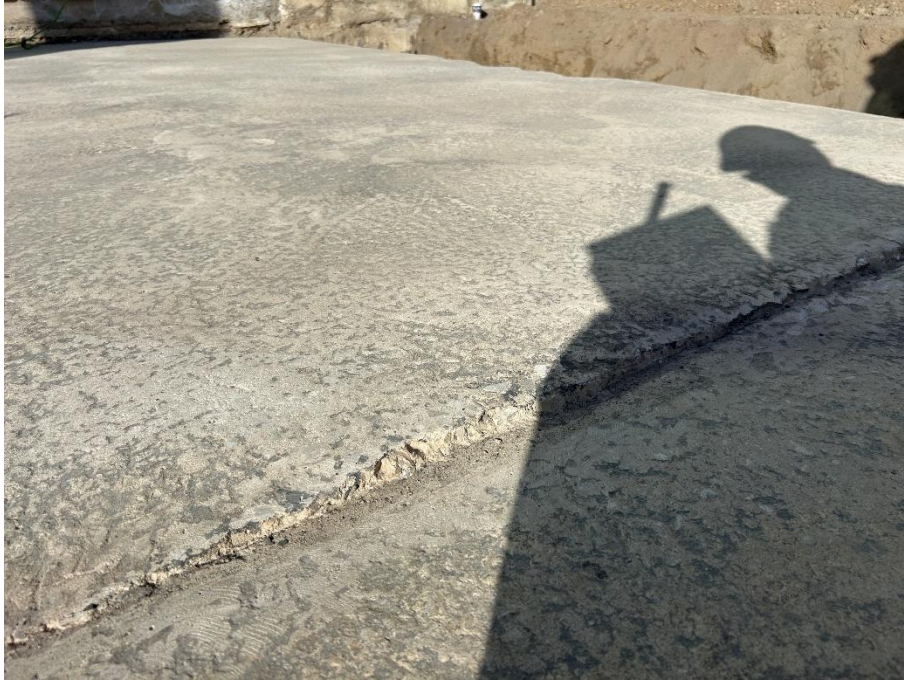
Photo 5: Step on South tunnel surface (grind down and provide sealant cant)

- R001-6 WF noted a small step on the surface of the South tunnel. This edge should be ground down following a similar process for the specified edge detailing. A sealant cant should be provided for a smooth transition.

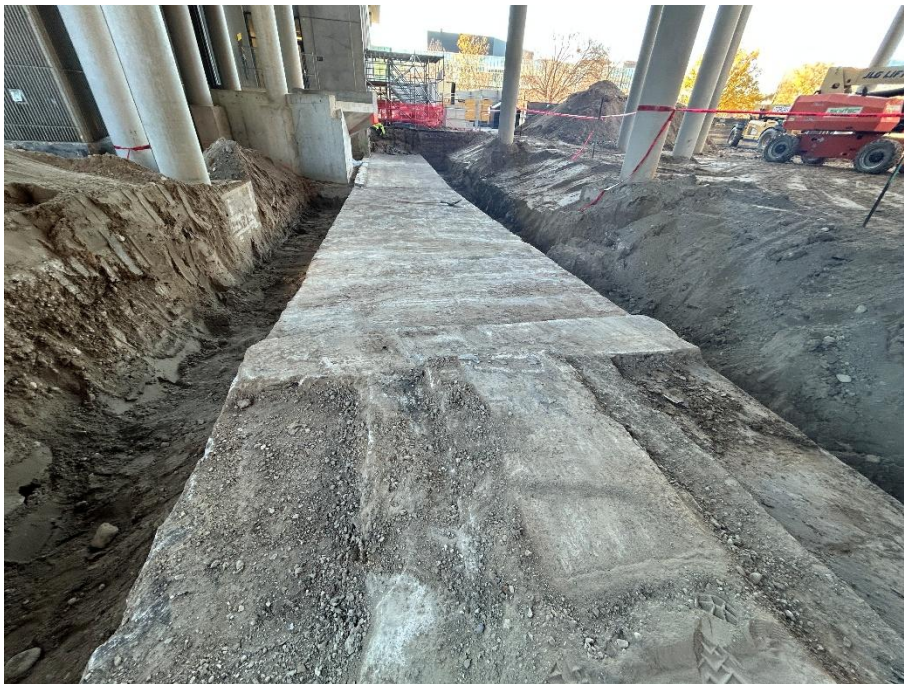
Photo 6: General condition of West tunnel

- R001-9 The West tunnel has a very rough surface and change in elevation where there is a hatch in the tunnel roof. WF recommends that the Contractor arrange for the waterproofing manufacturer to come to site to provide a recommendation of surface preparation under these conditions.
