POST-TENSION INVESTIGATION AND 5 YEAR PLAN – JURAVINSKI CONCESSION GARAGE

HAMILTON HEALTH SCIENCES

Project No.: 2025-0534-10

December 2nd 2025

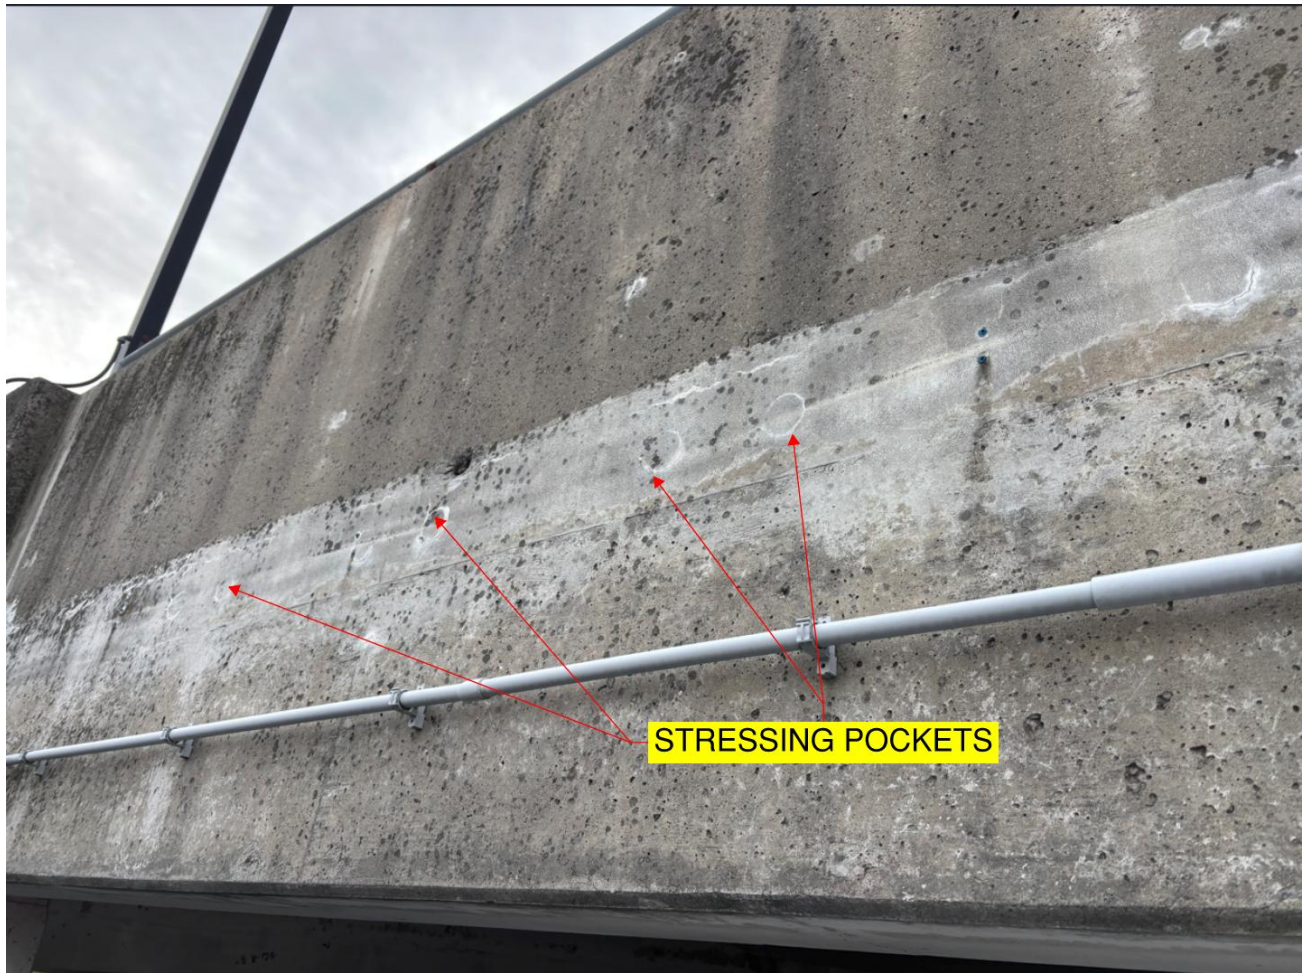
Photo 1: Stressing Pockets at Roof Deck

Stressing pockets were visible only at the top level of the parking garage. All other areas were not visible due to the masonry cladding on the perimeter and structures concealing them. The stressing pockets observed showed no signs of leakage, PT coating stains, or other signs of deterioration. (See Photo 1) Signs of early stage efflorescence around pockets at both sides of the garage roof were observed. The stressing pockets were typically observed with shrinkage cracks around the cold joint to the parent concrete.

- Replace leaking traffic deck expansion joint at roof deck, complete with polyurethane waterproofing tie-in to existing membrane (Do not use epoxy traffic coating).
- Replace leaking membrane-based expansion joint around stair/elevator cores. The current membrane joint is more susceptible to leaks than a compression foam expansion joint or rubberized gland joint. We recommend one of these two systems in this application.
- Repair damaged waterproofing at perimeter concrete curb.
- Provide waterproof coating over exposed stressing pockets around roof deck.

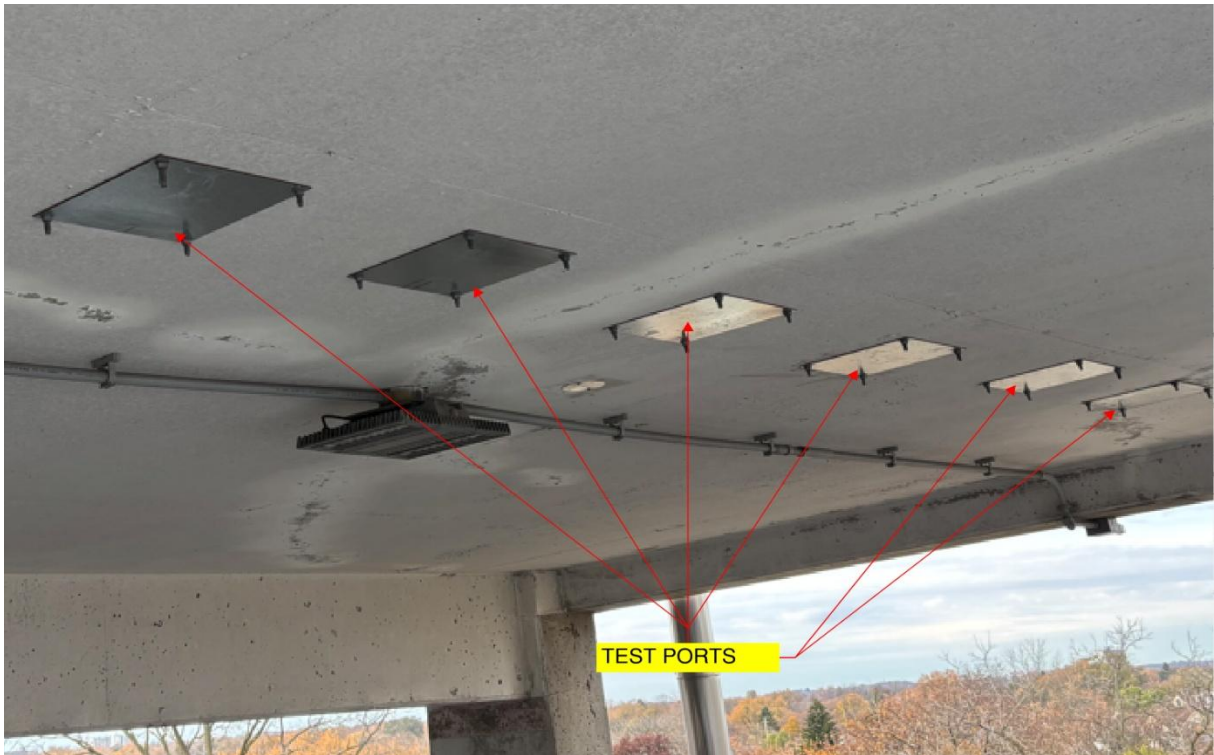
Photo 2: Test ports on underside of slab

Test ports were observed on slabs and beams at each level. Specific test ports that were reviewed in 2024 had information regarding the test results which all indicated the tendons were in good condition. The Appendix A provided shows exact locations of the test ports observed on the different levels (See Photo 2 and 3). Test ports were typically located at end parking bays. There were few test ports at the interior of the parking garage.

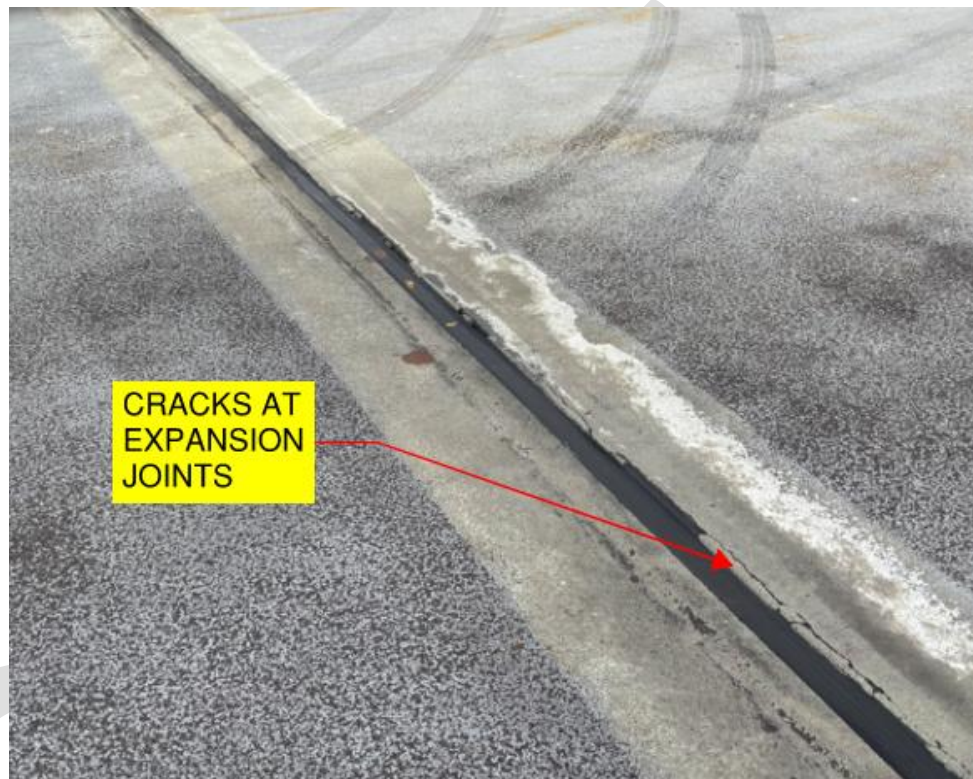
Photo 4: Expansion joint with cracks

One expansion joint and the traffic coating adjacent at the roof deck showed signs of cracking and deterioration (See Photo 4). This expansion joint when observed from level 5 below shows dampness saturating the concrete beams on either side of the expansion joint (See Photo 5). This area was displaying signs of active water leakage during the time of review. The other expansion joints, did not show any dampness or leaking water below. Many beams at expansion joints were observed at all levels with narrow longitudinal cracks centred about the width of the beam. These cracks were typically located at the mid-span of the beam. No beams were observed with flexural cracking patterns.

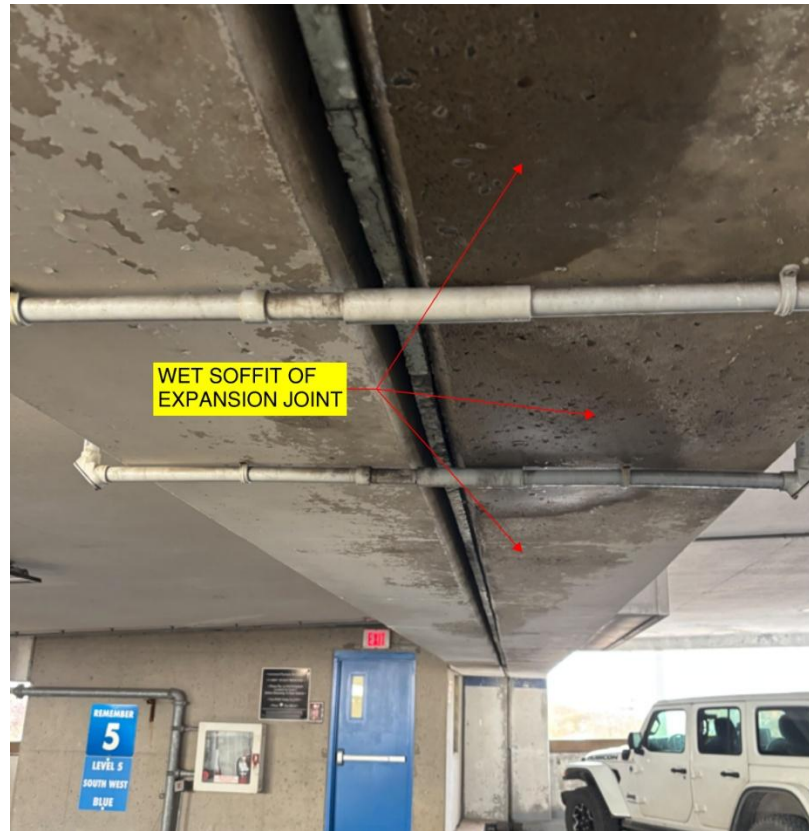
Photo 5: Beams at leaking roof expansion joint

The leaking expansion joints at the roof deck has saturated the concrete beams below on either side. Although this leak did not appear to be penetrate the unbonded tendons in the slab, its likely to be saturating the bonded post-tensioning in the beams and/or its corrugated metal duct. If this leak is not addressed, in our opinion it's likely that the bonded tendon in the beam will be corroded and lose strength over time. Its also possible that water may migrate into the encapsulated tendons in the slab over time.

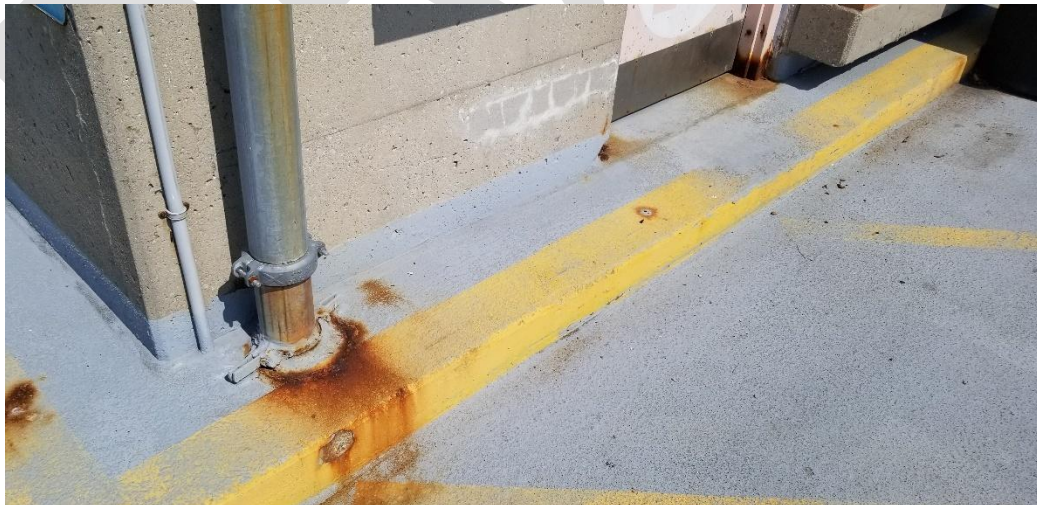
Photo 6: Expansion joint at Stair #1 and Elevator

The concrete expansion joint around the Stair #1 and elevator on the north side of the parking garage at the roof level was observed with a concrete bulkhead below, which appeared to be the result of a leaking expansion joint. This expansion joint is detailed with a curb that is continuously waterproofed with an upturn. The joint is sealed with what appeared to a caulked joint covered with waterproofing.

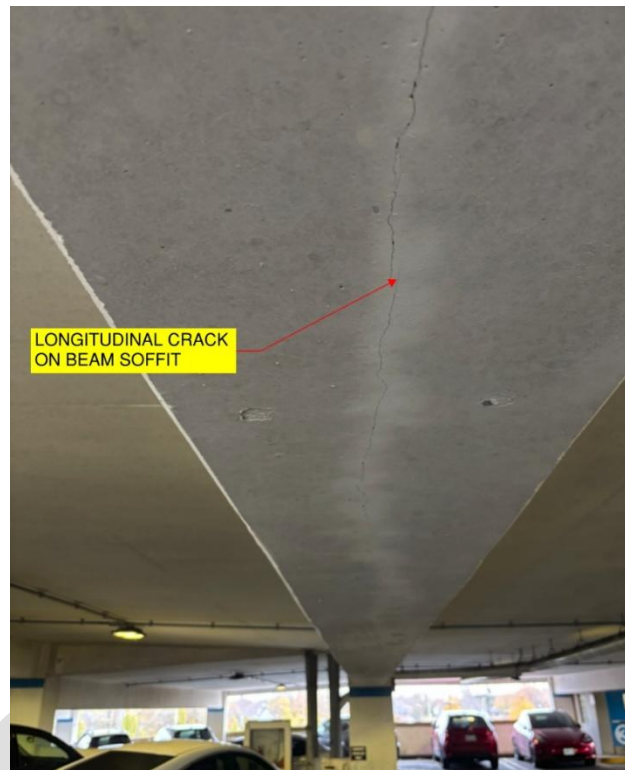
Photo 7: Typical longitudinal beam crack

Numerous concrete beams not located at expansion joints were observed with hairline longitudinal cracking. These cracks were typically located at the mid-span of the beam (See Photo 7). No beams were observed with flexural cracking patterns.

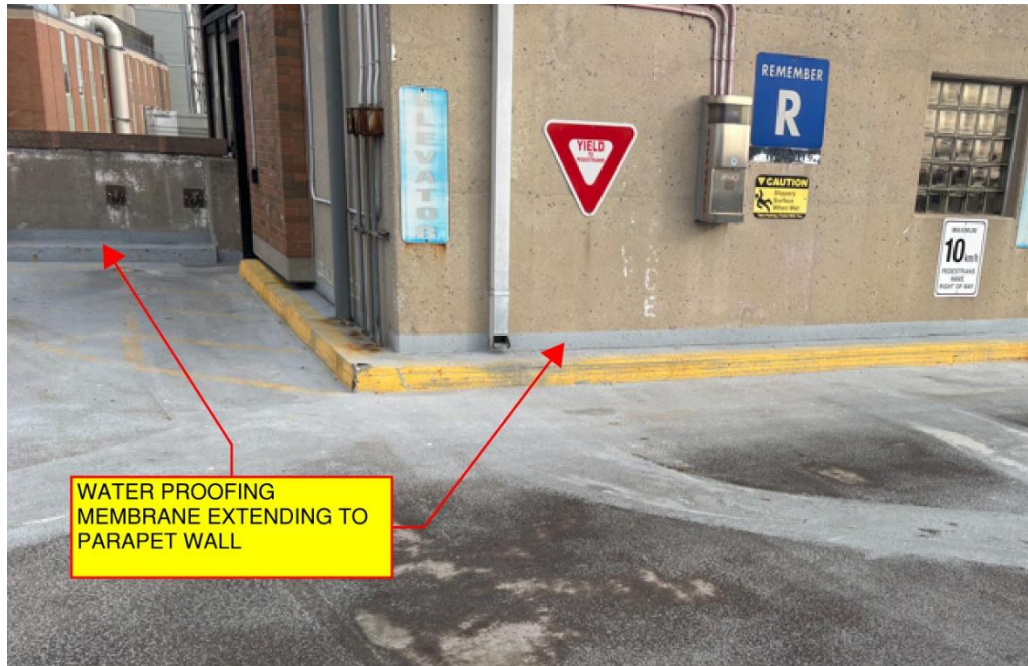
Photo 8: Water proofing membrane extending to parapet.

The waterproofing membrane at the roof deck appeared to be a polyurethane-based product, except adjacent to expansion joints a more brittle epoxy type material was observed that did not appear to contain waterproofing. The membrane was found to be significantly deteriorated at the drive aisle. The membrane was detailed on the perimeter concrete curb around the parking deck with an upturn (See Photo 8).

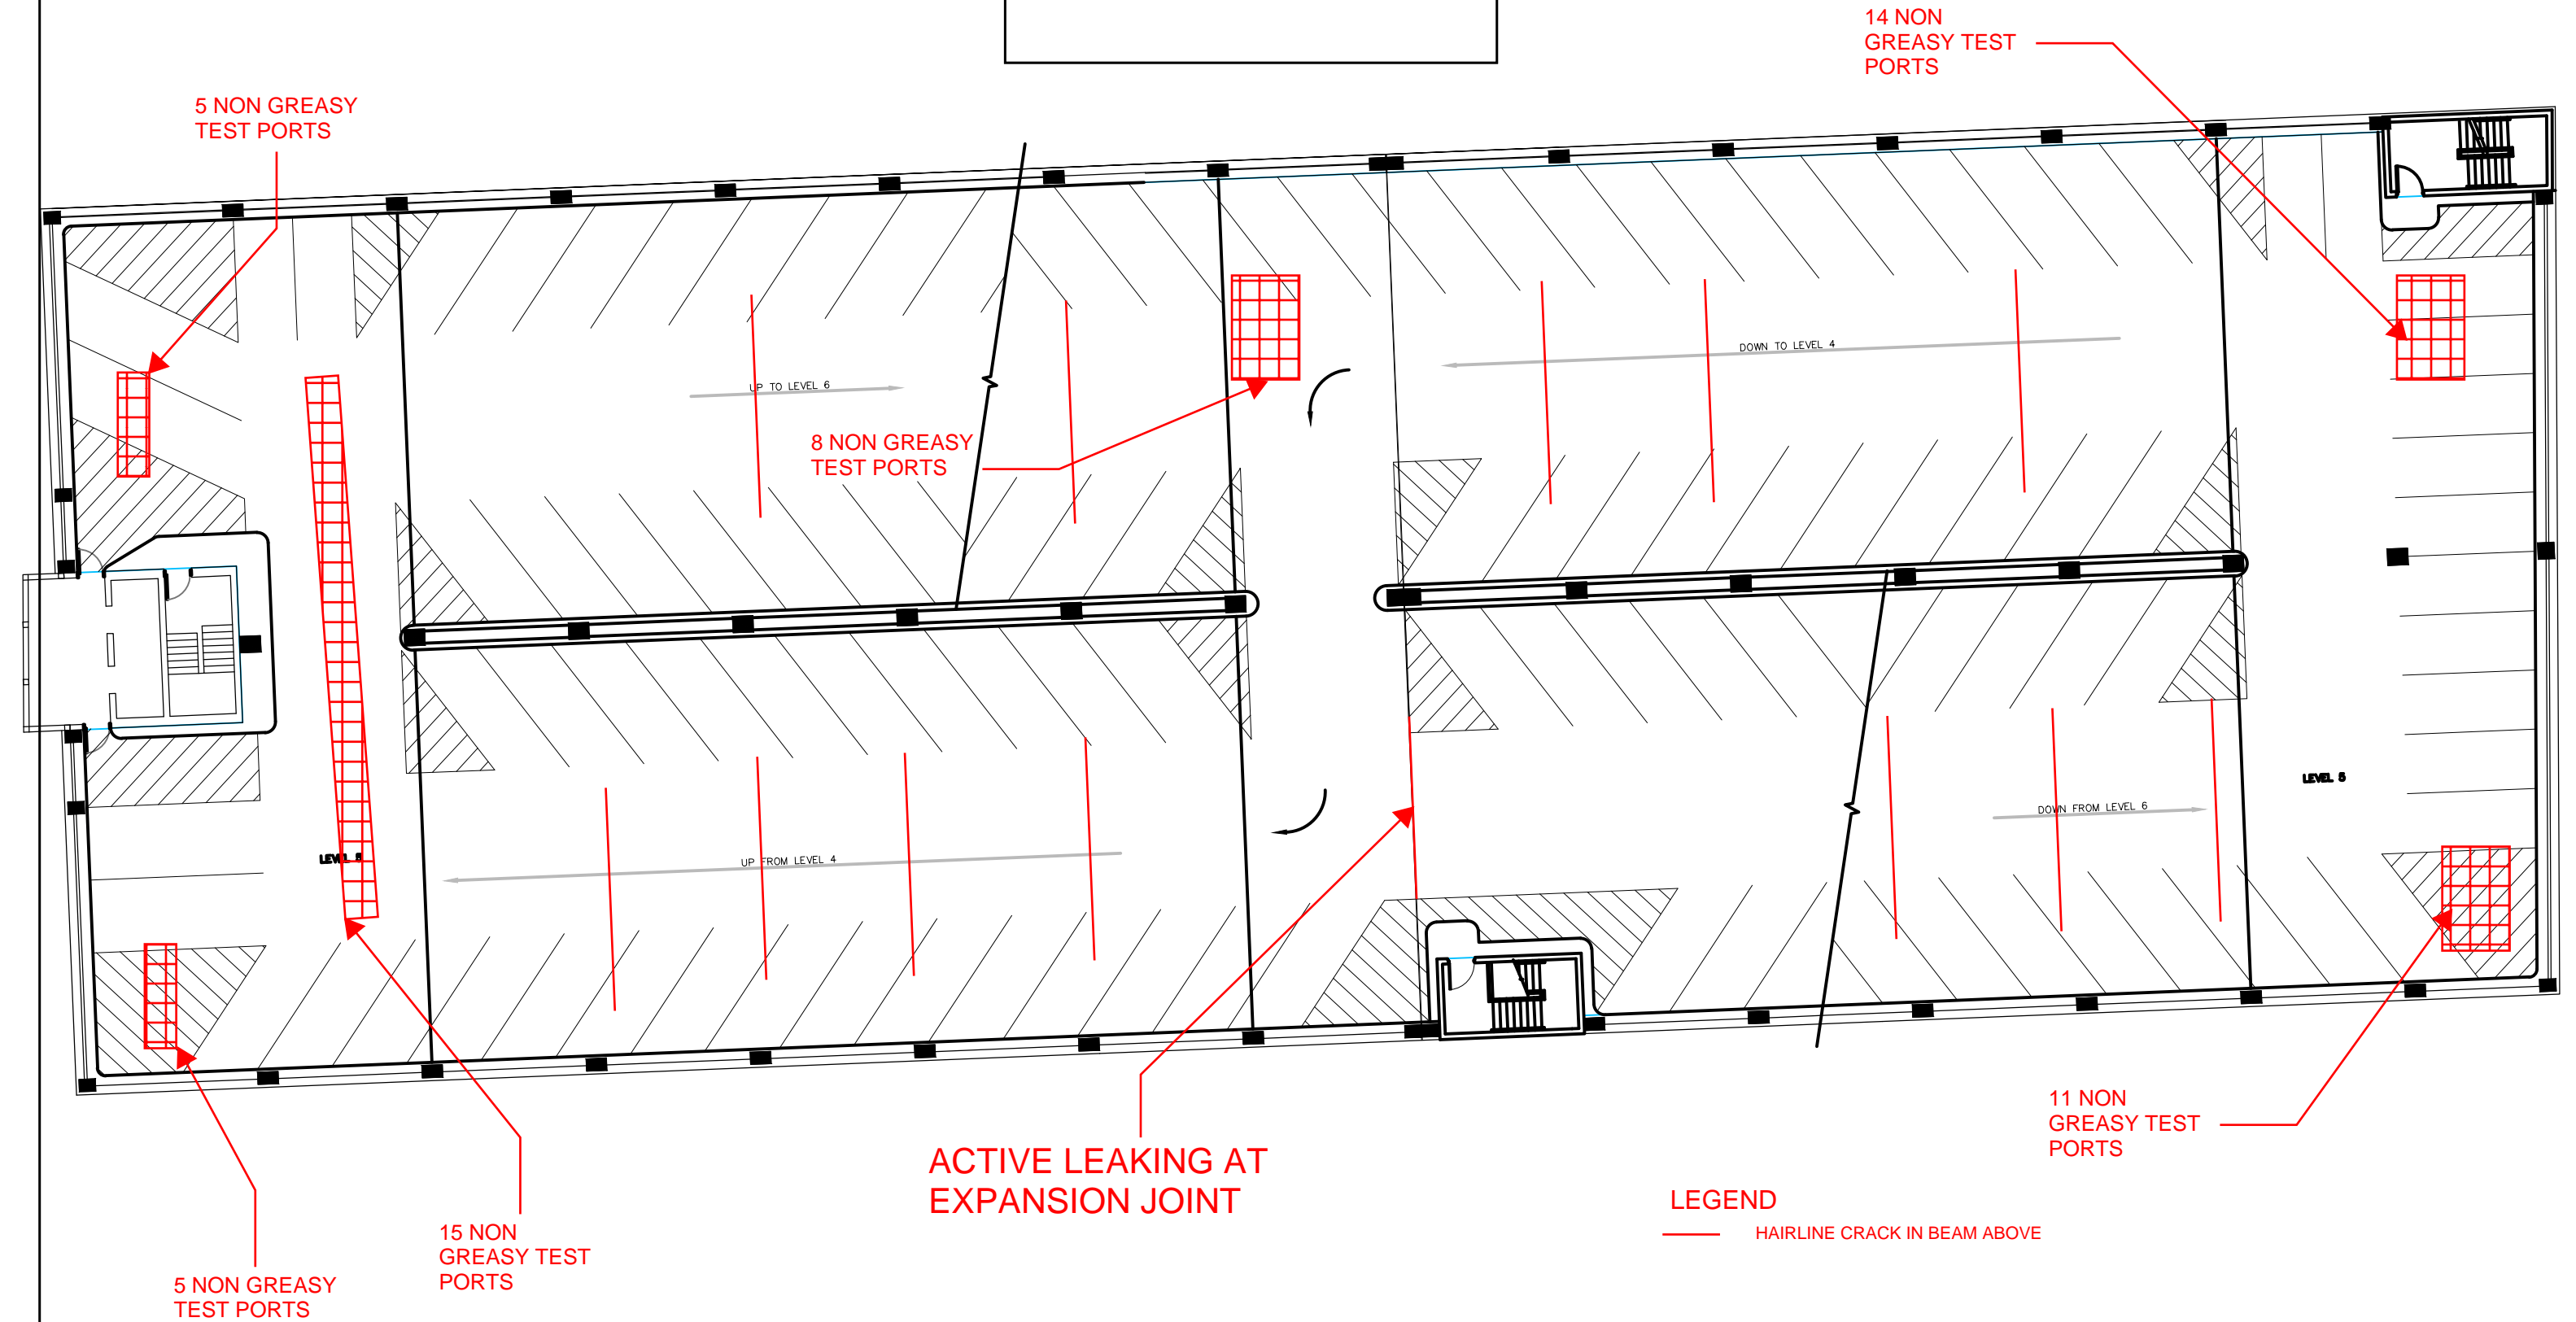
LEVEL 5

ACTIVE LEAKING AT EXPANSION JOINT

5 NON GREASY TEST PORTS

15 NON GREASY TEST PORTS

11 NON GREASY TEST PORTS

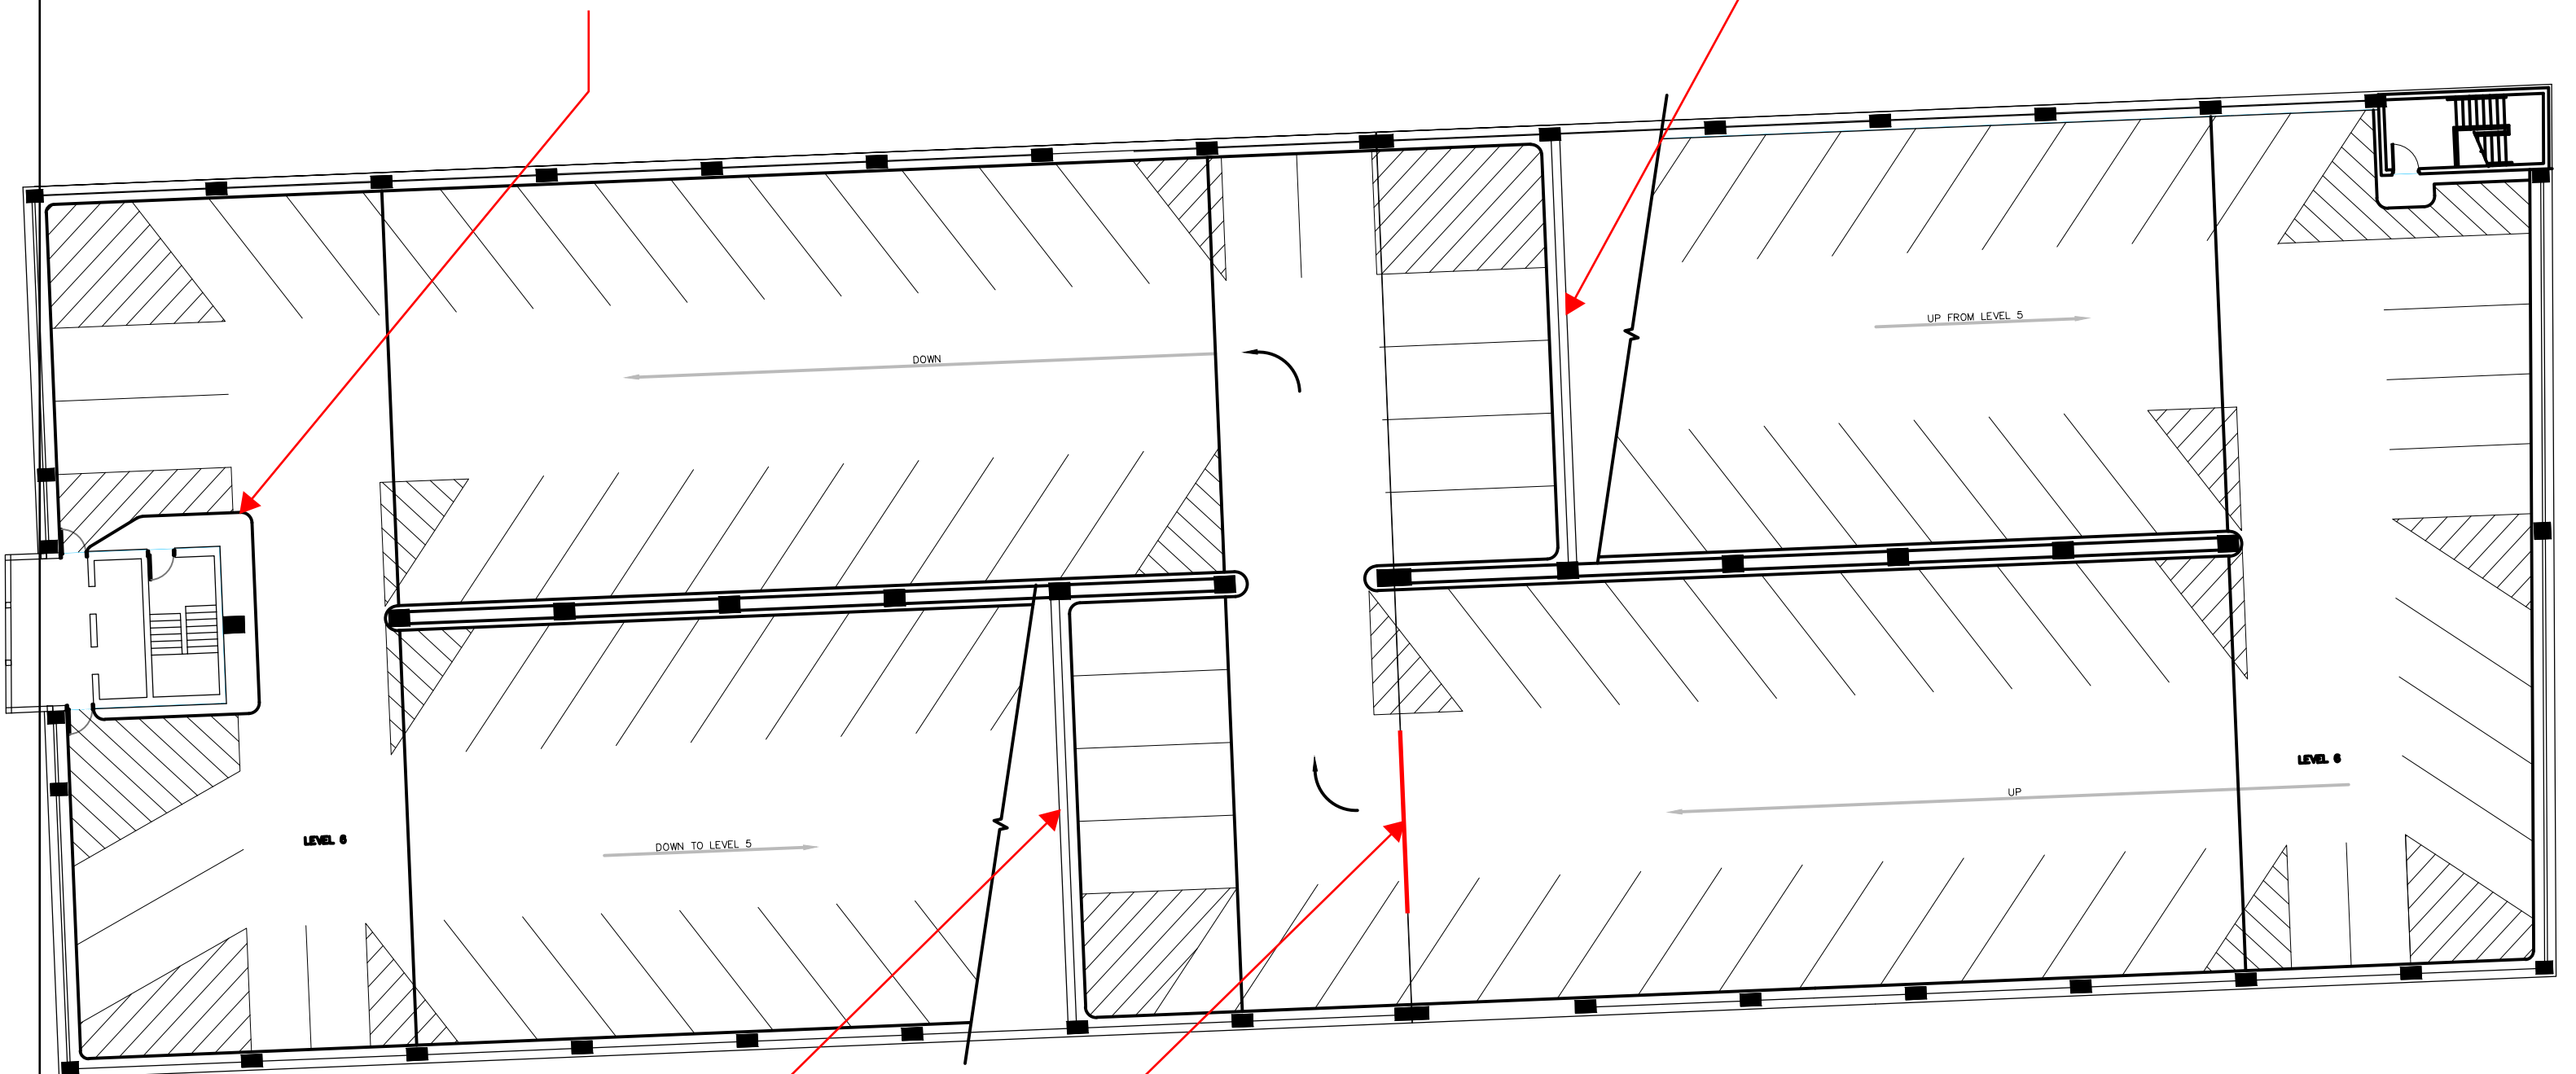
LEVEL 6

EXPANSION JOINT AT STAIR WALL
SEALED WITH CAULKED JOINT

STRESSING POCKETS
SHOWING EARLY SIGNS OF
EFFLORESCENCE

CRACKS AT EXPANSION
JOINT
