FIELD SERVICE BULLETIN

NUMBER: 624

PRODUCT Chameleon Vision

PURPOSE Inform Field Service of a potential field failure of the Vision shutter actuator

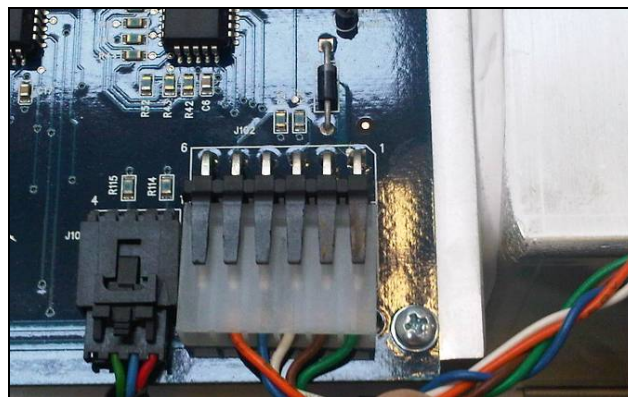
Figure 1

The supplier of the shutter actuator has wired some of the actuators incorrectly. The correct wiring is shown in Fig 1 and Fig 2 above. The J102 connector on the Verdi head board should be wired from pin 1 to pin 5 as Green, Brown, White, Blue, and Orange. We have checked all of our stock and discovered that some of the connectors have the Blue & Orange wires (pins 4 & 5) reversed.

The shutter initially works with this configuration sufficiently to get through the build phase, but after a short period of time the opto-coupler will fail.

ACTION REQUIRED For any Vision laser that is not yet installed, the outer lid should be removed before powering on and the J102 connector should be inspected for the correct wiring. Should you identify one that is wired incorrectly, it is safe to swap the wires over. If you identify one that has failed with the symptoms described above, a replacement shutter actuator is required. The replacement is a simple job but access to the underside of the laser is required.
