Brittle Fracture Analysis of a Bicycle Chain Tool

Carlos Cabrera, Fernando Davis, Nicolás Meyer, Juan Ignacio Odone, Martín Salinas

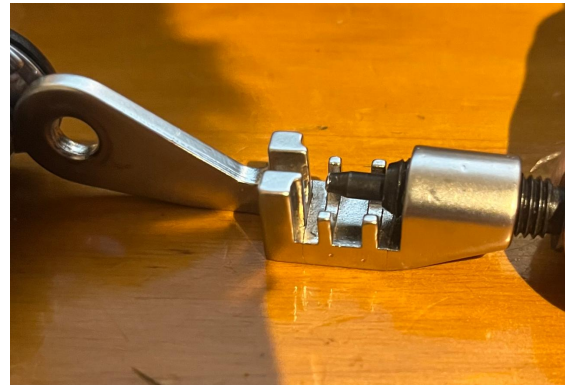
Bicycle chain tools are used to install or remove the pins that hold the chain links together. They work by applying an axial force to the pin, generated from a torque typically applied with a wrench or lever. In this case, the chain tool was part of a multi-tool given to participants of a mountain bike competition, which suggests it may have been manufactured using low-quality steel and with minimal quality standards.

Fig. 1. Bicycle chain tool.

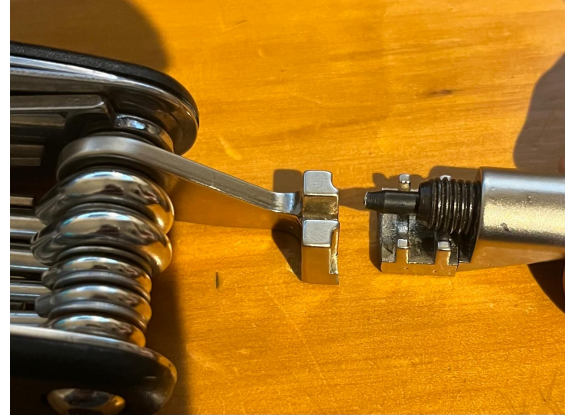
Fig. 3. Broken part.

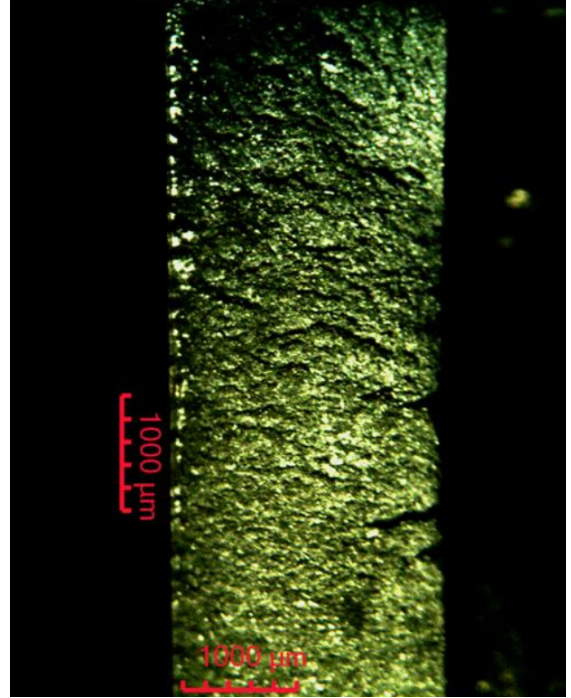
The analyzed fracture surface exhibits a predominantly granular morphology, indicative of a fragile fracture mechanism by cleavage. *River patterns* are clearly observed extending from the right edge toward the upper region, converging at an initiation point located at that edge. These features serve as evidence of rapid and transgranular crack propagation under sudden loading conditions and in the absence of significant plastic deformation. The lack of *beach marks* further rules out fatigue or ductile failure mechanisms, thus reinforcing the diagnosis of an instantaneous brittle fracture.

Fig. 4. Broken surface under a microscope.

Although no visible cracks were observed at first glance, Figure 4 shows potential crack-like features on the right edge and near the center of the fracture surface, with lengths on the order of 1 mm or less. Based on this, it is possible to plot the relationship between the applied force on the tool and the resulting stress intensity factor for both central and edge cracks.

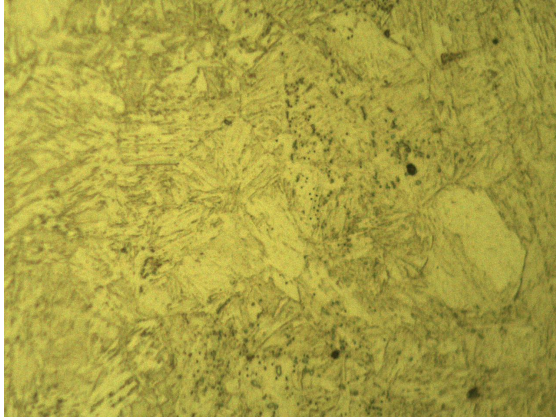
4) *Metallography*: Finally, it was decided to perform a metallography analysis to understand the crystallography of the material and the existence of copper within the composition. First, in order to observe the crystallography, a solvent composed of 2/3 HNO₃ and 1/3 HCl was used. With this, a crystallography mainly composed of martensite was observed, with a slight presence of ferrite.

Fig. 5. Material metallography.

This supports the thesis of brittle fracture of the material, due to the high brittleness of martensite, furthermore, the high mechanical strength and hardness is thus understood. Finally, with respect to the presence of copper, which is extremely rare in materials of this type. It is explained by the fact that in order to apply the chromium plating, firstly a copper bath is made, so that the chromium plating is more resistant. This was observed while sanding the material during the metallographic analysis. This explains the presence of copper and confirms that the sample is AISI 420 material.

Finally, it is concluded that both its mechanical properties and its heat treatment are suitable for hand tools. However, in order to improve the

properties, it is possible to increase the amount of nickel and carbon in the composition. In order to improve the toughness of the material after quenching and tempering. However, this would increase the cost of the analyzed piece.

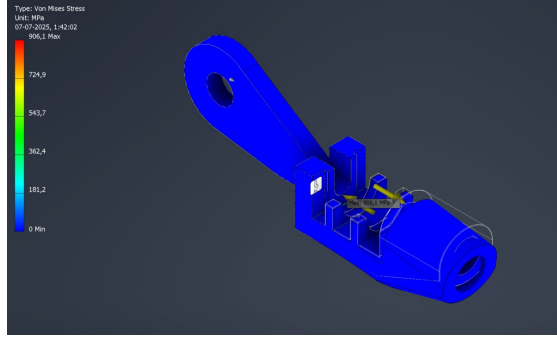
Based on the FEA performed on the CAD model and as shown in Figure 6, a maximum stress of 906 MPa was obtained, along with a stress concentration located precisely in the fracture zone of the original part. However, this value is significantly lower than the yield strength of the material, which suggests that this hypothesis does not provide a meaningful insight into the failure.

Fig. 6. Finite Element Analysis.

Geometrical optimization: Redesign critical regions to minimize stress concentrations using rounded profiles or localized reinforcements.

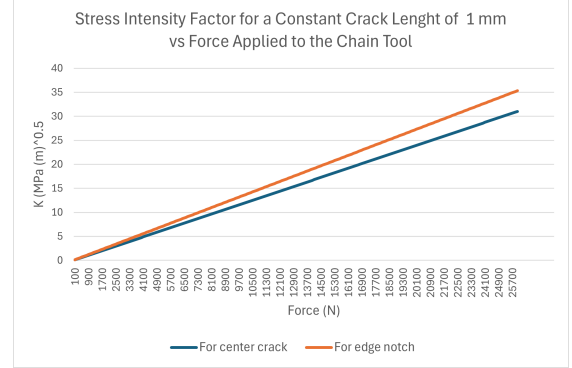
Fig. 7. Plot showing the relationship between the stress intensity factor K and the force applied to the tool. Crack length was considered to be of 1 mm.

As stated by Irwin, fracture occurs when the stress intensity factor K reaches or exceeds the material's fracture toughness K_c , which, as previously mentioned, is $30 \text{ MPa}\sqrt{\text{m}}$ for this material. As shown in Figure 7, the stress intensity factor remains be-

low the fracture toughness for forces under 20 kN, which is well below the estimated applied load. Furthermore, Figure 8 shows that even with a 6 mm crack, the stress intensity factor does not reach the critical value under the applied force of 650 N.

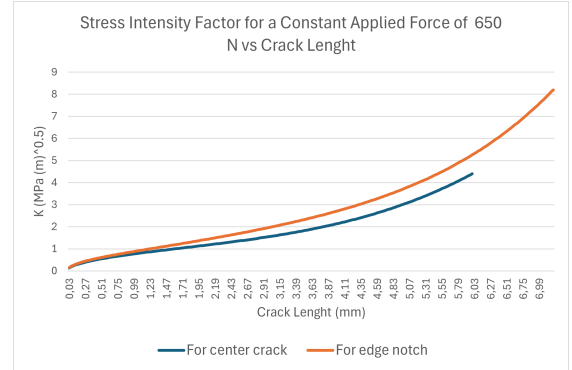
Another relevant relationship can be established by assuming a constant applied force. As previously mentioned, the force exerted on the tool during use is estimated to be 650 N. Using this value, it is possible to plot the effect of crack length on the stress intensity factor. This relationship is illustrated in Figure 8.

Fig. 8. Plot showing the relationship between the stress intensity factor K and the crack length. Force was considered constant at 650 N.
