Prime Accident Assessors Ltd.

ASSESSMENT REPORT

PAA/523/SANLAM/2021

REG NO. KCP 871M		VEHICLE MAKE YOYOTA HILUX		MODEL NO. GUN125R-BNFJHN		BODY TYPE PICKUP	
YEAR 2017	CHASSIS NO. AHTKB8CB702853663		ENGINE NO. 2G0-FTV		ENGINE CC 2,400cc.	FUEL TYPE PETROL	COLOUR WHITE
MILEAGE 174,579Km.		INSPECTED AT MAGOCI AUTOWORKS LTD, THIKA		DATE OF INSPECTION 16-Jul-2021, Fri		NOTES

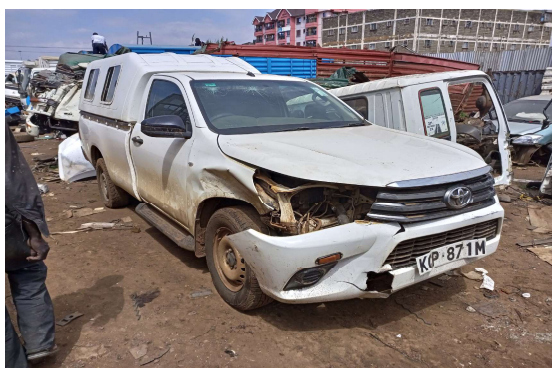
MECHANICAL CONDITION											
IGNITION Okay		ENGINE Running		CHASSIS Damaged		SUSPENSION Okay		STEERING Serviceable		TRANSMISSION Serviceable	
BRAKING				TYRES (TREADS RATING)							
FOOTBRAKE Serviceable		HANDBRAKE Holding		RHF 30%	LHF 30%	RHR 30%	LHR 30%	OTHER			
LIGHTS »		HEADLIGHTS BROKEN		BRAKING / HAZARD LIGHTS Okay				INDICATOR LIGHTS Okay		FOG LIGHTS Not Applicable	
WINDSCREEN Broken		WINDOWS BROKEN		DOOR LOCKS Okay		SIDE MIRRORS Okay		AC SYSTEM Not Tested		SRS SYSTEM Okay	
RADIO SYSTEM OKAY		DASH FASCIA & INSTRUMENTS Okay			EXTERIOR / BODY Okay				INTERIOR / UPHOLSTERY Okay		
NATURE OF IMPACT	HEAVY RHF END IMPACT COUPLED WITH HEAVY REAR END IMPACT

Photo showing damage caused by the impact

GENERAL SUMMARY				
RECOMMENDED CLAIM SETTLEMENT METHOD				
<input checked="" type="radio"/> Authorise Repairs <input type="radio"/> Settle as cash in lieu <input type="radio"/> Pay out pre-accident value				
PRE-ACCIDENT DAMAGES NOTED				
NOT ESTABLISHED				
DAMAGED PARTS				
TO BE REPLACED		See repairs estimate below		
TO BE REPAIRED		LHR CARGO BODY PANEL, REAR CABIN PANEL		
TO BE REPAINTED		RHF DOOR, RHF WING, FRONT BUMPER, LHR CARGO BODY PANEL, REAR CABIN PANEL, BONNET LID, RADIATOR PANEL AND RHS VALENCE		
REPAIRS ESTIMATE
