W² Issue 12-10

4662 PEN CARRIAGE POSITIONING

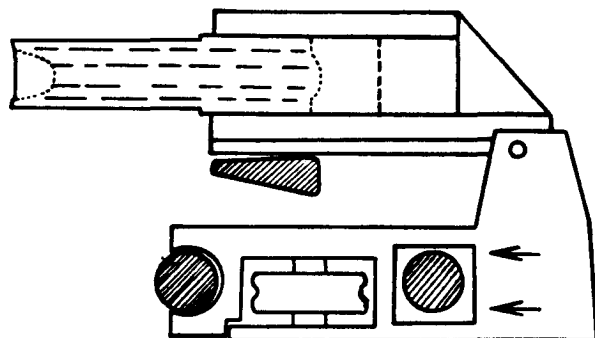
Figure 1

The 4662 can be visually inspected to determine if the rear of a pen carriage is positioned too high. Looking at the side of the pen carriage, observe the square hole surrounding the rear slide shaft. The slide shaft should be positioned closer to the top of the square hole. See figure 1.

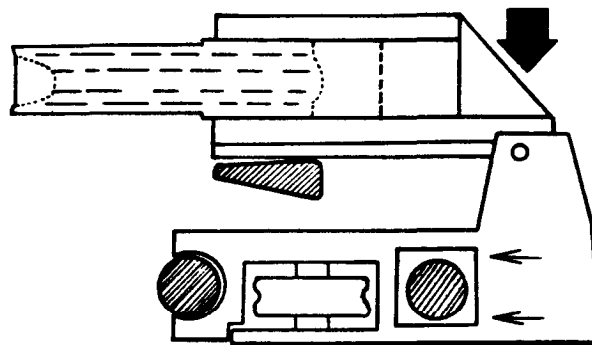
Figure 2

It is possible to jar the rear of a 4662 pen carriage into an incorrect position on the carriage slide shafts. If the rear of the carriage is incorrectly positioned, the result can be line skipping, or with option 31, pen exchange problems.

If the carriage slide shaft is located closer to the bottom of the square hole, figure 2, the pen carriage needs to be correctly positioned. This can be accomplished by placing firm downward pressure on the rear of the pen carriage just above the pivot point, see figure 2, while supporting the bottom of the carriage slide shafts to keep them from becoming bent or warped. The downward pressure should cause the pen carriage to snap back into its normal operating position.
