1980 PROGRAM ERRORS (CONT.)

4006-1, 4051/52/52A DISPLAY BOARD MOD

Corporate Mod #54922

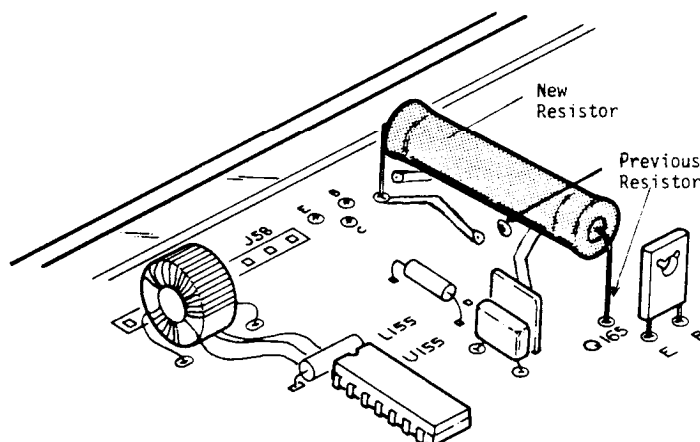
Figure 1

The display board in the 4006-1, 4051/52/52A products is experiencing a high failure rate due to high AC line voltages causing the failure of R64, R339, and Q165. The failure of R64 can generate enough heat to scorch, or even burn, the board.

Corporate modification #54922 fixes this failure mode by changing the value, wattage and placement of R64, and changing the source voltage of the CE1/CE2 circuit from +320 volts to +185 volts. To accomplish this, R64 is physically repositioned. It now connects between the +185-volt source (R39) and the collector of Q165. Physically, it will be positioned as shown in Figure 1.

R64 changes from 68K 2W resistor, P/N 305-0683-00, to a 30K 8W resistor, P/N 308-0105-00. The Display board for the 4006-1 changes from a 672-0537-11 to a 672-0537-12 and the Display board for the 4051/52/52A changes from a 672-0546-11 to a 672-0546-12.
