1450 FREQUENCY RESPONSE TILT WITH TEMPERATURE

2445/2465 POTENTIAL RELIABILITY PROBLEM

4054/4054A Q5001 AND Q5002 MODIFICATION

### 4054/4054A SCREWS CPU SANDWICH TO FRAME ASSEMBLY

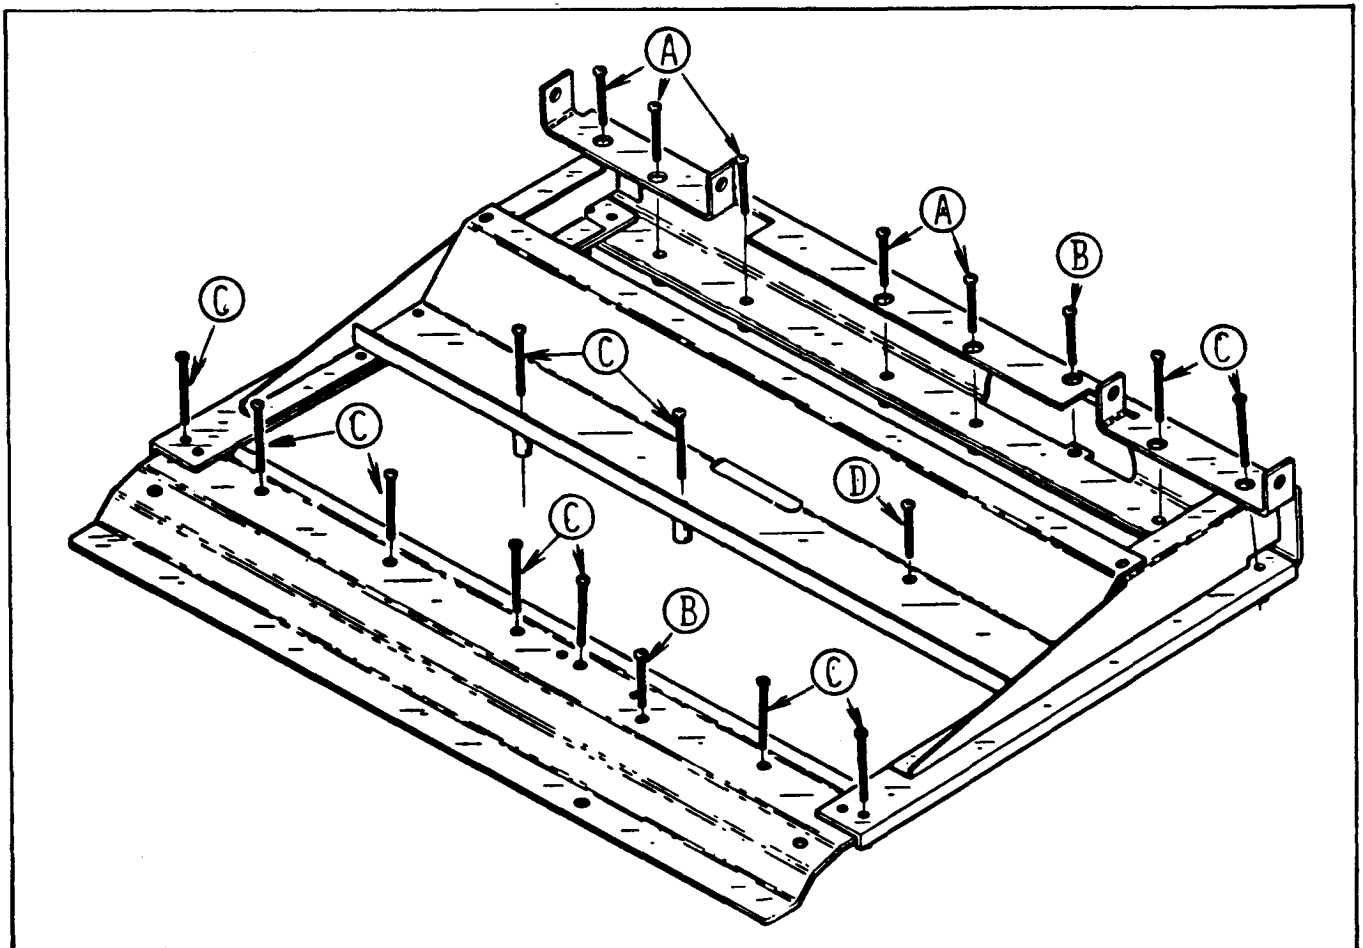
Figure 1

Questions have filtered in from different field personnel concerning the length and placement of the screws which hold the CPU sandwich to its frame assembly. The figure below shows the frame assembly, the screws and the holes which the screws are inserted through. Note circled alpha characters, each denote a different length screw. Following the figure is a table for cross-referencing the index character to screw length.

Note that there are two "D" type screws listed. On the 4054A this screw goes through the ALU board and into the I/O board, whereas on the 4054 it only screws to the ALU board.
