New Research into the MV Estonia Disaster

Petri Valanto

Hamburg Ship Model Basin HSVA

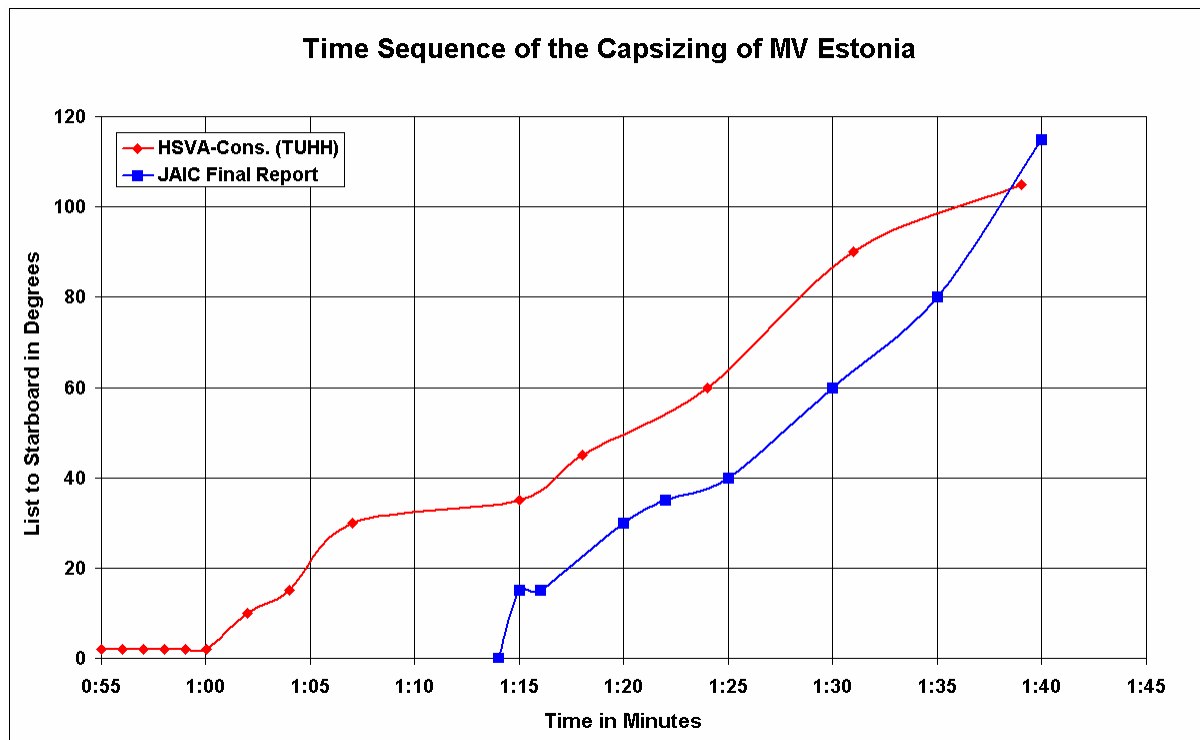
Fig. 2: Development of list to starboard during the MV Estonia accident.

Estonia have given some additional information often supporting our conclusions based on the early testimonies. A new time sequence of the course of the accident in form of ship's list as a function of time was established purely on the basis of the survivors' testimonies by the TUHH, the second partner in the HSVA-Consortium. This sequence of the ship's list is one of the crucial facts to be reproduced with the motion simulation of the damaged ship. Figure 2 shows the new time sequence of the capsizing of the MV Estonia together with the list development reported by the JAIC. There is a clear difference between these two time-histories. The HSVA

consortium believes that the actual accident started earlier, around 01:00, and not at 01:14 as stated by JAIC. The values of list in the TUHH-curve are based on subjective observations made by the survivors. It is possible that the actual values of list were at certain points somewhat lower than those felt and reported by the survivors.

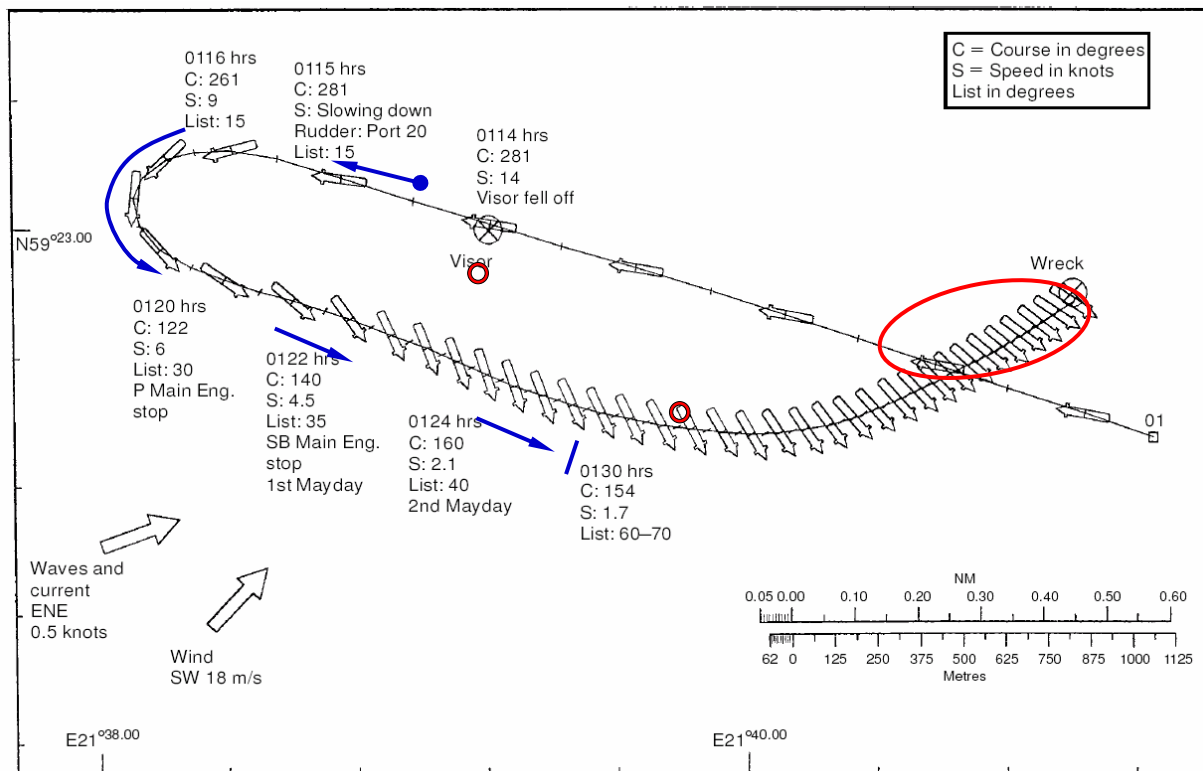
Figure 3 reproduced from the JAIC Final Report (1997) shows the MV Estonia's track during the last hour. The red circles and the ellipse mark areas where the visor, an unknown object and various loose items lay on the seabed, based on sonar measurements carried out in October 1994 (Nuorteva, 1995). These are hard facts in the Estonia investigation: The vessel must have passed very near these points.

Fig. 3: MV Estonia's track during the last hour, as composed by the Navigation Simulator at the Maritime Academy in Kalmar, Sweden (JAIC, 1997).

The blue arrows in the figure show the part of the track, which is subject to be defined with the help of the survivors' testimonies and

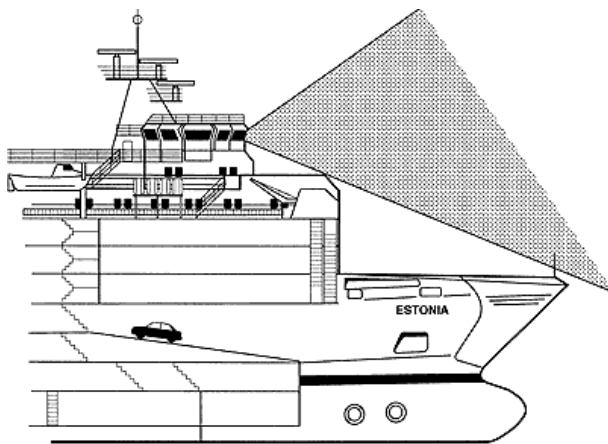
officers on the bridge could not see the visor itself, as shown in Figure 4, they may have seen that the spray flying upwards, when the bow hit a new wave was very different, because the visor had dropped. Also the feel of the ship at each wave impact must have changed, because the vessel without the visor had now a very blunt bow shape above the waterline. It is, however, very likely that the officers on the bridge at that moment did not realize that the visor, due to built-in interlocking, may have also pulled the ramp open.

Fig. 4: Approximate field of vision from the bridge (JAIC, 1997).

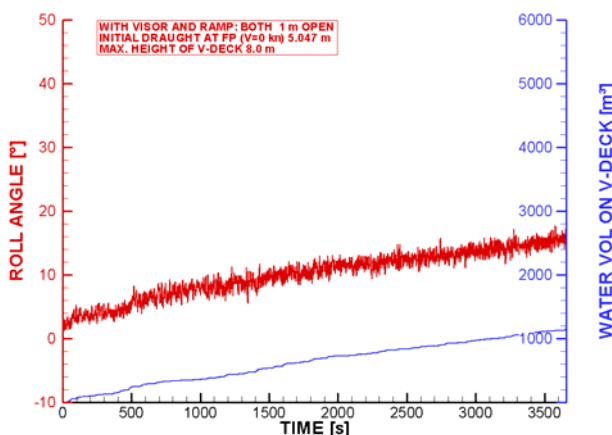
Simulation result: In this scenario the inflow rate of about 10-20 m³/min is relatively small from the point of view of the ship stability. However, also this amount certainly appears considerable for an observer on the vehicle deck or somebody observing this via a TV-monitor, like the crew in the Engine Control Room (ECR) did.

The water accumulates slowly on the vehicle deck; in ca. 26 min the list of the ship reaches 10°. The list increases gradually as the water volume on the vehicle deck increases. If no corrective action were taken, the ship would be in danger to capsize after more than 3 hours.

Fig. 5: Roll angle and water volume on the vehicle deck when both the visor and ramp are about 1 m open.

This scenario may have taken place before the ramp opened, but not for very long, as the gradually increasing list, e.g. 7° after 10 min, would have been noticed sooner or later by the crew. The simulation does not indicate any sudden heeling or other sudden ship motions.

- ⇒ The flooding rate in this scenario is too slow for it to be the final scenario for the flooding of the vehicle deck.
- ⇒ The scenario can be true for the very initial phase of the accident, but not for very long, as the slowly increasing list would have been observed by the crew.

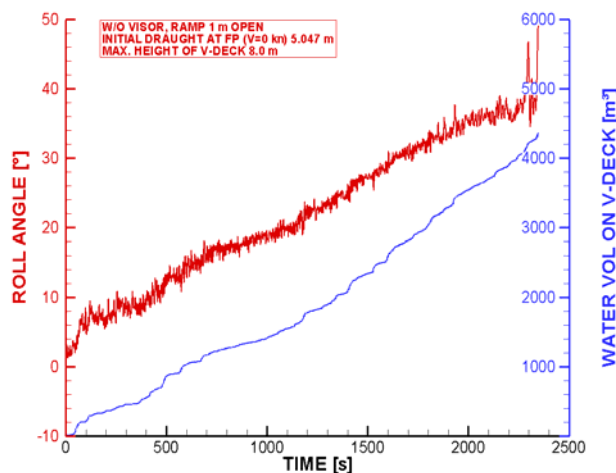
Simulation result: In this scenario the inflow rate of about 70-80 m³/min is considerable from the point of view of the ship stability and certainly appears massive for an observer on the vehicle deck or on a TV-monitor. In addition in this case the airflow at the open gaps beside the ramp consisting of the ship speed and a component of the wind outside may have speeded the finer water spray coming in up to about 20 m/s or more.

The water accumulates on the vehicle deck; in ca. 7 min the list of the ship reaches 10°. The list increases monotonously as the water volume on the vehicle deck increases. If no action were taken, the ship would be in danger to capsize in about 40 minutes. Due to the gradually increasing list the situation would have been noticed by the crew relatively soon. Even after a considerable list there would have been enough time to take action against the water inflow on to the vehicle deck. The simulation does not indicate any sudden heeling or other sudden ship motions.

This scenario is difficult from the point of view of the ramp position. The wave forces the ramp would encounter in this inclined position would be considerable, thus no weak support can hold the ramp in this partially open position. The ramp weights about 12.5 tons. It is, however, light enough to be moved by the waves the ship encountered in the night of the accident.

Fig. 6: Roll angle and water volume on the vehicle deck without visor when the ramp is about 1 m open.

- ⇒ The flooding rate is perhaps somewhat too slow for this scenario to be the final scenario for the flooding of the vehicle deck.
- ⇒ The inflow to the vehicle deck could hardly remain unnoticed by the crew. In this scenario the ship gets a list of 14-15° in 10 min. After this observation the crew would still have had sufficient time to take action against the inflow.
- ⇒ This scenario does not fit to the known technical facts reported by the JAIC.

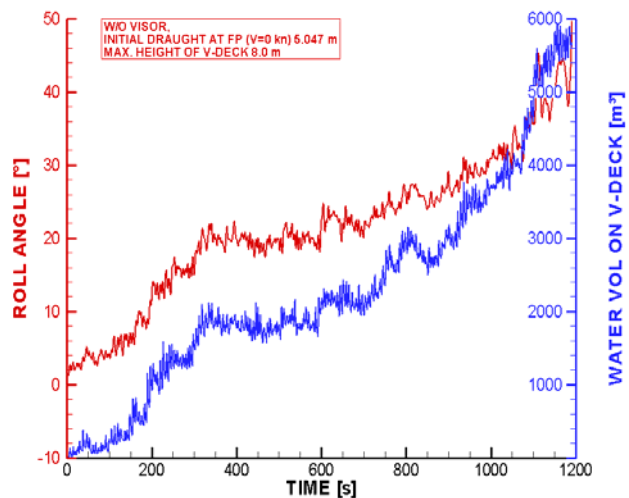
Simulation result: In this scenario the computed inflow rates vary between 300-700 m³/min, which are of course relatively high also from the point of view of the ship stability. This scenario is very likely to have taken place, but not for very long, as the increasing list, over 10° in three to four minutes would certainly have been noticed by the crew. If no corrective were be taken, the ship would be in severe danger to capsize in little more than 10-20 minutes, which did not happen. The likely further progressive flooding of the vessel

Fig. 7: Roll angle and water volume on the vehicle deck without visor when the ramp is fully open.

Notice that the curve in Figure 7 describing the water volume on the vehicle deck has a somewhat rougher look than the earlier curves shown in Figures 5-6: This is due to the open bow ramp, which allows more water sloshing in and out of the vehicle deck than in the earlier cases with the bow ramp only about 1 m open.

- ⇒ The flooding rate is suitable for this scenario to be the final scenario for the flooding of the vehicle deck.
- ⇒ The inflow to the vehicle would certainly be noticed by the crew. In this scenario the ship gets a list of over 10° in 3-4 minutes. If the crew in this scenario would not rapidly slow down or turn the ship, it would capsize. This scenario can be considered in general to fit with most testimonies by survivors and to known technical facts.

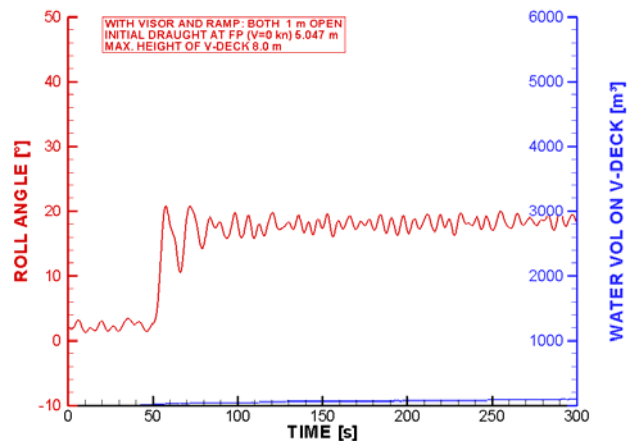
Fig. 8: Case (a): Roll angle and water volume on the vehicle deck, when both the visor and ramp are about 1 m open, start of turn at $t=50$ s.

In the case (a) the simulations provide a step of 18-19° in the heeling angle curve, the heel angle reaches 20° and remains high, as shown

in Figure 8. The transient roll oscillations after the step dampen rapidly. The water inflow on to the vehicle deck is not strongly influenced by the increased heel of the vessel, and the ship list remains practically constant. The water volume on the vehicle deck is in this particular case small. The situation has an almost quasistatic character and does not appear to correspond as well with the survivors' testimonies as the case (c) below.

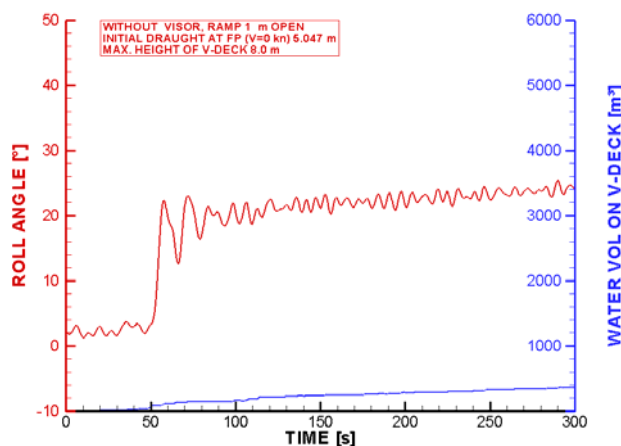
Fig. 9: Case (b): Roll angle and water volume on the vehicle deck, without visor, with the ramp about 1 m open. start of turn at $t=50$ s.

Case (b): If the simulation for the case (a) is carried out without the visor, the curves look in the beginning very similar, with the exception that the additional heeling increases the inflow onto the vehicle deck and the ship would be in danger to capsize in less than 20 minutes. For this reason, even if problematic from the point of view of the ramp position, this scenario cannot be left out of further consideration as the main scenario.

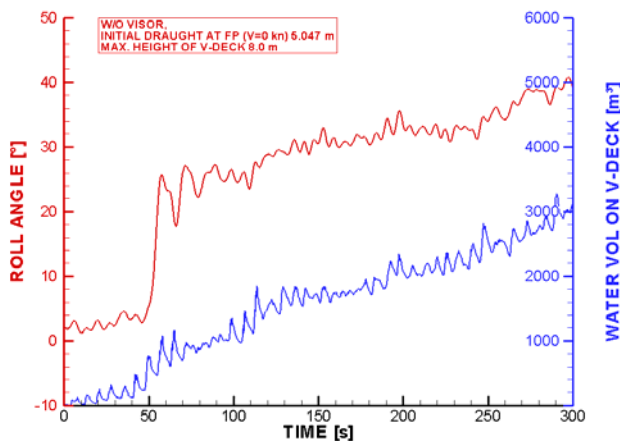
Fig. 11: Case (c): Roll angle and water volume on the vehicle deck, without visor, ramp fully open, start of turn at $t=50$ s. Second realization of random waves.

In the case (c) the step is a little higher (19° - 22°) leading to a momentary heeling angle of up to 26° . The water sloshing on the vehicle deck is likely to contribute to the magnitude of the sudden heeling motion. In this case the inflow through the completely open bow increases due to the sudden heel. Figures 10 and 11 illustrate the case with two different random wave realizations used in the simulations.

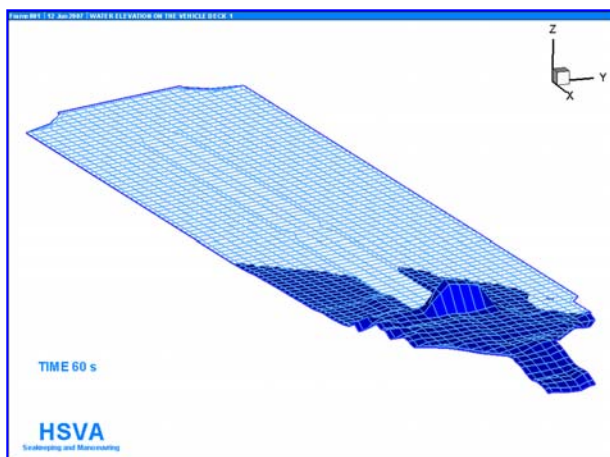
The numerical computations show how the water flows in from the open ramp to both sides of the central casing on the vehicle deck. The simulations show wilder sloshing motion in the longitudinal direction, when the ramp is fully open compared with those cases, when it is only about 1 m open.

Fig. 12: Waves on the vehicle deck coming through the fully open ramp slosh against front face of the central casing and splash water high up.

See the incoming wave hitting the front face of the central casing in Figure 12. The numerical grid on the vehicle deck is coarse, and the shallow-water-equations used in the computations are an idealization of the reality. Thus this small detail cannot be described very accurately by the numerical model, but in reality the wave at the front face of the central casing would have splashed water high up making the video camera fixed on this front face wet, as described by three crew members in the Engine Control Room (ECR). It is likely that this can take place only when the ramp is open.

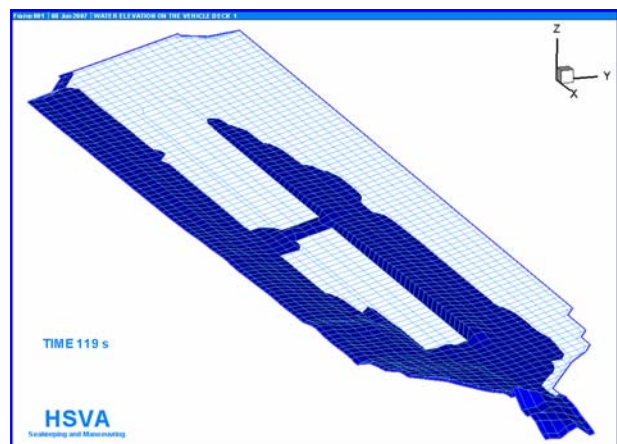
onto Deck 1 below. The flooding of the vehicle deck starts from the bow, as also shown in Figures 12-14. Thus it is more likely that in the early phases of the accident water would flow into the front compartments on the Deck 1 than those further aft. This is also supported by the testimonies of those who survived from the Deck 1, as shown in Figures 15-16. Depending on the case as early as 3-4 minutes after the start of the accident some water can flow down to Deck 1 through the front staircases in the central casing.

Fig. 13: Waves slosh water onto the vehicle deck through the fully open ramp. The flooding starts from the bow. Before the turn starts the heeling angle is relatively small.

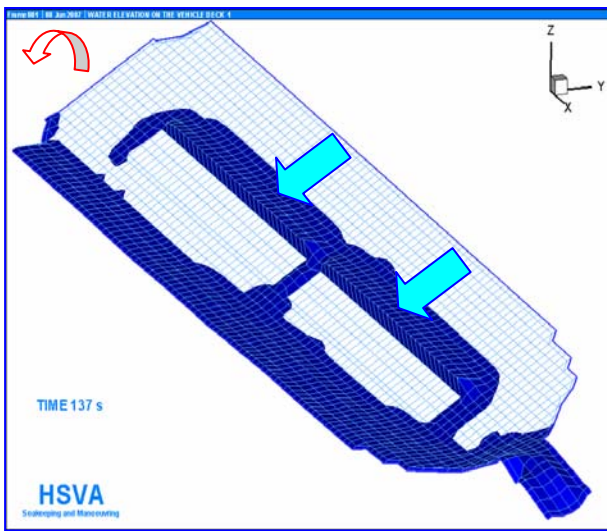
A further interesting point is added when one looks what happens on the vehicle deck, if the vessel makes a turn. When the vessel starts the turn to port, it heels suddenly to starboard, and the water on the port side of the vehicle deck flows towards the central casing, where the water level rises and in addition the water sloshes high against the port side central casing

Fig. 14: When the turn has started at 120 s. the ship heels suddenly, the water on the vehicle deck rushes to starboard and the water level rises momentarily high on the port side wall of the central casing as it flows towards the lower starboard side.

wall and can easily flow into the staircases and from there down on to Deck 1 below. Figure 14

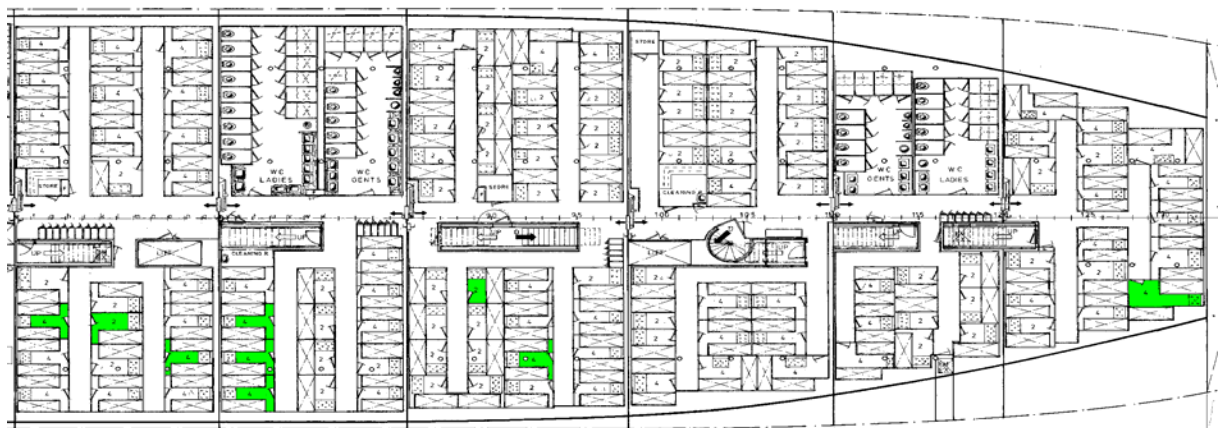
Fig. 15: Location of survivors, who reported water on Deck 2 (Vehicle deck) above, but not on Deck 1

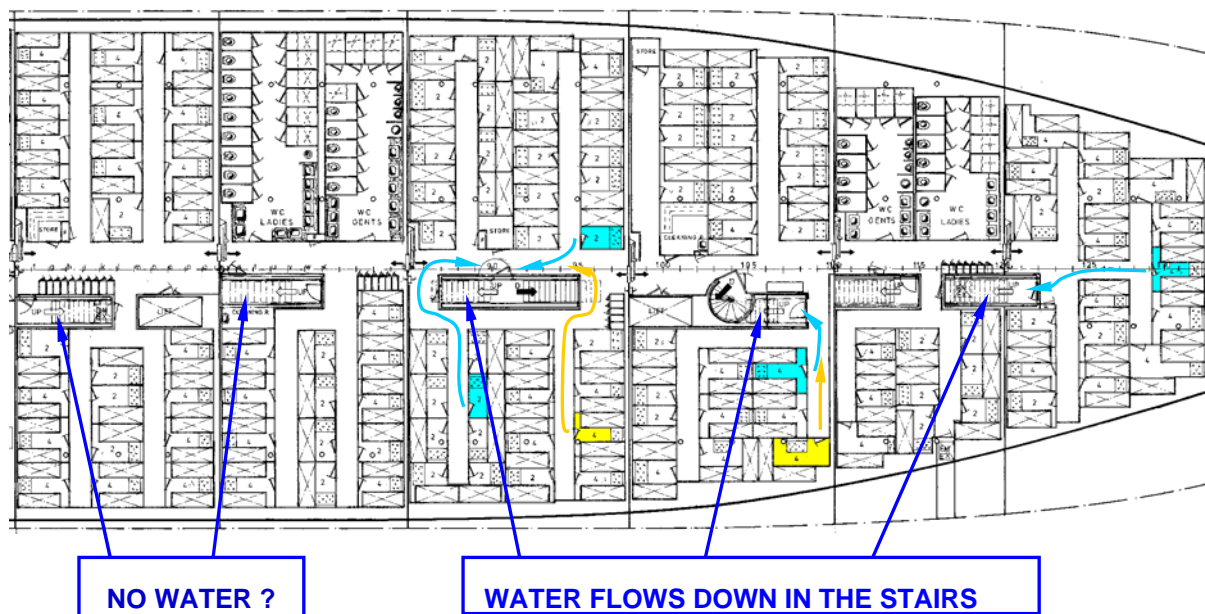
Fig. 16: Location of survivors, who reported water on Deck 1, and their likely escape routes,
