MV Estonia, a Plausible Sinking Scenario

Rolf Imstøl

Bergen University College

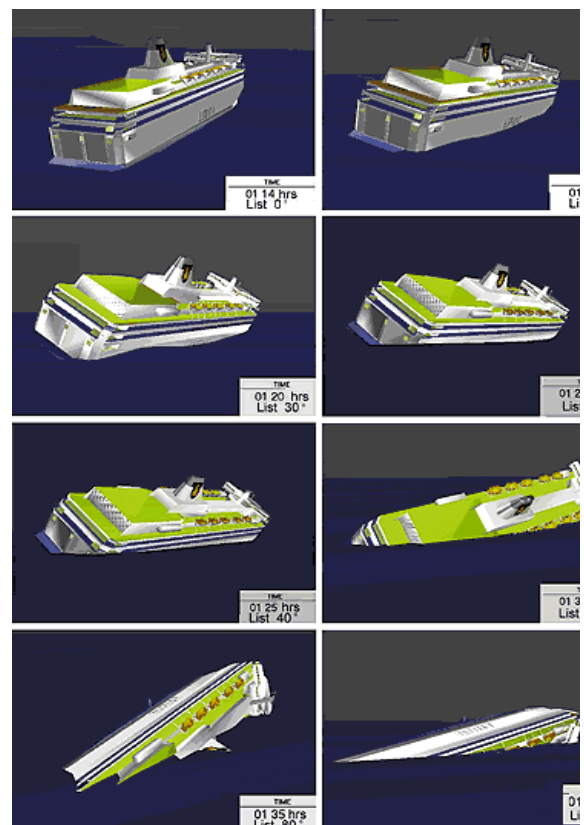
Figure 1: Computer generated scenario by JAIC. The author presumes these pictures are based on testimony by survivors rather than by simulation of any scenario [1, Fig. 13.3].

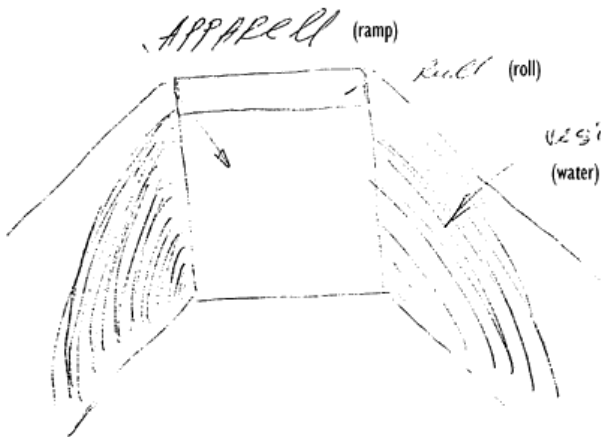
Water cascading in beside the bow-ramp had been observed at the engine control monitor for considerable time prior to disaster [5]. A similar monitor was located in the chart-room adjacent to the coning-position.

Figure 2: The water inflow observed at the engine control monitor [2, Fig. 6.1].

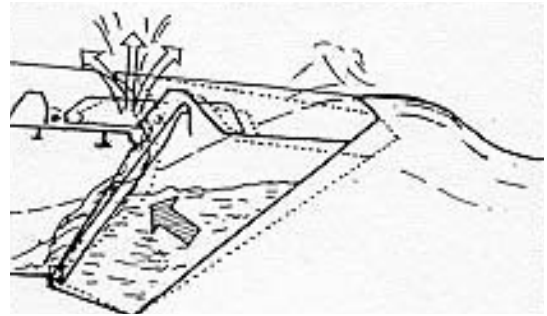
- The bow visor was observed flexing prior to disaster and water was observed

cascading up between the hinges of the visor [8, p65]. Though one could not see the visor from the coning-position a lookout would have been able to study it from the forward staircases [2, §3.2.7].

Figure 3: Observed water cascading up behind the visor [4, §31].

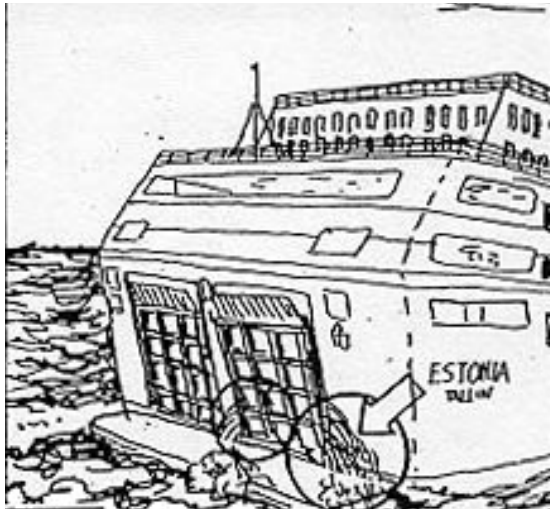
- The rear-ramp was observed to be slightly open. The German group of experts has suggested it might have been opened deliberately to drain water from the car-deck [4, §31].

- Figure 4: The German group of experts has suggested the rear ramp was opened to drain out the water that flowed in by the bow ramp [4, §31].
- Radio-logs by the Swedish high command may have been lost [8, p169].

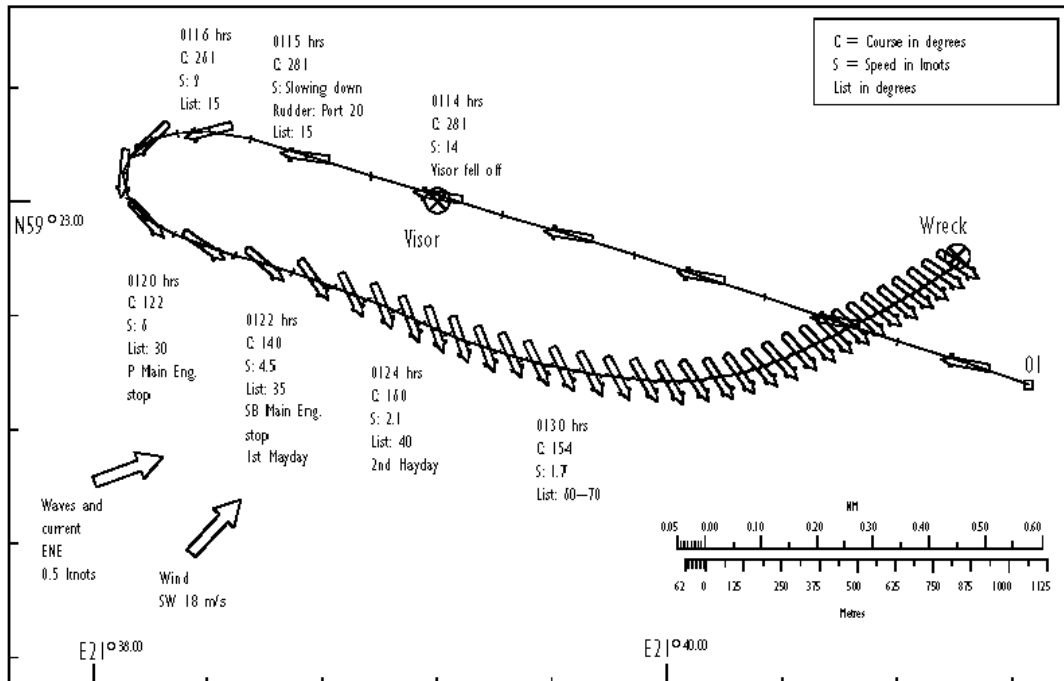
- The finish radar-plot is missing. The master of Silja Europe pointed at the interrogation that the plot by JAIC was obviously wrong [8, p213]. Dr. Valanto of HSVA seems to agree on this because the elapsed route does not

Figure 5: The JAIC plot shows how they expect the ship headed up against foul weather after the visor has been lost [2, Fig 13.2].

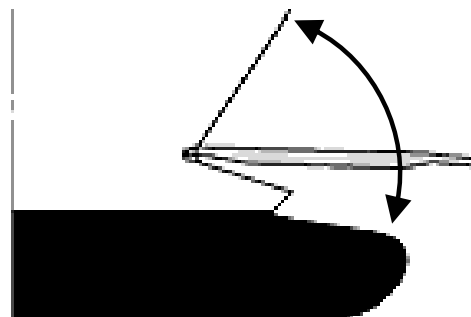
- The fore peak is expected to have been full. [2, \$5.3]
- Model tests presented by SSPA at the workshop indicate the bow ramp would have bounced wildly up and down if the ship encountered the waves with full speed. Unfortunately SSPA refuses to hand out a copy of this very interesting video.

Figure 6: Model tests shows the bow-ramp would bounce wildly and close itself for the oncoming waves [2, Fig 10.2].

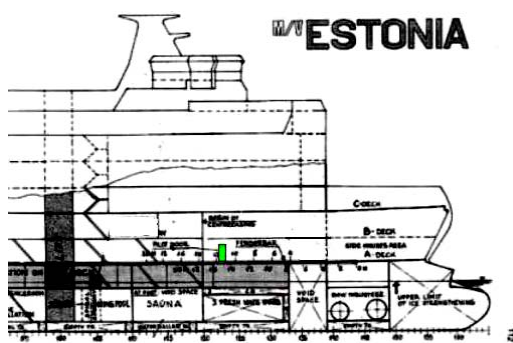
- Anders Björkman states: *The forward starboard pilot door is situated in that area (at frame 122) and should thus have been visible on the mudline video. However, the video films of both 1 October (seabed survey) and 2 December (mud line survey) have been edited in just that area, i.e. the films have been cut and the superstructure side and the pilot door cannot be seen!* [10, \$1.16].

Figure 7: The figure shows how the mud level was expected to be at the site of the forward starboard pilot door [10, Fig 1.16.4].

- Anders Björkman further states: *The Gregg Bemis dive expedition 2.24 inspected the area (Section D) in 2000 and found that the superstructure side was covered by sand (!) up to the level of the fender between hull and superstructure that didn't match the seabed mud, i.e. sand had been deposited against the wreck to change/raise the mud line and to cover the superstructure side*

and the pilot door. The whole area below the wreck - where you could have seen the superstructure side in 1994 - was filled with sand in 2000! It can hardly have been swept in by, say currents. [10, \$1.16]

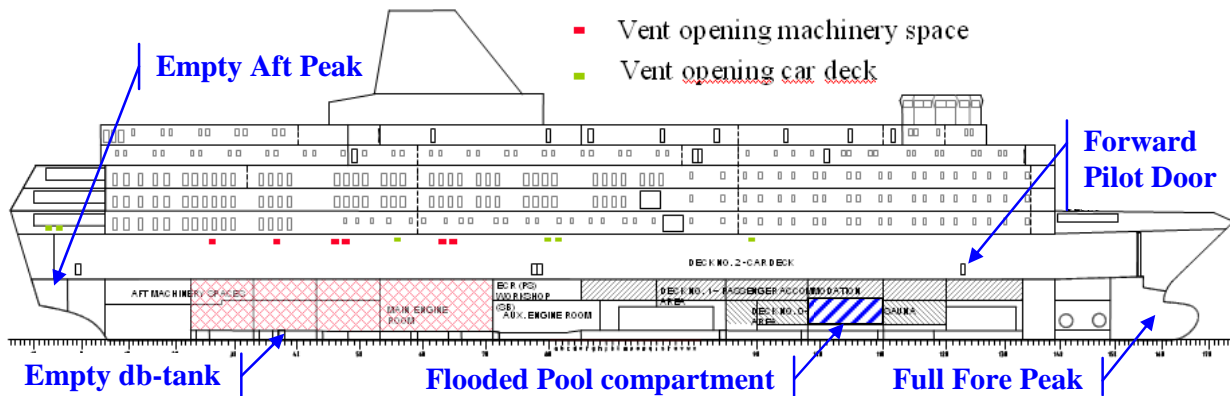
Figure 8: Inflow points according to Chalmers University at the workshop and ballast distribution according to JAIC

The only scenario I find to comply with above observations is as follows: Sometimes during the evening of disaster, the pool-compartment, situated forward at the lower deck, started to leak. Additionally, the leakage beside the bow-ramp seems to have been more predominant on her last voyage (Fig. 2). The sketch by the engineer on duty indicates that the water-level in front of the ramp may have been approx 6m above CWL and the flow seems to have been rather constant [5]. Such flow fits with the observation that the visor was flexing as one may expect the visor was forced open by the wave impact; otherwise closing.

Flooding of the pool compartment would of course make the bow work harder and the pressure on the ramp would be higher than normal. As long as the trim was by stern, the ship could drain water from the car-deck by opening the rear ramp as suggested by the German group of experts. However, sooner or later the ship would be likely to trim by head. Due to starboard heel and the gradient of the car-deck the starboard pilot door would become the lowest point of the car-deck and it would be the best option for additional drainage.

Flooding of the pool-compartment would cause the ship to trim forward entailing the bow to work harder and the inflow beside the bow-ramp to increase. Under such circumstances it seems quite likely that the ship command would discharge ballast from the full fore peak to reduce the pressure on the bow. Though one should have checked the keel for leakage if the water on the car-deck stowed ahead, one may hardly blame the command if they, unknowing of the leakage, attempted to raise the bow by emptying the fore peak and filling the db-tank to reduce strain on the bow. If they really felt they were in hurry they might have ballasted the aft peak as well though this would cause rather great free surface moment.

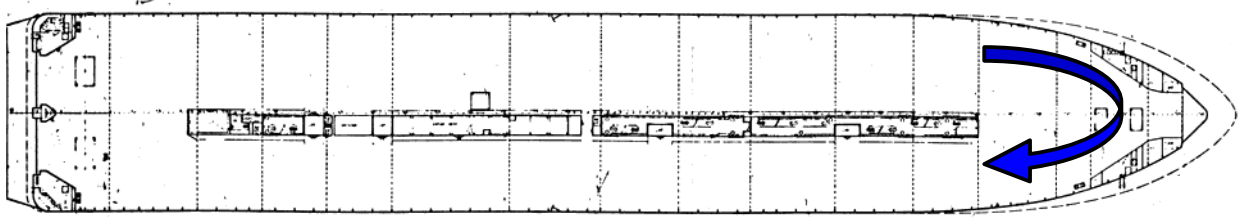
weighted down by water inside the visor and, to some extent, water on the forecastle deck. If this water was released during a short period of time, the longitudinal equilibrium could falter and provoke an internal monster wave which would dislocate cargo longitudinally as well as transversally. The centre-casing would combine roll and pitch movements caused by internal water flow on the car-deck because the water had to circumvent the centre-casing.

Figure 9: Car-deck & centre-casing. The centre-casing may very well create circular water-flow thus combining the roll & pitch.
