Anatomy of a Capsize: Then and Now

Metin Taylan

Capsizing of a ship is always a tragedy no matter what the magnitude might be. This paper deals with capsizing of a small size LPG tanker. Stability of the tanker has been analyzed by considering various aspects of stability qualities of it. Different loading conditions were taken into account to determine the effect of displacement and center of gravity variations on stability. Dynamic stability of the ship has also been looked at and compared with the international rules and regulations. The analyses and accidents reports carried out by the panel of experts following the accident were repeated. Possibly causes of the incident were investigated and some comments and suggestions were made. This work also gives us the opportunity to compare the technology of late 60's and today in terms of accuracy and capabilities.

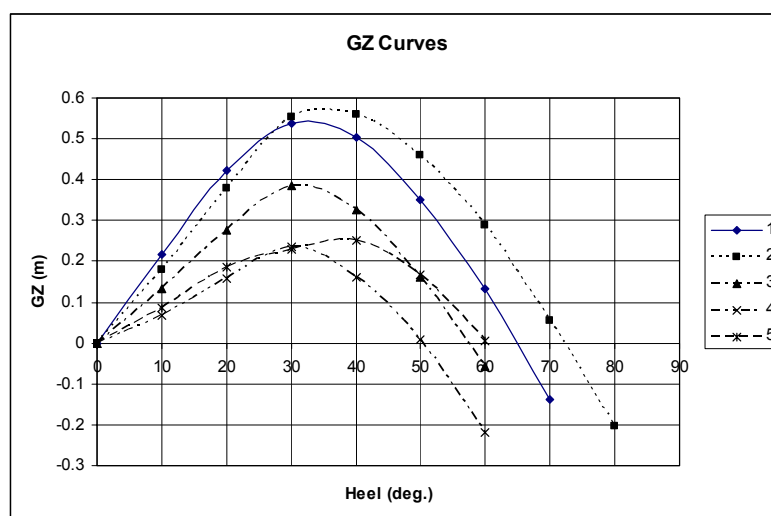
Fig. 3. GZ curves for 5 different loading conditions.

From Table 3 and Fig. 3 it is seen that the tanker satisfies IMCO stability standards.

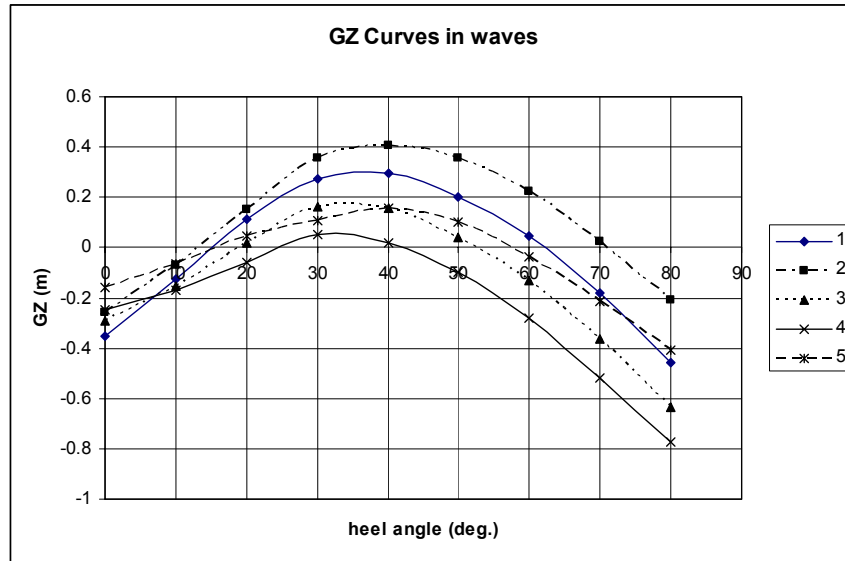
Fig. 4. residual GZ curves in waves.

When the requirements of weather criterion are compared with the results in Table 5, it is seen that although all of the cases met the roll area requirement, three of the cases, loading conditions 3, 4 and 5, failed to meet list angle requirement. That means, the tanker was not fully in compliance with the IMO weather criterion.

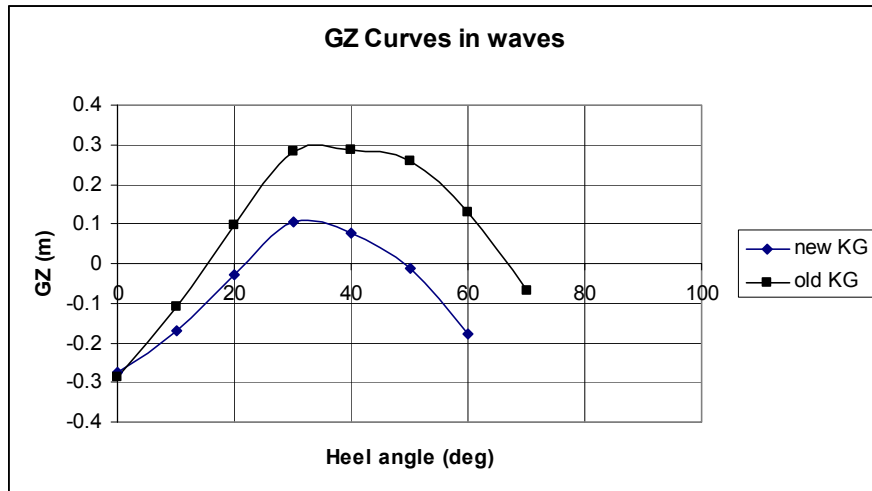
Fig. 5. Residual GZ curves in waves for old and new KGs.

Stability of the tanker in calm water complies with IMCO stability criteria for both original and new KG values. However, when it comes to stability in waves, list angle for the new KG fails to satisfy the criteria, while the original KG barely passes it, Table 6. Corresponding righting arms curves for two different KG values as plotted in Fig. 5.

Based on the information supplied by the eye witness of the accident, simulations are carried out for two different disputed KG values of the tanker. Although the tanker met the weather criterion for its original KG value, it is obvious that the tanker doesn't have reserve stability margins to overcome excessive heeling forces.
