# Use of the Wolfson stability guidance for appraising the operational stability of small fishing vessels

Matteo Scarponi, *Wolfson Unit MTIA, University of Southampton*, [M.Scarponi@soton.ac.uk](mailto:M.Scarponi@soton.ac.uk)

This paper describes the use of the Wolfson guidance and other stability criteria in the context of two recent accident investigations on small fishing vessels: 11.4m scallop dredger JMT and 9.9m stern trawler Stella Maris. Both vessels capsized and sank whilst handling their catch in benign weather conditions. The Wolfson guidance, which is suitable for all types of fishing vessels including those with no stability information, enables estimation of the safe operational limits for both JMT and Stella Maris. Also, given the probable loss scenarios and residual stability characteristics, the Wolfson guidance predicted that both vessels were operating outside such limits at the time of each loss.

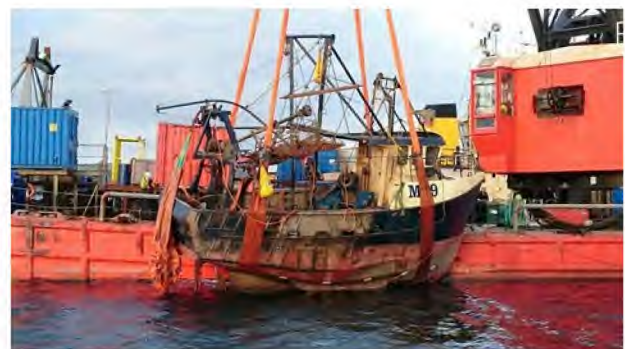
Figure 1 – Salvaged wreck of F/V JMT (Credit: MAIB)

The MAIB report concludes that the capsizing was probably triggered by the sudden release of the contents of the starboard side dredges, while the unrestrained port side dredges and their contents remained suspended from the 5m high 'goalpost' gantry.

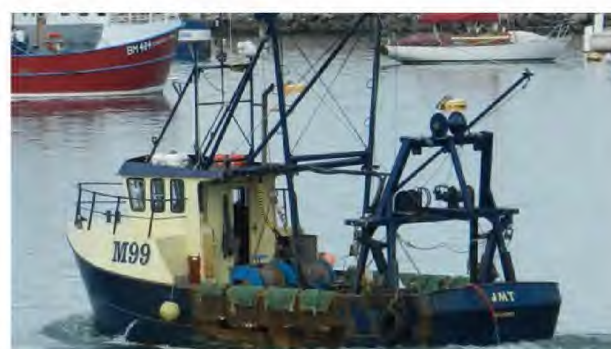
Figure 3 – JMT following 2013 conversion (Credit: trawlerpictures.net)

JMT (previously Lady Patricia) was built in 1988 as a conventional stern trawler and was fitted with a forward wheelhouse, amidships 'scotch poles' and a stern gantry (Figure 2). Between 2003 and 2013 the vessel's stern gantry was raised and a port side shelterdeck was added. Subsequently, the vessel was converted for scallop dredging, which involved fitting winches and outriggers for handling the scallop gear, removing the shelter deck, raising the stern gantry further and replacing the scotch poles with a goalpost gantry. The latter vessel configuration (Figure 3) was approved by Seafish Marine Survey in 2013 and, subsequently, by the MCA.

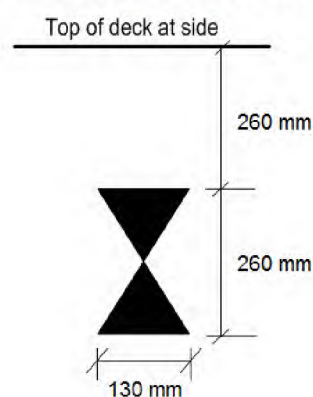
The vessel's Wolfson Stability Notice and Freeboard Mark are given in Figure 4 and its calculated level of safety in the various load conditions is given in Table 2. The Wolfson guidance indicated that the vessel had:

- low residual freeboard due to loading in all the standard conditions and in two operational conditions, namely no.7 - tow lift, dredges just off seabed and no.8 - full dredges resting on bulwarks;
- low residual freeboard due to lifting in the operational condition that probably triggered the capsizing: no.9 - starboard dredges emptied on deck and port dredges suspended from goalpost gantry;
- that the vessel was in danger of capsizing in seastates exceeding 0.7m significant wave height (low end of Douglas seastate 3).

Figure 4 – Stability Notice and Freeboard Guidance Mark for FV JMT

It was also highlighted that 'of the alternative stability assessment methods detailed in MGN 427(F), only the Wolfson method would have provided an indication of the vessel's operational limits, and when caution was required' [11]. MAIB recommendation 2016/130 to the Maritime and Coastguard Agency emphasizes that 'all existing vessels of under 15m should be marked using the Wolfson Method, or assessed by use of another acceptable method'.

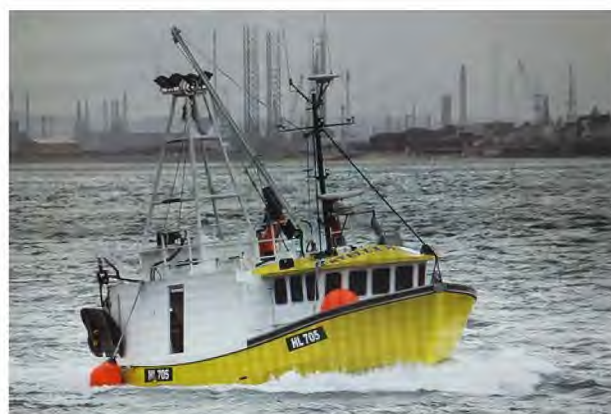
Stella Maris was built in 1999 as a conventional stern trawler. Initially, it was equipped with a gilson derrick for performing cod end lifts over the side and releasing the catch on deck. In 2013 it underwent major modifications, see Figure 5, to enable lifting over the stern into a catch hopper, thus improving the quality of the catch. To that effect, the gilson derrick was removed and a stern gantry was fitted, which raised the lifting point by approximately 1m. Also, the cod end had to be raised by approximately 1.65m above the bulwark to clear the upper edge of the hopper, so it could be emptied in the hopper from an overhead position. The catch would then remain in the hopper and gradually feeding to the sorting area beneath the shelterdeck.

**Figure 5 – Stella Maris following 2013 modification (Credit: Jon Irwin)**

The vessel capsized and sank whilst attempting to lift a heavy cod end of fish and debris. The estimated weight in air of the cod end was 1.8t and the stern lift was performed using a 2.8t (first layer pull) rated winch and a gilson block fitted near the top of the stern gantry ie about 6m above deck.

As successive layers of wire built up during the lift, the winch pull reduced until the cod end could not be lifted any higher and remained suspended from the gilson block. The skipper then veered the winch in an attempt to lower the cod end back into the sea, but the net snagged on a guide pole fitted at the starboard transom corner. This caused the starboard transom quarter to submerge and, ultimately, resulted in a capsize.

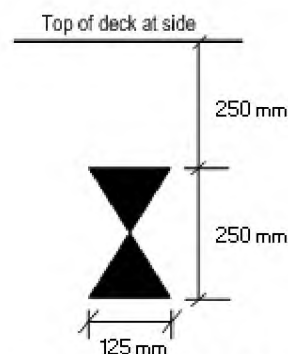
The calculations presented in Annex B of Ref. [13] show that performing a centreline, 1.8t lift over the stern from the gilson block induces a large trim by the stern, about 8 times the port departure trim. This causes the minimum freeboard position to shift further aft than at port departure, by a distance between 5 and 10% LOA. Thus the Wolfson mark should be positioned between 25 and 30% LOA forward of transom, not at 35% LOA to represent the true residual stability of the vessel when lifting.

Figure 6 – Freeboard Guidance Mark for Stella Maris

The dimensions of the Wolfson mark may be calculated from the vessel's beam and overall length as per Appendix A, and are shown in Figure 6.

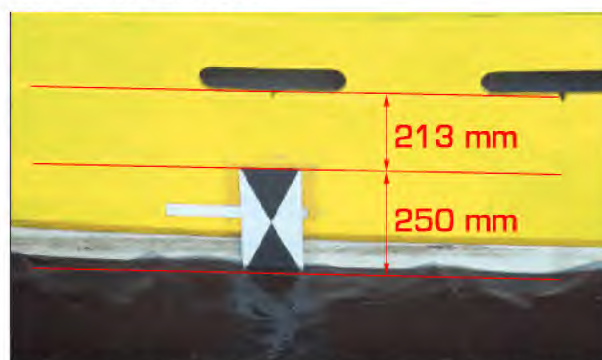
Figure 7 – Wolfson mark as applied in Ref. [12] with tentative dimensions added. As-inclined waterline.

As the sister vessel's calculated port departure freeboard was 40mm higher than at inclining, a small clearance was expected between the lower edge of the mark as applied to the sister vessel and its port departure waterline, so the MAIB Report concluded that the sister vessel would have been 'just in the Wolfson guidance mark green safety zone in the depart port condition' [13].

However, Figure 7 indicates that perhaps the mark should have been lowered by about 40mm to achieve the calculated 250mm separation between the deck at side and the top edge of the mark. Such a vertical shift would position the lower edge of the Wolfson mark at the port departure waterline, as

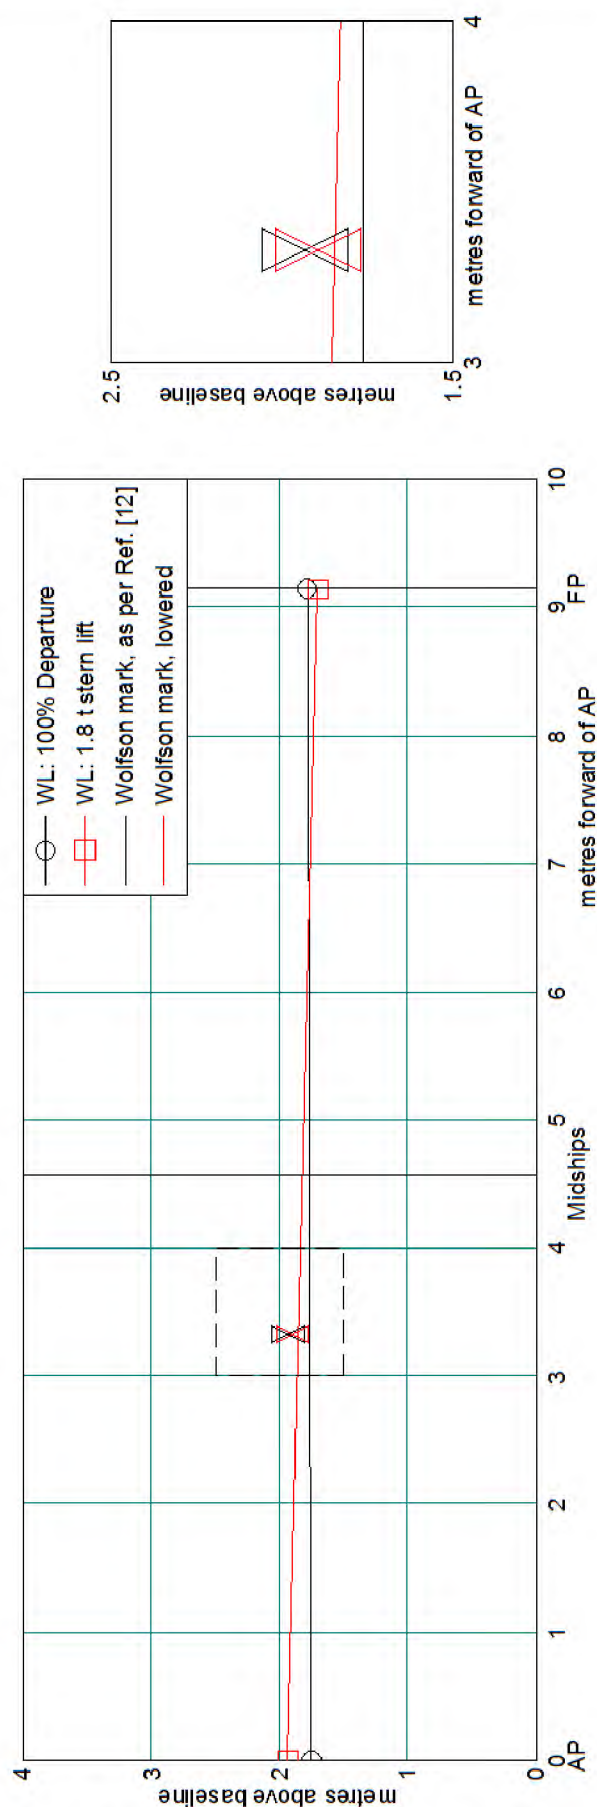
shown in Figure 8. So the vessel in the port departure condition appears to be at the boundary of the green and amber safety zones.

Figure 8 shows two waterlines derived from the vessel's calculated draughts at FP and AP, as indicated in Annex B of Ref. [13]. The Wolfson mark is positioned as per MAIB report, but its correct position may be further aft and approximately 40mm lower than in the report, as discussed in Sections 4.3 and 4.4 above.

The red waterline of Figure 8 represents the 1.8t stern lift, zero heel condition described in Annex B, page 64. As the Wolfson mark is partially immersed, the Wolfson guidance indicates a 'low level of safety' for the vessel in that load condition.

The gilson winch is rated at 2.8t (first layer pull) so hoisting 1.8t should be regarded as a realistic operating condition that reduces the vessel's freeboard to a level that, according to the Wolfson guidance, may endanger the vessel.

For the probable loss condition described in Annex B, page 69 the calculated equilibrium heel angle is 8.4 degrees to starboard. A simple calculation shows that a Wolfson mark affixed on the starboard side of the vessel would be submerged at that heel angle. Therefore, the Wolfson guidance predicts that the vessel's residual stability is reduced to an unsafe level in such a condition, and the vessel is in danger of capsizing.

Figure 8 – 100% departure and 1.8t stern lift waterlines
