RESEARCH OPPORTUNITIES IDENTIFIED DURING THE CASUALTY ANALYSIS OF THE FISHING VESSEL ARCTIC ROSE

Lieutenant George A. Borlase, United States Coast Guard
U.S. Coast Guard Marine Safety Center
400 7th St. SW, Room 6302
Washington, DC 20590
gborlase@msc.uscg.mil

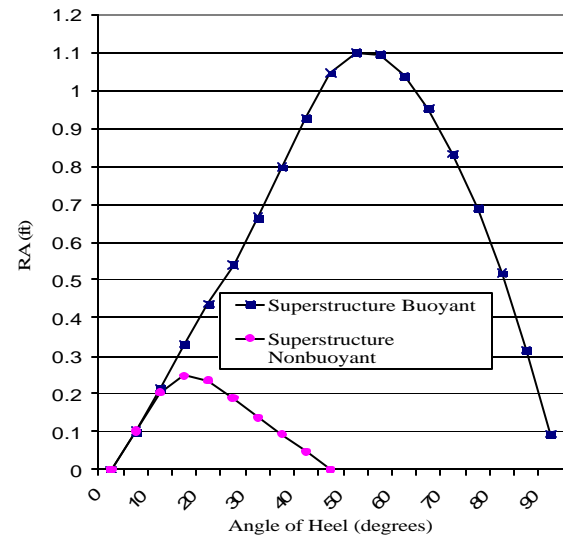
The superstructure modeled is on top of the main deck, 20 feet in length (1/5 the length of the vessel), 8 feet high and 24 feet wide, the entire beam of the vessel. With the superstructure nonbuoyant, the angle of maximum righting arm is at the angle of deck edge immersion. With the superstructure buoyant, the angle of maximum righting arm is increased to the angle at which the top of the superstructure is immersed. However, if the superstructure cannot physically be kept weathertight due to openings without closures and operational considerations, buoyancy is lost and the naval architect and the master may have a false sense of security as to the vessel's intact stability.

Figure 3. Righting Arm for ARCTIC ROSE Assuming Superstructure Buoyant and Nonbuoyant

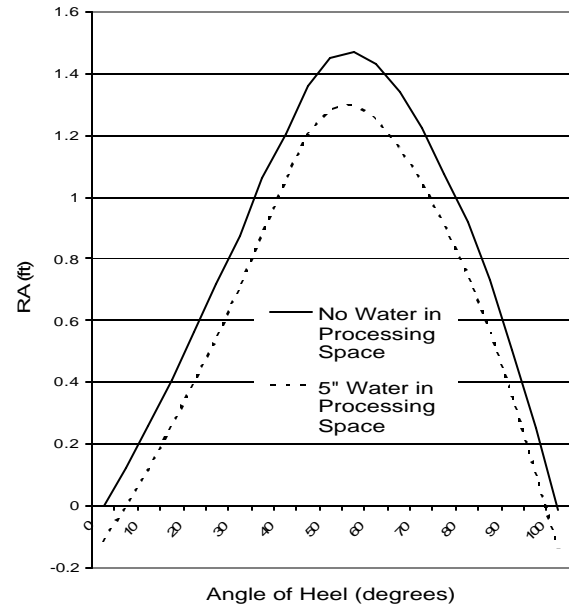
Figure 4. Righting Arms for ARCTIC ROSE in Assumed Condition at Time of Accident

water in the processing space, and were inserted into equation (1) to evaluate the effect of water on deck on the capsize resistance of the vessel. The moment of inertia method was used to calculate the free surface effect from the water in the processing space, and was responsible for most of the reduction in the righting arm.

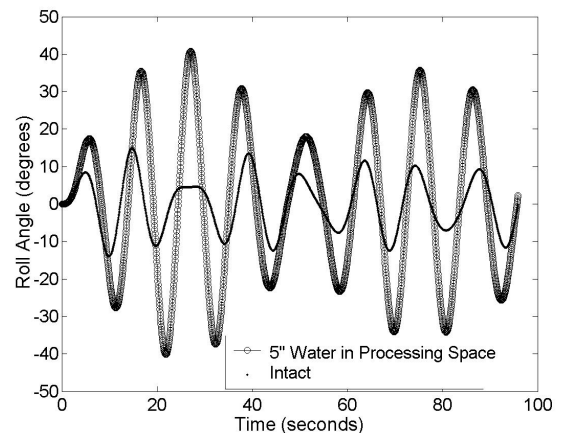
Figure 5. Roll Angle Time History for ARCTIC ROSE, Zero Initial Roll Angle and Roll Velocity, 8 ft Wave Height, 12 s Wave Period

This solution of equation (1) displays the nonlinear response of the vessel, and the increased roll angles of the ARCTIC ROSE due to the water in the processing

space. In the intact condition, the maximum roll angle is only about 15 degrees, but with water inside the vessel the maximum roll angle more than doubles to 40 degrees. Based on the freeboard of the vessel at the time of sinking, rolls of at least 23 degrees to each side would have put the open door in the processing space underwater with every roll, increasing the chance of water accumulating inside the processing space and progressively flooding throughout the vessel.

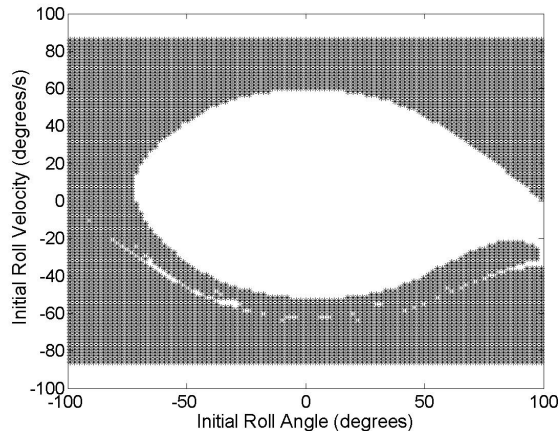
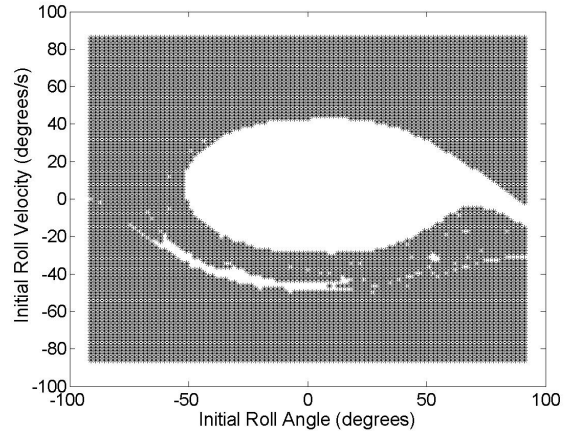
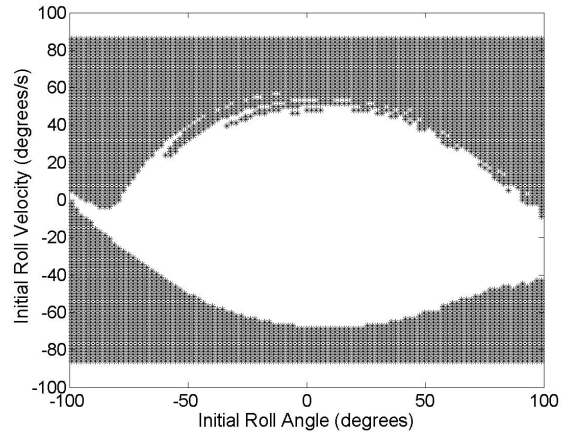
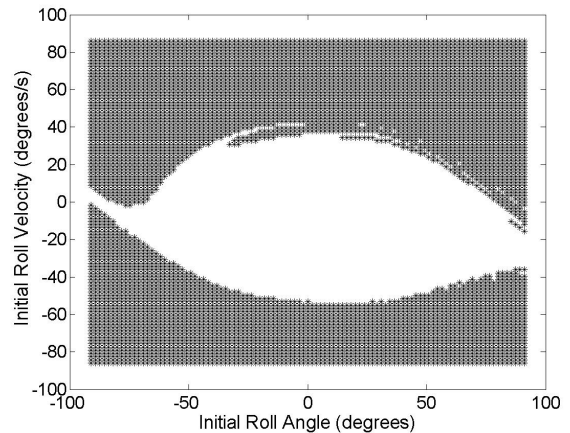
For an 8 second and 12 second wave period, and an eight-wave train of sinusoidal waves, equation (1) was solved for varying initial roll displacement and velocity conditions as described in [12]. If the vessel capsized (as defined by an angle of roll greater than the angle of vanishing stability) at any point during the excitation, the coordinate corresponding to those initial conditions was marked with a black diamond. Otherwise, the vessel is assumed to have “survived” the wave excitation and the coordinate was left blank. Figures 6 through 9 show the safe basins for the ARCTIC ROSE excited by an 8 foot wave height but with different wave periods and different righting arms to reflect the static effect of water in the processing space. The safe basin plots show the vessel’s capsize resistance degrades in a similar behavior to those described in [12,13,15].

Figure 6 Safe Basin Plot for ARCTIC ROSE, Intact Condition, 8 ft Wave Height, 12 s Wave Period

Figure 7. Safe Basin Plot for ARCTIC ROSE, 5” Water in Processing Space, 8 ft Wave Height, 12 s Wave Period

Figure 8. Safe Basin Plot for ARCTIC ROSE, Intact Condition, 8 ft Wave Height, 8 s Wave Period

Figure 9. Safe Basin Plot for ARCTIC ROSE, 5” Water in Processing Space, 8 ft Wave Height, 8 s Wave Period

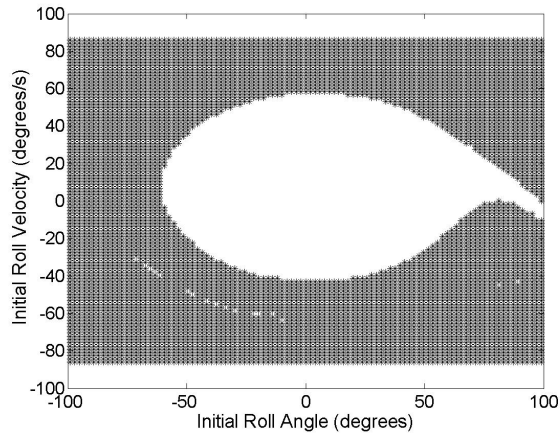
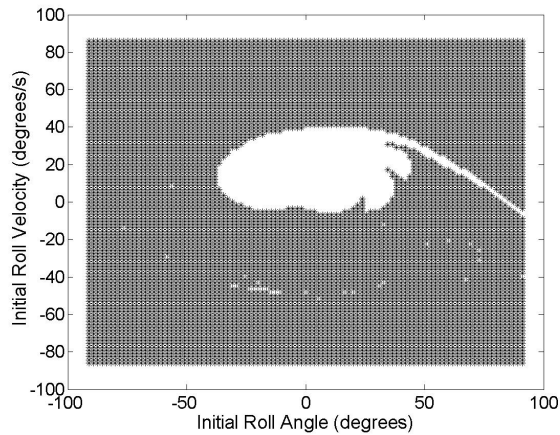
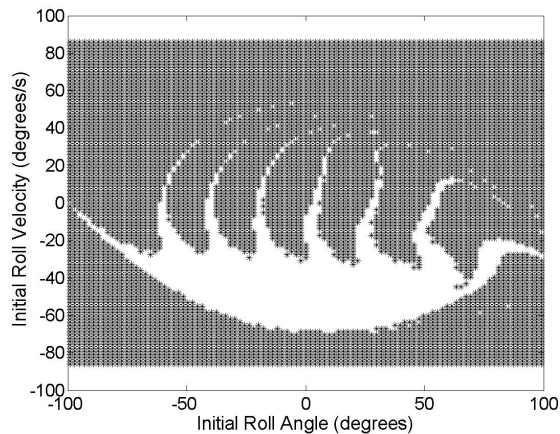
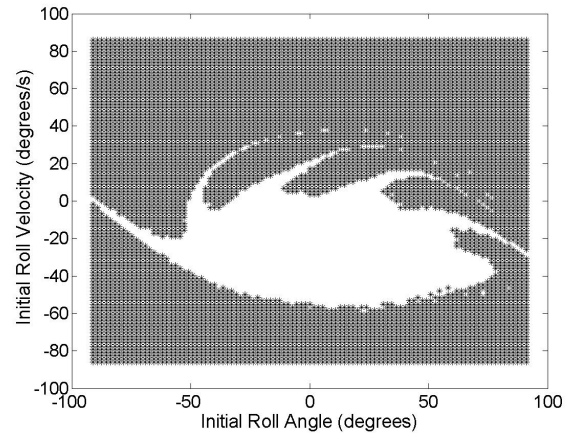
Figures 10 through 13 show the safe basins for the ARCTIC ROSE excited by a 14 foot wave height but with different wave periods and different righting arms, again to reflect the static effect of water on deck. The safe basins exhibit different degradation behavior based on the frequency of excitation. For reference, the calculated natural period of the ARCTIC ROSE in the assumed loading condition at the time of the sinking was 7.7 seconds.

Figure 10. Safe Basin Plot for ARCTIC ROSE, Intact Condition, 14 ft Wave Height, 12 s Wave Period

Figure 11. Safe Basin Plot for ARCTIC ROSE, 5'' Water in Processing Space, 14 ft Wave Height, 12 s Wave Period

Figure 12. Safe Basin Plot for ARCTIC ROSE, Intact Condition, 14 ft Wave Height, 8 s Wave Period

Figure 13. Safe Basin Plot for ARCTIC ROSE, 5'' Water in Processing Space, 14 ft Wave Height, 8 s Wave Period

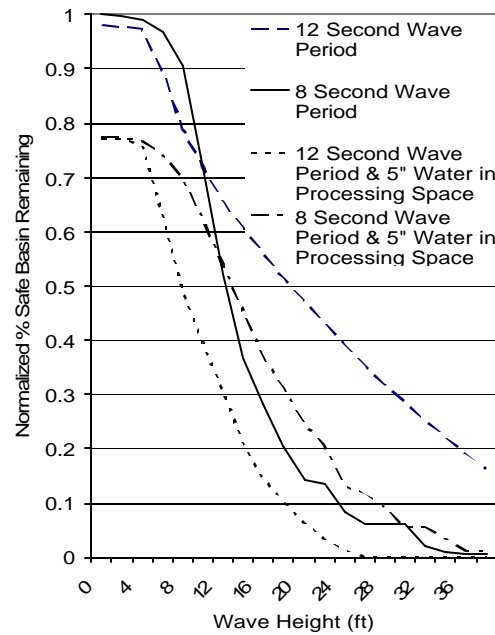
The integrity curve shown in Figure 14 was calculated using the techniques described in [12]. It shows the number of unmarked coordinates, or safe points, in the safe basin for the corresponding wave height. The wave height at which the lines decrease sharply is the critical height, beyond which the capsize resistance decreases greatly. For the ARCTIC ROSE, this critical wave height was approximately 10 feet.

Figure 14. Integrity Curve for ARCTIC ROSE

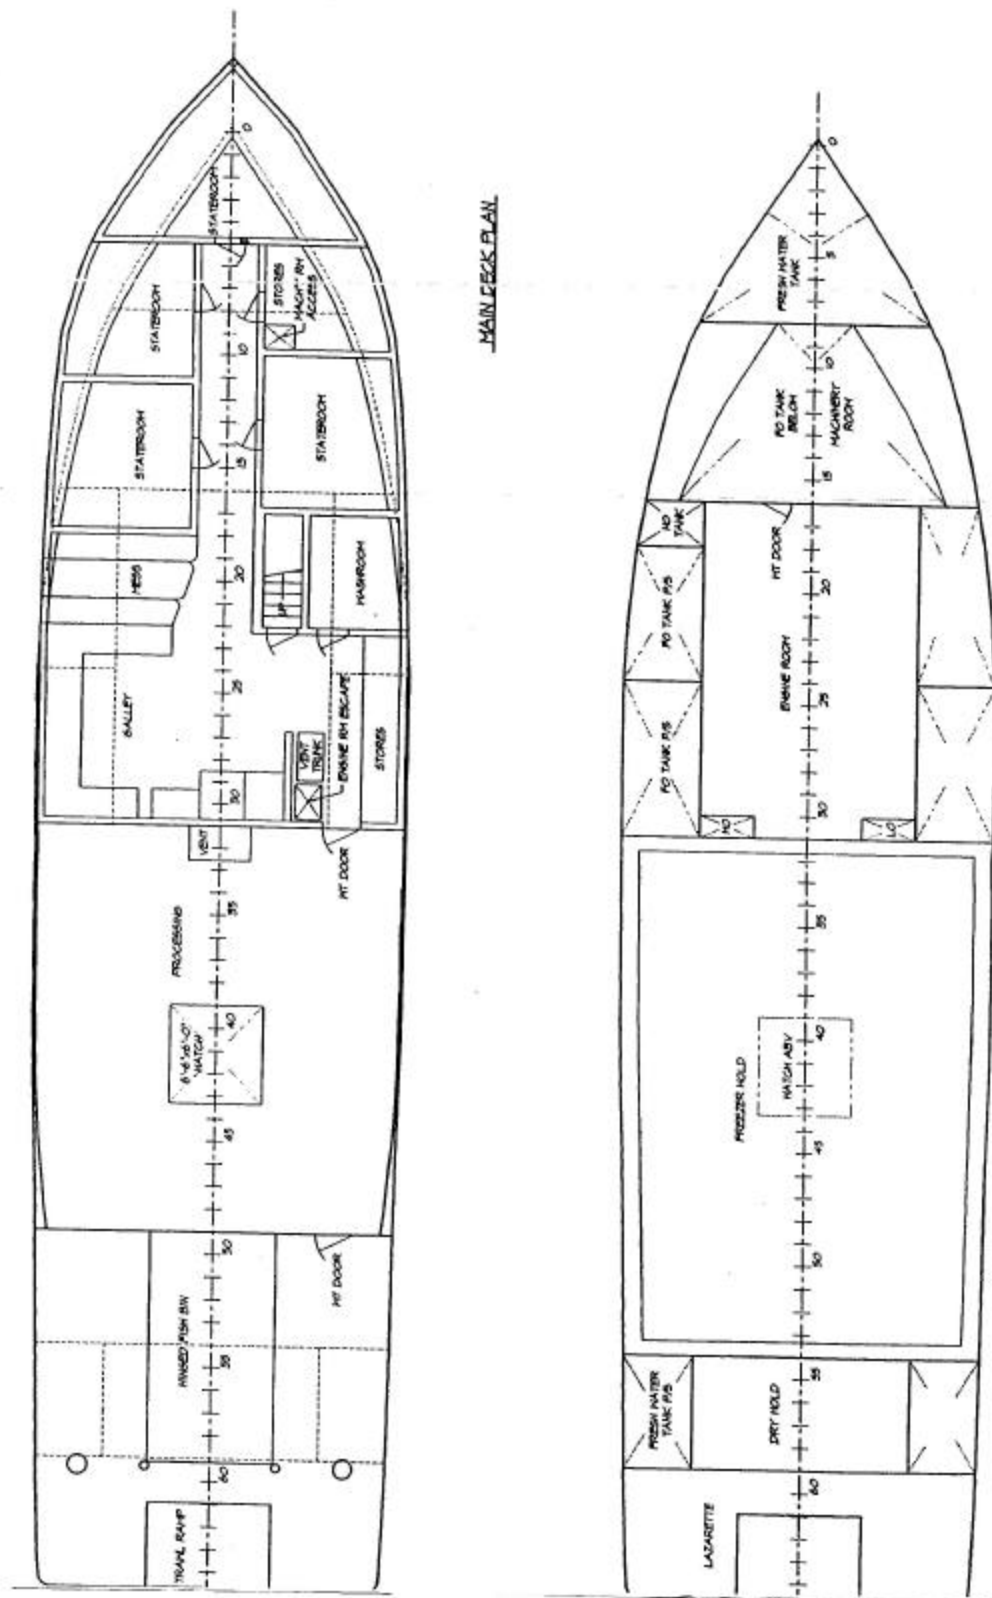
calculations to evaluate time to capsize and time to sink. The results of the MSC analysis are shown in Table 1. According to the analysis, the most likely reason the ARCTIC ROSE sank was progressive flooding from the aft weather deck to the processing space through an open door connecting the two areas, and the flooding then progressed to the galley, fish hold, and engine room through non-watertight doors and hatches. A sketch showing the general arrangement of the main deck and below deck of the ARCTIC ROSE was provided to the

FMBI by Jensen Maritime Consultants, Inc., and is included in Figure 2. The progressive flooding scenario that most likely sank the ARCTIC ROSE is very similar to that assumed to have resulted in the loss of the GAUL, a Norwegian trawler that sank in February 1974, killing all 36 men onboard [2].

Figure 2. General Arrangements of Main Deck and Below Deck of ARCTIC ROSE
