Fatal stability loss of a small craft on a wave crest – based on a real safety investigation

ABSTRACT

This paper is based on the investigation of the pilot boat accident which took place in the Gulf of Finland, south of Emäsalo, on 8 December 2017 at approximately 5 PM, Safety Investigation Authority Finland (2018).

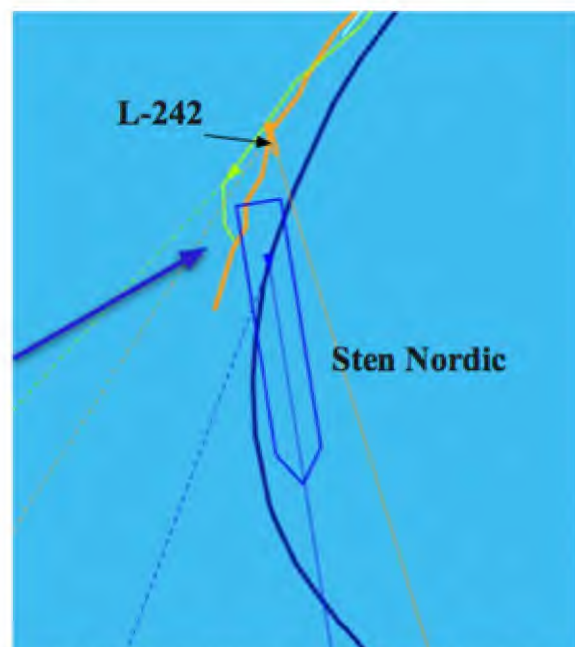
stern of the tanker and became exposed unexpectedly to high, steep recurring waves caused by the combined effect of the vessel and the sea waves. The path travelled both by the tanker and that of the pilot boat *L-242* are shown in Figure 1.

Figure 1: The paths travelled by the tanker and the pilot boat *L-242* shortly before the boat capsizing.

The situation prior to the boat capsizing is shown. The blue arrow depicts the prevailing direction of the sea waves' propagation. The speed of the boat was approximately 9 knots.

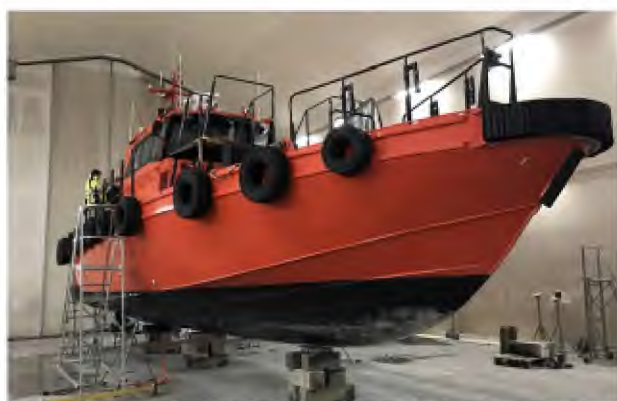
Figure 2: Pilot boat L-242 investigated after the accident. (Source: SIAF)

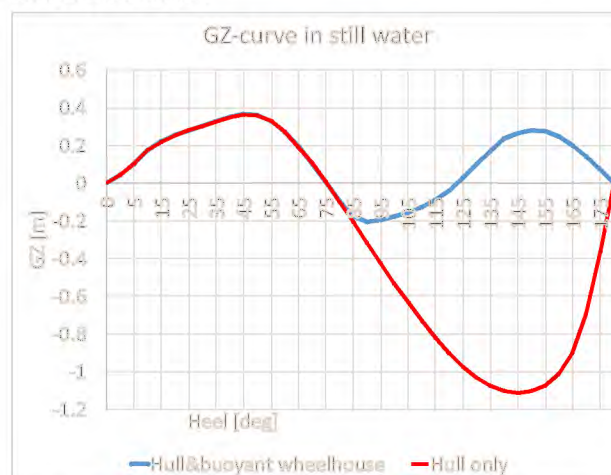
Figure 3: Righting moment curve (GZ-curve) of the pilot boat.

It was observed that the restoring moment of the pilot boat can temporarily lose up to 70% of its maximum in steep waves, during which a sudden, strong external force can capsize the boat. Such an external force can occur due to a rudder movement or a powerful gust of wind. No account of these factors had been taken in the design, manufacture or use of the boat. On the basis of the investigation, there is also reason to believe that the crew of the pilot boat *L-242* had no grounds for believing that the boat would capsize.

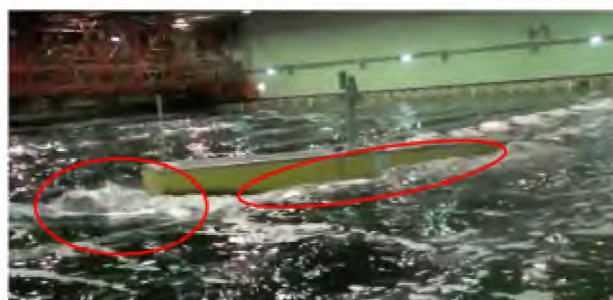
Figure 4: Model of a RoPax vessel in long-crested irregular waves in the multi-functional basin of Aalto University.

The waves used in the model tests were higher and longer ($H_S = 4.8$ m and $T_1 = 5.9$ s) than the ones that were present during the accident. However, a similar effect on the waves formed downstream due to turning of *Sten Nordic* can be expected.

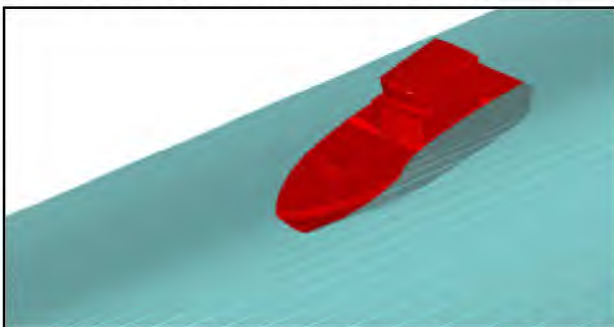
Figure 5: Position of static equilibrium of the pilot boat in regular sinusoidal wave of length 40 m and height 3 m. Heading 50°.

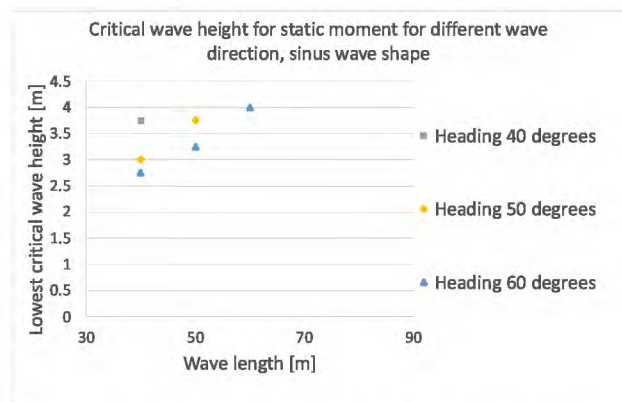
The results of this static, i.e. slowly increasing, loading by rudders on the boat in the critical waves are presented in Figure 6.

Figure 6: Critical wave heights for static loading caused by turning rudders by 40°.

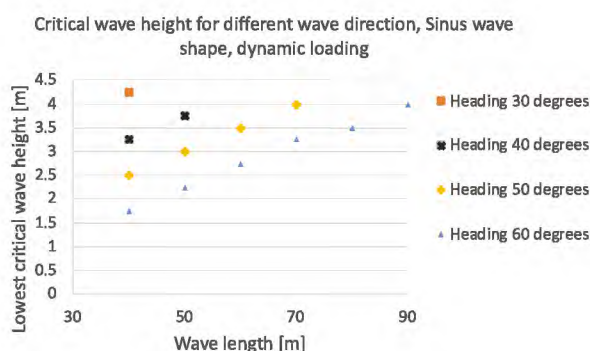
Figure 7: Critical wave heights for dynamic (step function) loading caused by turning rudders by 40°.

It is clearly seen that the dynamic rudder command substantially increases the risk of capsizing. A nearly linear increase of critical wave height with length suggests that wave steepness is the primary reason for capsizing. The critical wave steepness depends upon heading. The most dangerous heading capsizing the boat in waves of smallest steepness is 60°.

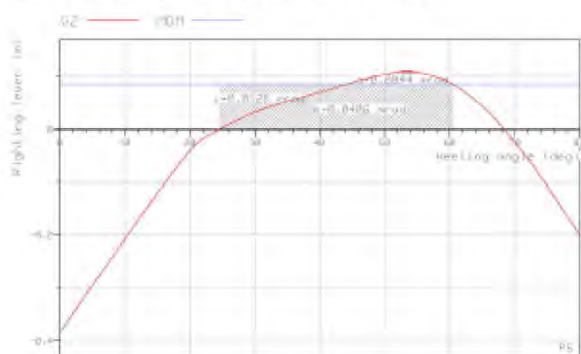
An example of the boat capsizing due to a rapidly changed rudder angle in the critical wave and heading condition is illustrated in Figure 8. The static balance of the boat in this condition yields a heel of 24°.

Figure 8: Dynamic loading due to rapidly turned rudders capsizes the boat in 40 m long and 3.5 m high wave, heading 40°.

A substantial decrease of the GZ-curve maximum, stability range and the capability to withstand dynamic loads is noted. The latter is not enough to resist dynamic load of the rudders.
