Experimental Investigations into Accidents of Two Japanese Fishing Vessels

135GT PURSE SEINER ACCIDENT

113GT STERN TRAWLER ACCIDENT

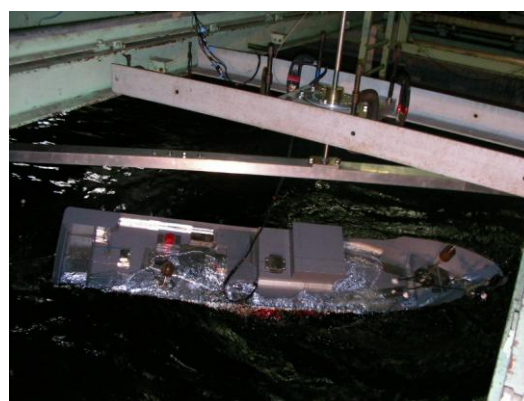
In the experiment a 1/23.9 scaled model ship was moored to the carriage with weak springs to simulate the situation of lying to with a sea anchor and keep intended encounter angle in waves and ship motions were measured in starboard bow to beam waves (Fig. 1). In the experiment wave conditions (properties and encounter angle) and ship conditions (position of centre of gravity and function of freeing ports) were varied and their effects on capsizing were investigated.

Fig. 1: Model Ship in Waves.

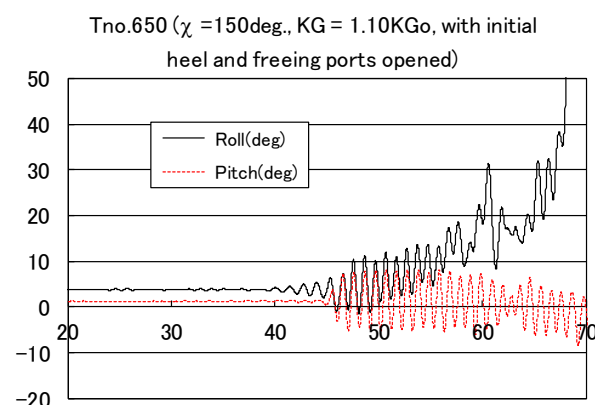
Fig. 2: Measured roll angle and pitch angle in regular wave of $\lambda = 1.6\text{m}$ and $H_w = 0.13\text{m}$ with a superimposed concentrating wave. $\chi = 150^\circ$, $KG = 1.10\text{KGo}$ and with initial heel and all freeing ports opened.

Fig. 2 shows typical time histories of roll angle and pitch angle in capsized case. From the measured ship motion and the observation during the experiment the capsizing sequence in bow waves could be summarised as follows (refer to Fig. 2). At first shipping water around midship part occurs and water floods the fore deck. This increases the bow trim and the starboard heel and the resultant freeboard around the starboard bow section decreases. This change in the mean position of the ship stimulates further shipping water. At last successive shipping water occurs and the increased flooded water reduces the stability of the ship, then the wave action turns over the ship. In short, the mechanism of the capsizing

in bow waves is that the increased flooded water on the fore deck reduces the freeboard of bow part and the reduced freeboard accelerates shipping water then with the increased flooded water stability of the ship reduces drastically and capsizing occurs.

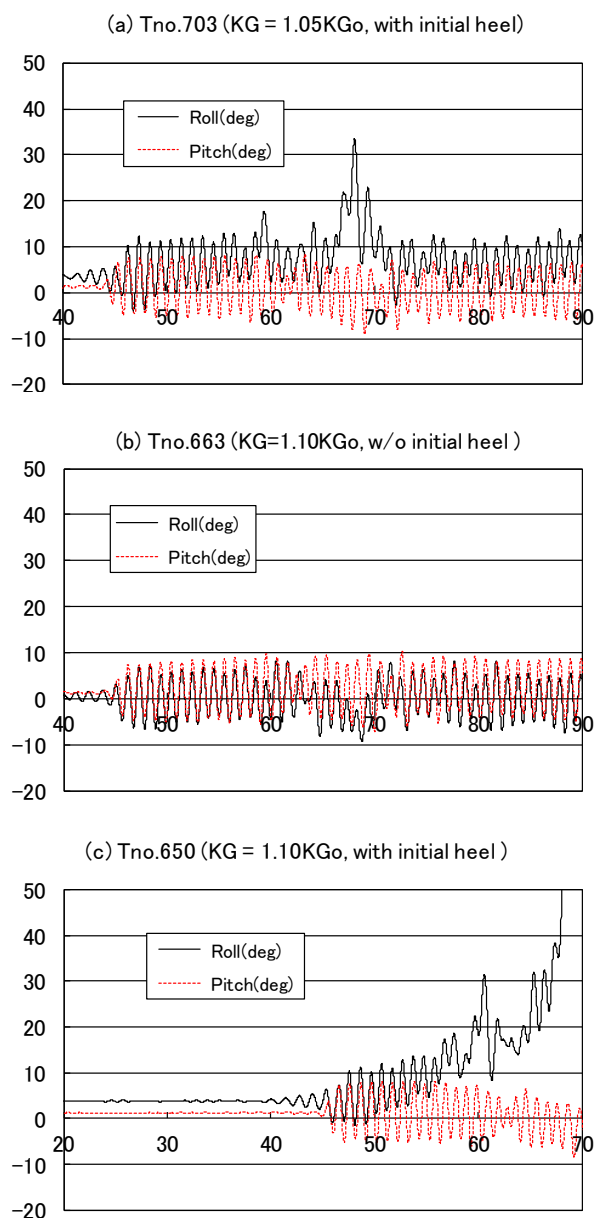
Fig. 3: Effects of height and lateral deviation of C.G. on measured roll angle and pitch angle in regular wave of $\square = 1.6\text{m}$ and $H_w = 0.13\text{m}$ with a superimposed concentrating wave. $\square = 150^\circ$ deg. and with all freeing ports opened.

which have been clarified in the experiment, it is presumed that following factors, increased height and lateral deviation of C.G., poor function of freeing ports and improper encounter angle to waves played key roll to the capsizing of the purse seiner.

On the other hand the experimental result shows that no capsizing occurred with the encounter angle of 165 degrees and even in the highest C.G. condition capsizing did not occur with no lateral deviation of C.G. and all freeing ports opened (Table 4 and Fig. 3).

These experimental results imply that careful operation and sufficient maintenance of vessels with the above things into consideration might prevent similar accident.

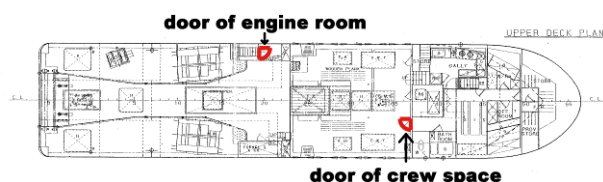
The subject ship model used in this research is the 1/16 scaled. The principal particulars are shown in Table 5. According to the investigation of salvaged trawler, two watertight doors were opened. Opened doors are shown in Fig. 4. For recording shipping water and flowing point, the model ship was installed with 5 video cameras and 360 degrees video camera. The positions of cameras are shown in Fig. 5. The 360 degrees camera recorded situation in the working room as shown in Fig. 6.

Fig. 4: Opened watertight doors.

- 1) The stern trawler met more than 2 times higher wave of average.
- 2) Shipping water flowed into the engine room from the opened watertight door.
- 3) Maximum of GZ was decreased by flooded water.
- 4) With the reduced stability the opening of engine room was easy to under the water level.
- 5) In less than 5 minutes, the trawler sank.

by state so that prompt attitude adjustment is possible so as to prevent water from flooding in. And for "Stern trawler Yamada-maru No.2 accident", the remarks require that during navigation, exit doors etc. on the deck should always be closed and whenever they are opened for access, they should be closed promptly.

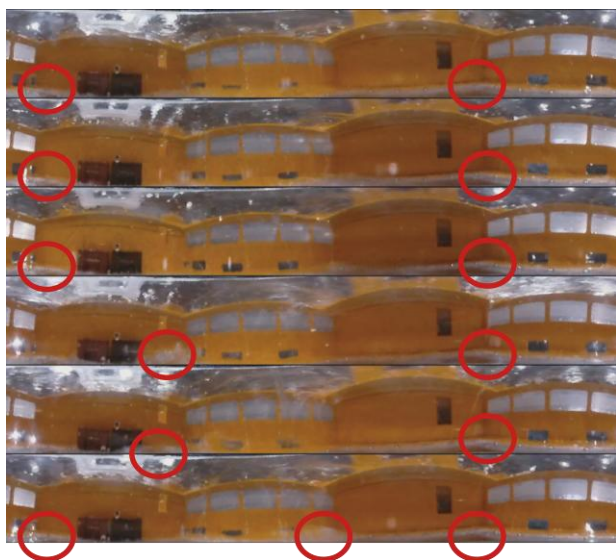
Fig. 7: Flooding water in the working room (red circle) observed with wave period = 6 sec, wave height = 5.88m, $\chi = 28$ degrees. (interval = 0.8sec; time goes on from top to bottom)

An example of flooded water in the working room at "huge flooded water on deck" case is shown in Fig. 7 and the time series of ship motion and rudder angle in the same condition are shown in Fig. 8. The average heel angle of

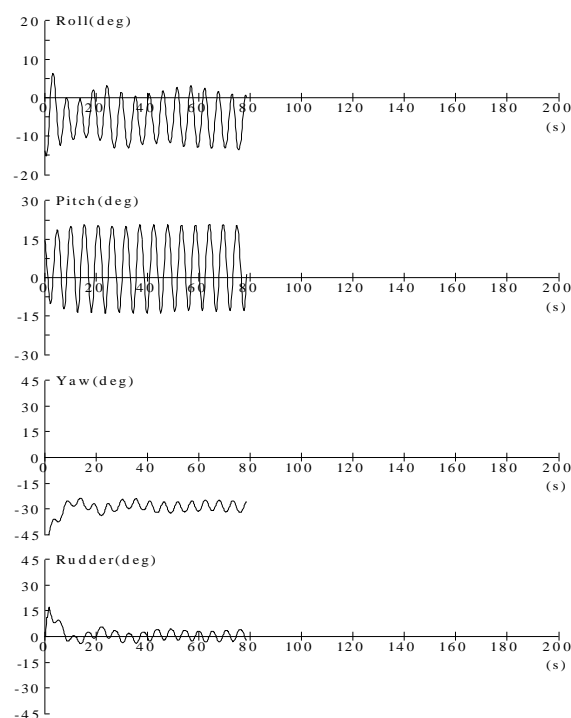
water on deck was -7 degrees in this case. But Fig. 8 shows that the flooded water in the working room had never reached to the door of crew space.

Fig. 8: Time series. (wave period = 6 sec, wave height = 5.88m, $\chi = 28$ degrees)

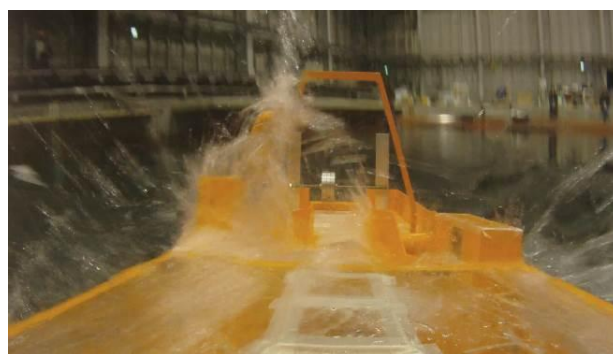
Fig. 9: Shipping water on upper deck

Fig. 9 shows the shipping water on upper deck. It shows that the shipping water from bow went straight to the opening entrance of engine room.

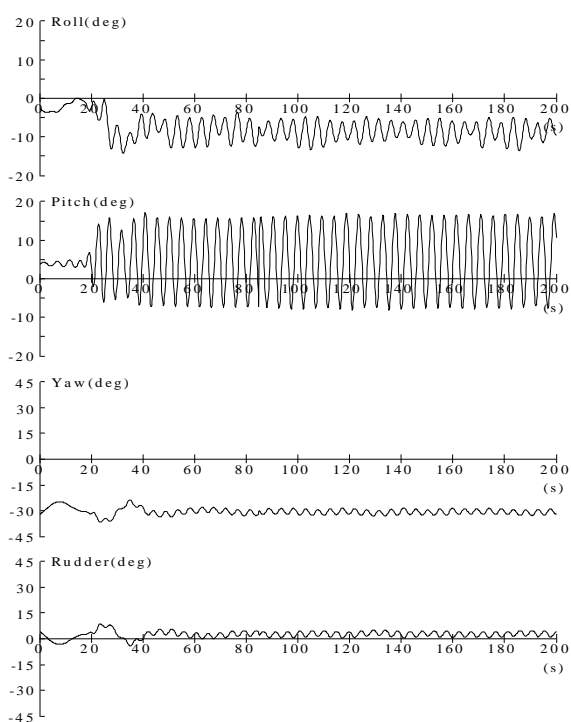
Fig. 11: Time series. (wave period = 5.5 sec, wave height = 1.94 m, $\chi = 28$ degrees)

Time series with 12 t of flooded water is shown in Fig. 11. 1.94 m wave height is enough to make initial roll angle to the situation of water on deck.

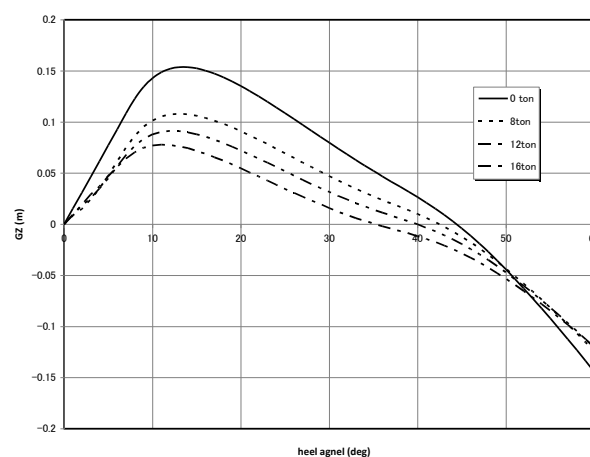
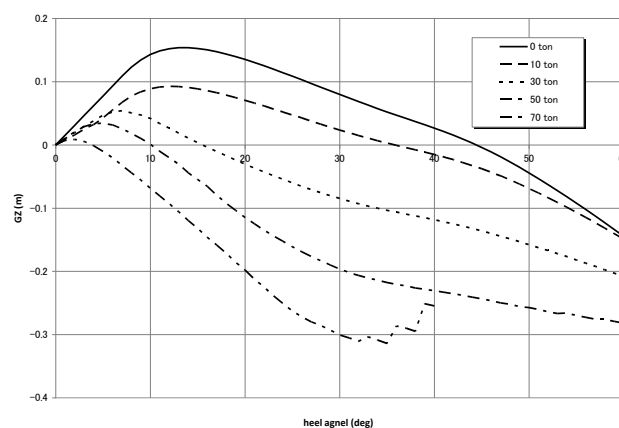
Stability curve with flooding water in engine room is shown in Figures 12 and 13. It shows that maximum GZ is reduced by 30% with 12 t of flooded water and by 50% with 16 t of flooded water. And, there is no stability left with 70 t of flooded water.

Stability calculations show that more than 70 t of flooded water in the engine room makes

total loss of stability. Based on the estimated flowing rate of water into the engine room, 2 minutes is enough time for flowing water of 70 t into the engine room. Reserve buoyancy of this trawler is about 202.7t. Less than 5 minutes is enough to sink it.
