# Aviation Investigation Final Report

<b>Location:</b>	Thomson, Georgia	<b>Accident Number:</b>	ERA18LA168
<b>Date &amp; Time:</b>	June 14, 2018, 18:00 Local	<b>Registration:</b>	N45TX
<b>Aircraft:</b>	Stinson L 5	<b>Aircraft Damage:</b>	Substantial
<b>Defining Event:</b>	Powerplant sys/comp malf/fail	<b>Injuries:</b>	1 None
<b>Flight Conducted Under:</b>	Part 91: General aviation - Personal

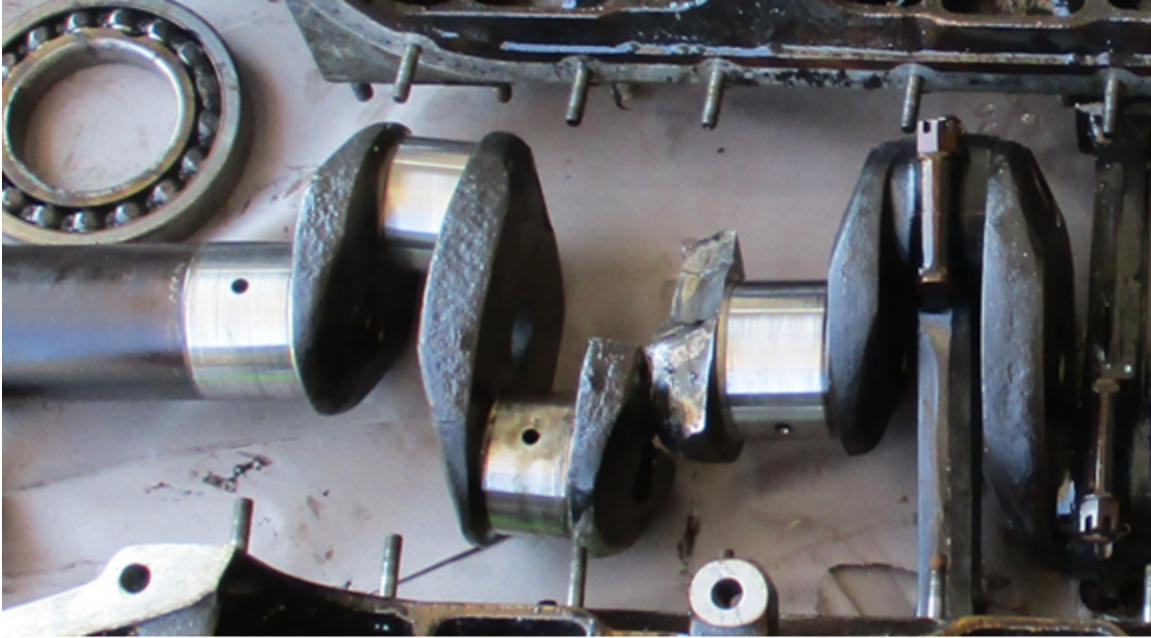
Figure 1 Crankshaft fracture

Additional damage found on the Nos. 1 and 2 cylinders was caused by the crankshaft failure and pistons that impacted their respective rods and skirts. In addition to the main fracture, a separate crack was discovered slightly aft of the No. 1 main bearing and had propagated nearly the width of the crankshaft, but had not fully failed. The thrust nut, which required 375 ft-lbs of torque, was easily removed without effort or special tools, indicating that it was torqued to a value significantly below specification. This could cause axial play along the crankshaft and contribute to the progression of the crankshaft failure that was likely initiated during the previous 2 propeller strikes. The crankshaft likely failed after its structural integrity was compromised during previous propeller strikes. The improper torque on the thrust nut likely exacerbated the failure of the crankshaft.

Failure of maintenance personnel to inspect the crankshaft after two previous propeller strikes, which resulted in failure of the crankshaft and a total loss of engine power. Contributing to the crankshaft failure was insufficient torque applied to the thrust nut.

The airplane was recovered for detailed teardown and examination of the engine. Removal of the Nos. 1 and 2 cylinders revealed that the crankshaft fractured at the No. 2 crank pin. (see Figure 1.)

The thrust nut was removed in order to open the crankcase. The amount of torque required to loosen the thrust nut was not measured, but was significantly less than the 375 ft-lbs specified by the engine overhaul manual, as it required no special tools and little effort to remove. Upon opening the crankcase, it was confirmed that the crankshaft was fractured along with ancillary damage caused by the Nos. 1 and 2 pistons and connecting rods impacting their respective skirts. In addition to the main fracture, a separate crack was discovered slightly aft of the No. 1 main bearing that had propagated nearly the width of the crankshaft, but had not fully failed.
