Aviation Investigation Final Report

| Location: | Kennett, Missouri | Accident Number: | WPR18LA256 |
| Date & Time: | September 7, 2018, 15:00 Local | Registration: | N131TX |
| Aircraft: | Cirrus SR22 | Aircraft Damage: | Substantial |

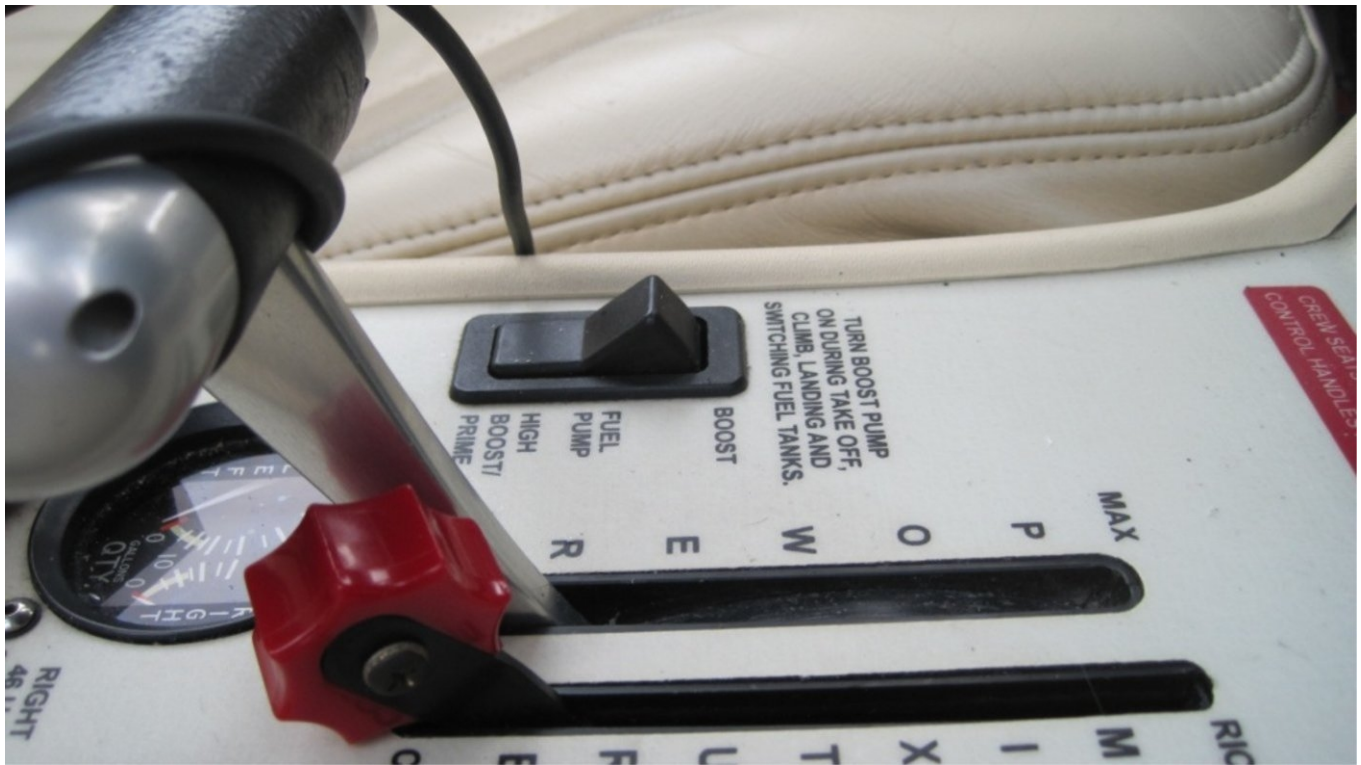
Figure 1. Fuel Boost Pump Switch

It is likely that, during his attempt to free the headset control module, the pilot inadvertently and unknowingly repositioned the unguarded three-position fuel pump control rocker switch, located on the center console, to the HIGH BOOST/PRIME position. This selection resulted in the loss of engine power.

The pilot's inadvertent activation of the fuel pump control rocker switch, which resulted in a loss of engine power shortly after takeoff. Contributing to the accident was the pilot's distraction with an entangled headset cord.

The airplane was equipped with an electrically powered fuel boost pump. A three-position (boost, off, high boost/prime) rocker switch to control the fuel pump was located on the horizontal surface of the center console between the two forward seats, just left of the engine power lever. (see Figure 1.) The fuel pump is unpowered (off) when the switch is in its neutral position. Depressing the forward end of the switch face powers the pump in the BOOST mode, which is used for takeoff, climb, landing, and switching fuel tanks. Depressing the aft end of the switch face powers the pump in the HIGH BOOST/PRIME mode, which is used to prime the engine before engine start, and for suppressing vapor formation in flight above 18,000 ft with hot fuel. The switch was not guarded or otherwise physically protected from inadvertent operation.

Examination of the wreckage revealed that the CAPS parachute was still attached to the airplane. The engine and cowling were almost completely fracture-separated from the fuselage. The windshield was fractured into multiple pieces. The headset cord was wrapped around the engine power lever, and the fuel pump switch was in the HIGH BOOST/PRIME position. No other non-impact damage or abnormalities were observed.

About 4 months before the accident, Cirrus began implementing software changes intended to prevent improper operation of the electric fuel boost pump. The approach consisted of a software-controlled lockout feature that was to be retroactively applied to all SR22T model Cirrus airplanes via service bulletins (SBs). The revised software locks out the high boost function of the pump (when HIGH BOOST/PRIME is selected) until the airplane reaches a pressure altitude of 10,000 feet; this prevents an engine power loss at low altitudes due to improper selection of HIGH BOOST/PRIME.
