Aviation Investigation Final Report

Location:	Temple, Texas	Accident Number:	CEN18LA385
Date & Time:	September 10, 2018, 08:45 Local	Registration:	N946JY
Aircraft:	Zenair ZENITH CH 750	Aircraft Damage:	Substantial
Defining Event:	Fuel related	Injuries:	1 Minor
Flight Conducted Under:	Part 91: General aviation - Personal

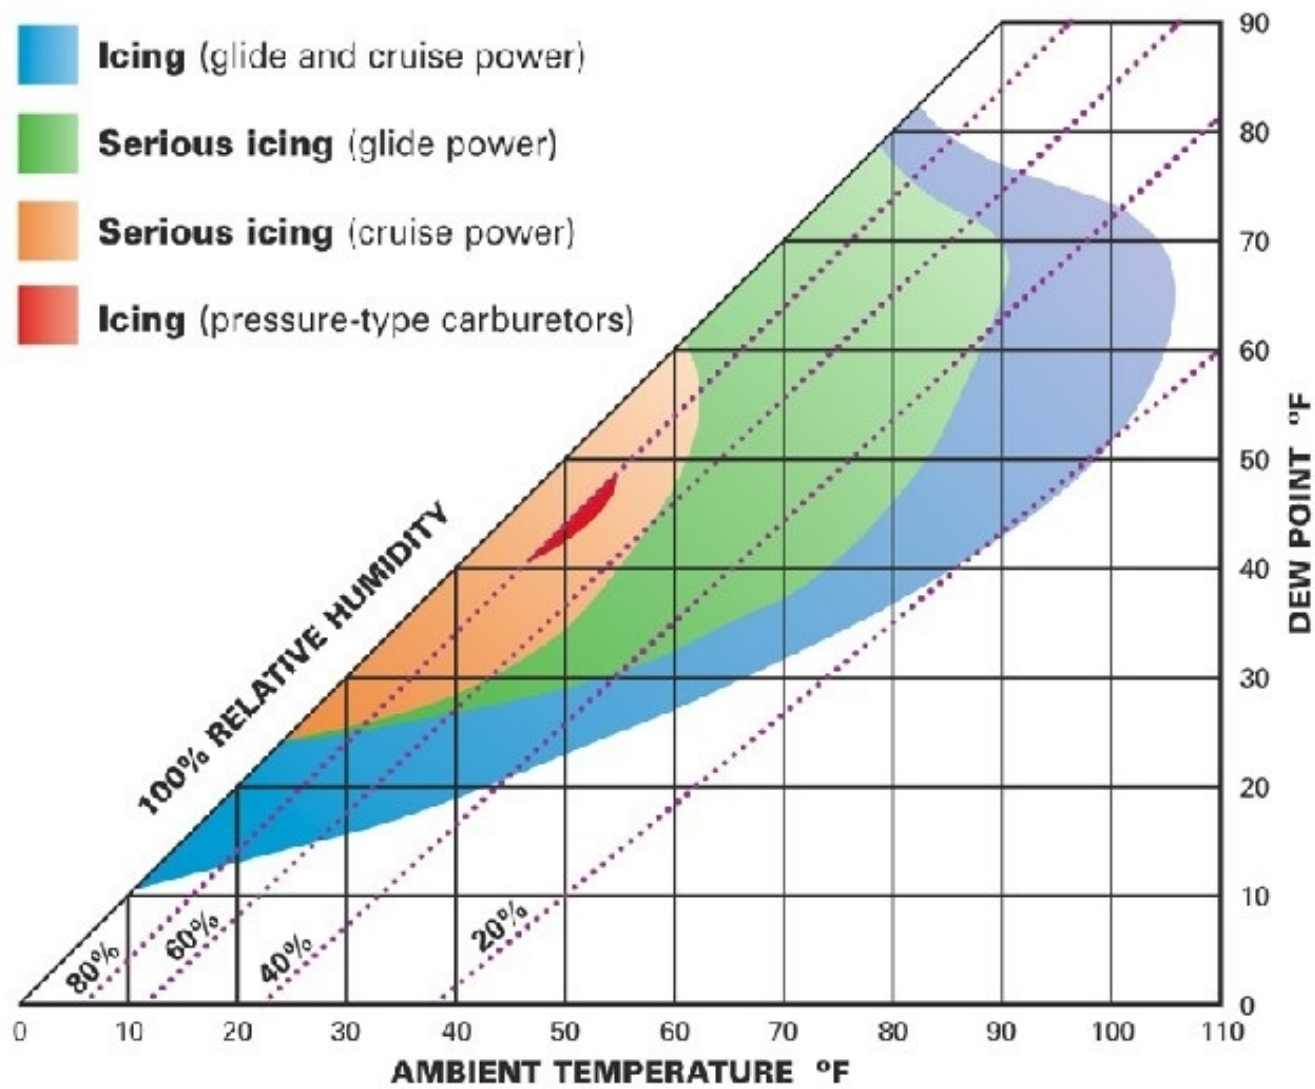
Figure 1 - FAA Carburetor Icing Probability Chart

The carburetor icing probability chart included in Federal Aviation Administration Special Airworthiness Information Bulletin No. CE-09-35, Carburetor Icing Prevention, indicated that the airplane was operating in an area that was associated with a serious risk of carburetor ice accumulation at glide power settings (Figure 1).
