Aviation Investigation Final Report

Location:	Whittier, Alaska	Accident Number:	ANC18FA036
Date & Time:	May 12, 2018, 09:40 Local	Registration:	N7061W
Aircraft:	Piper PA-28-180	Aircraft Damage:	Substantial
Defining Event:	Controlled flight into terr/obj (CFIT)	Injuries:	1 Fatal
Flight Conducted Under:	Part 91: General aviation - Personal

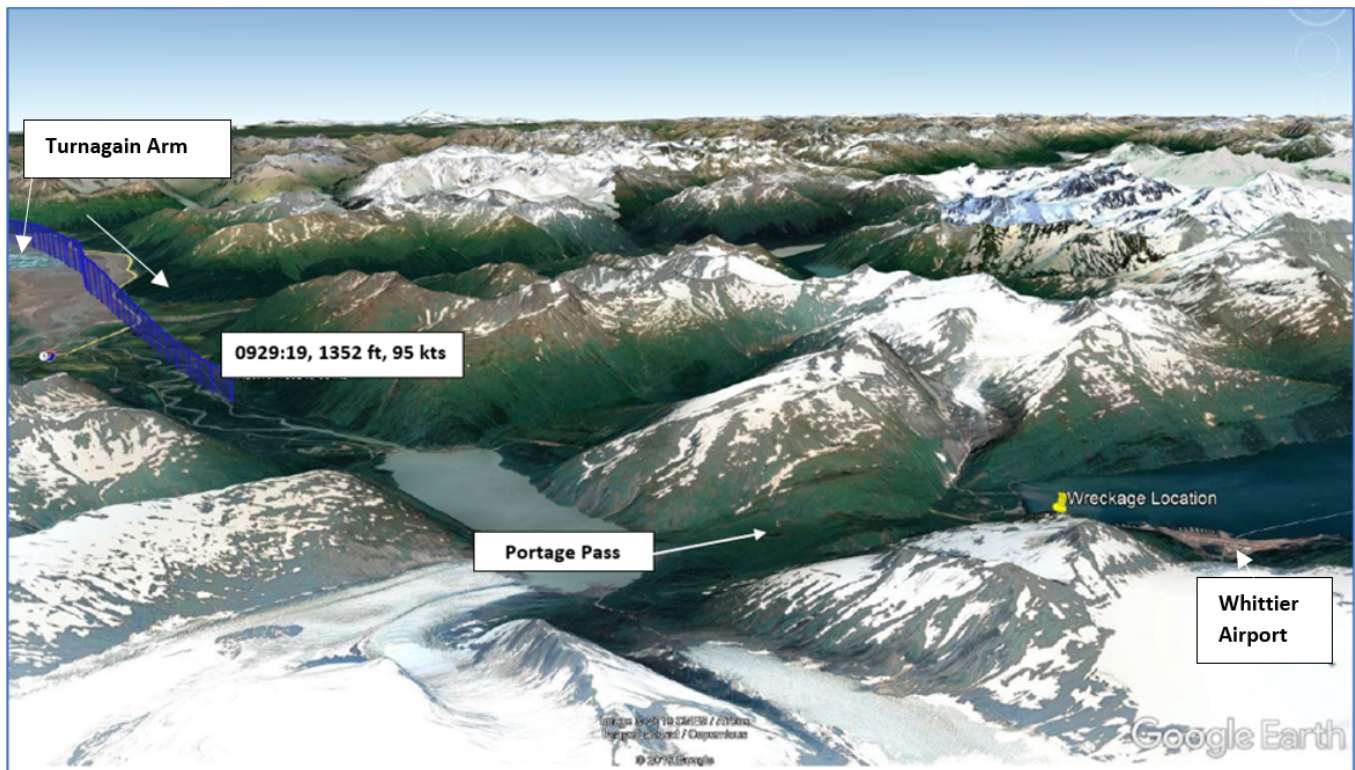
According to Federal Aviation Administration (FAA) air traffic control records, the airplane departed MRI at 0859 and proceeded to the Turnagain Arm waterway, which is a narrow waterway between the Kenai Mountains and the Chugach Mountains, where the pilot reported his position at Bird Creek at 0916. No further radio communications were received from the pilot. A review of data from a recovered Garmin Aera 500 device onboard the airplane revealed that the pilot flew southeast along Turnagain Arm. About 0929, the last data point was recorded about 5 miles from the accident site and indicated the airplane at 1,352 ft mean sea level (msl) at 95 knots ground speed, heading approximately southeast. (See figure 1.)

Figure 1. GPS flight track (blue) and wreckage location on Google Earth image.

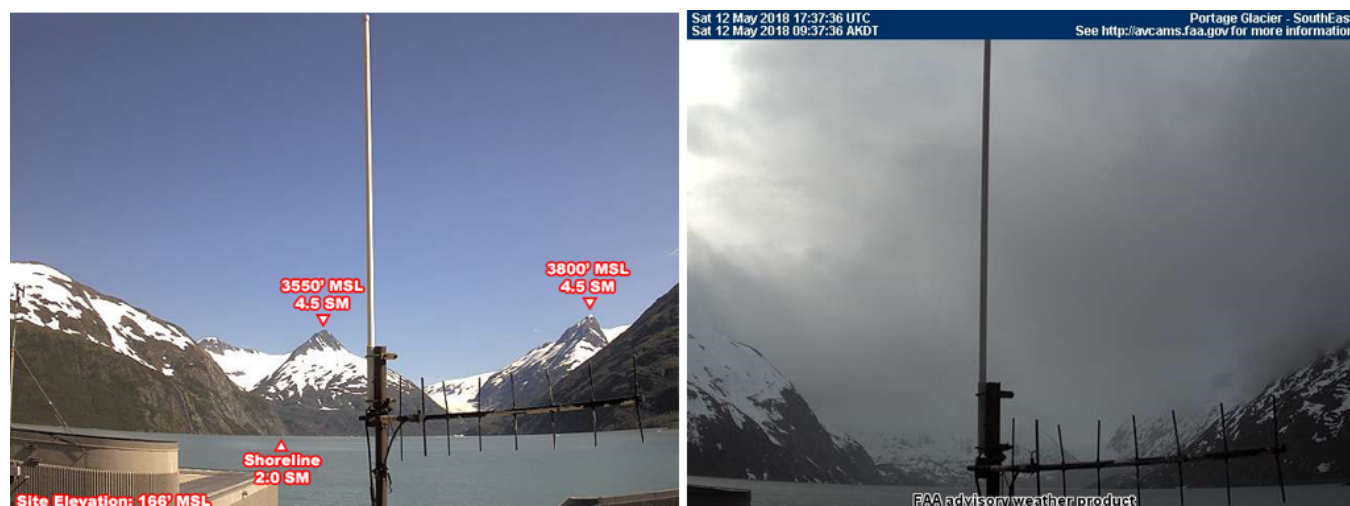
Archived images from the FAA aviation weather cameras on the morning of the accident at Whittier and Portage Glacier between 0937 and 0941 depicted obscured mountain tops and visibility between 2 and 10 statute miles (sm) in the areas south and northeast of the accident site. (See figure 2.)

Figure 2. Portage Glacier weather camera image on a clear day (left) and on the accident day at 0937 (right).

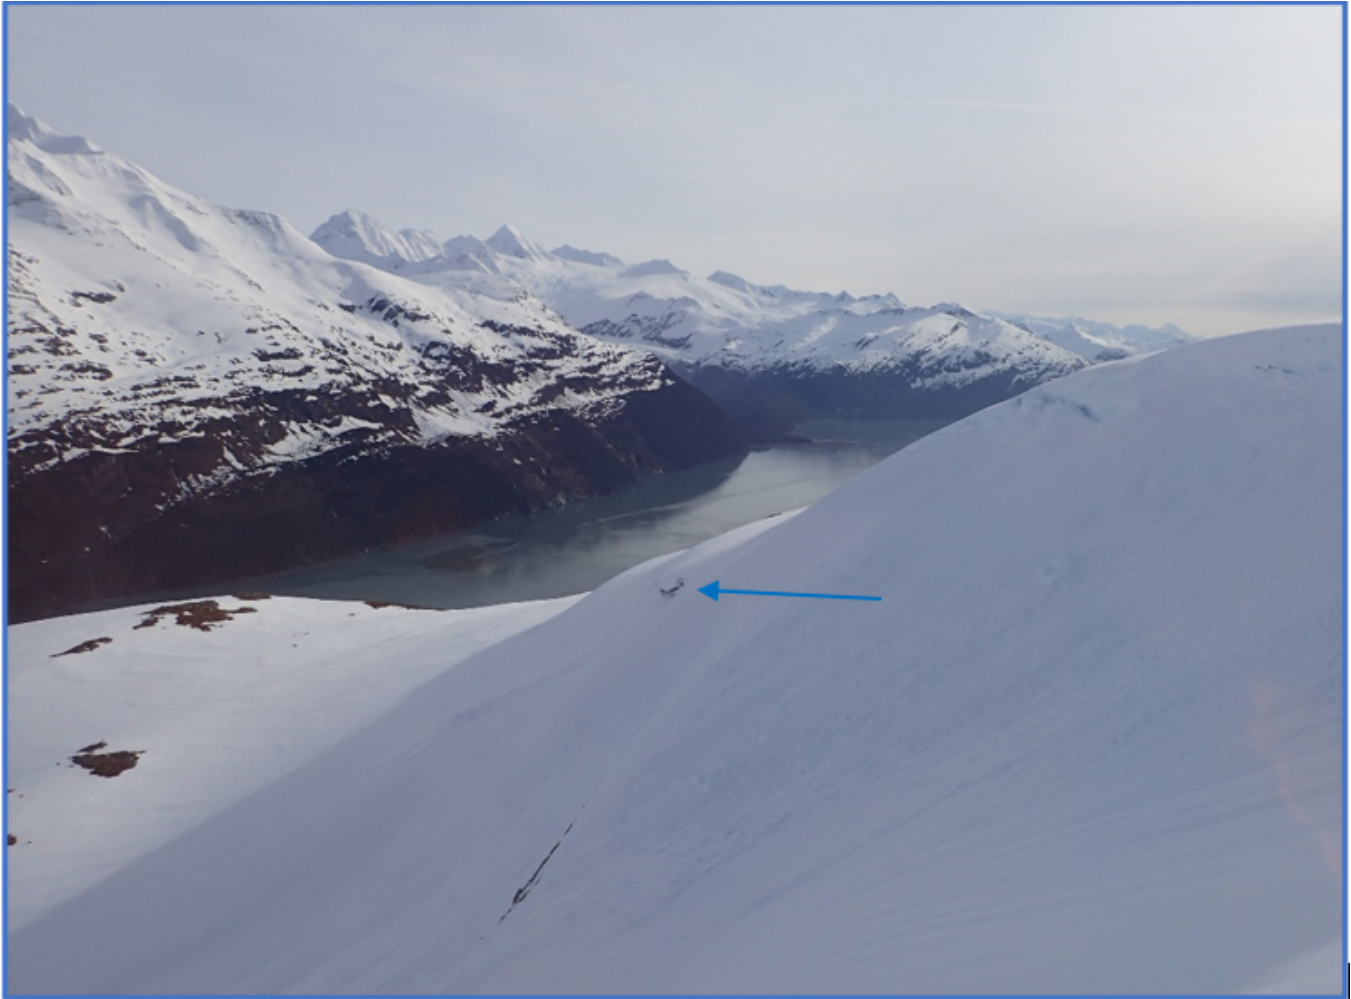
The wreckage came to rest in deep snow on a 40° incline in a slightly nose-up, level attitude on a heading of 110°. Both wings exhibited significant leading-edge crush damage and were each rotated about 30° to the right around the airplane's vertical axis. All of the airplane's major components were located in the immediate vicinity of the main wreckage. (See Figure 3.)

Figure 3. Airplane at the accident site.
