# Aviation Investigation Final Report

<b>Location:</b>	Reno, Nevada	<b>Accident Number:</b>	WPR18FA131
<b>Date &amp; Time:</b>	May 1, 2018, 19:31 Local	<b>Registration:</b>	N352BT
<b>Aircraft:</b>	AMERICAN AIR RACING LTD THUNDER MUSTANG	<b>Aircraft Damage:</b>	Substantial
<b>Defining Event:</b>	Powerplant sys/comp malf/fail	<b>Injuries:</b>	1 Fatal
<b>Flight Conducted Under:</b>	Part 91: General aviation - Personal

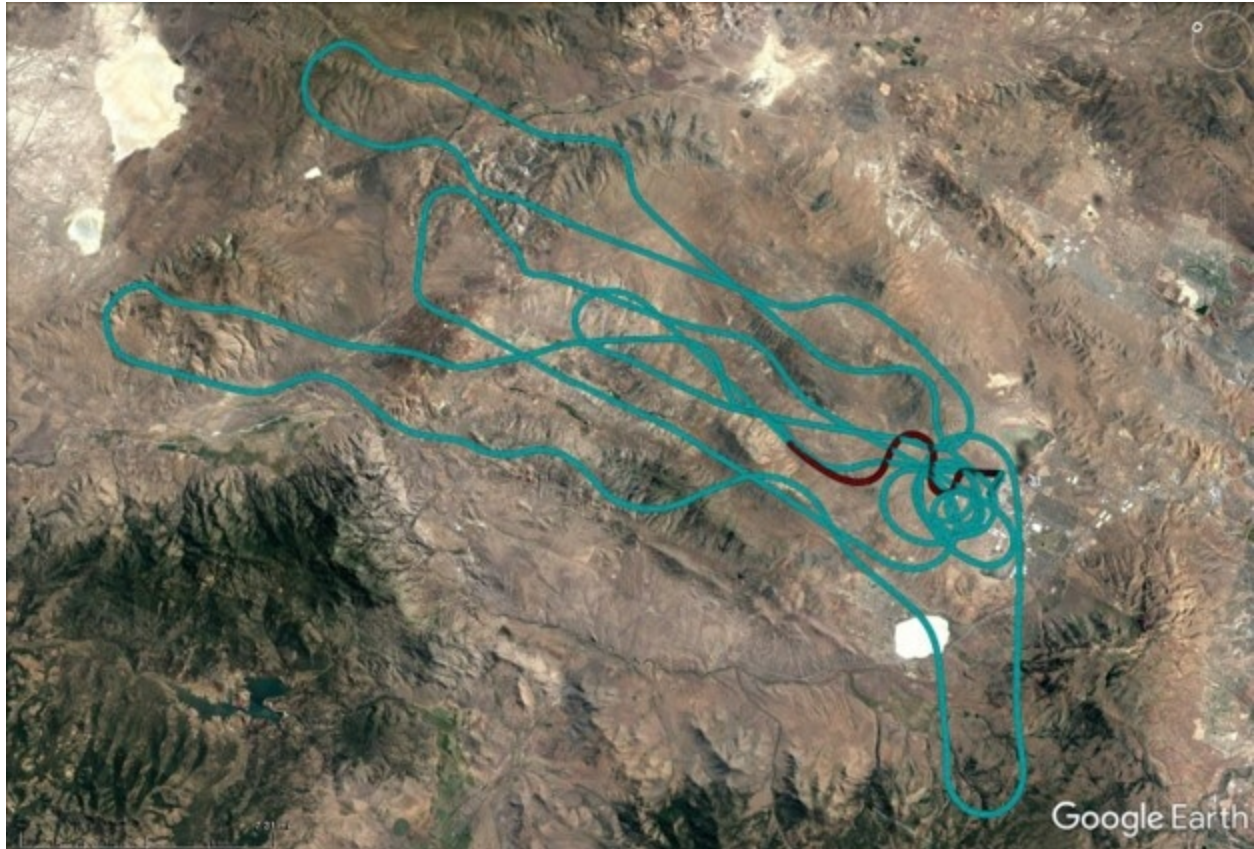
During the initial north-south passes (Figure 1), the engine was operating at a speed of about 4,050 rpm, while the manifold pressure varied between 10 and 13 inches of mercury, and the exhaust gas temperatures (EGT) were all about 1,300°F.

Figure 1 – Entire Flight Track (accident portion highlighted in red)

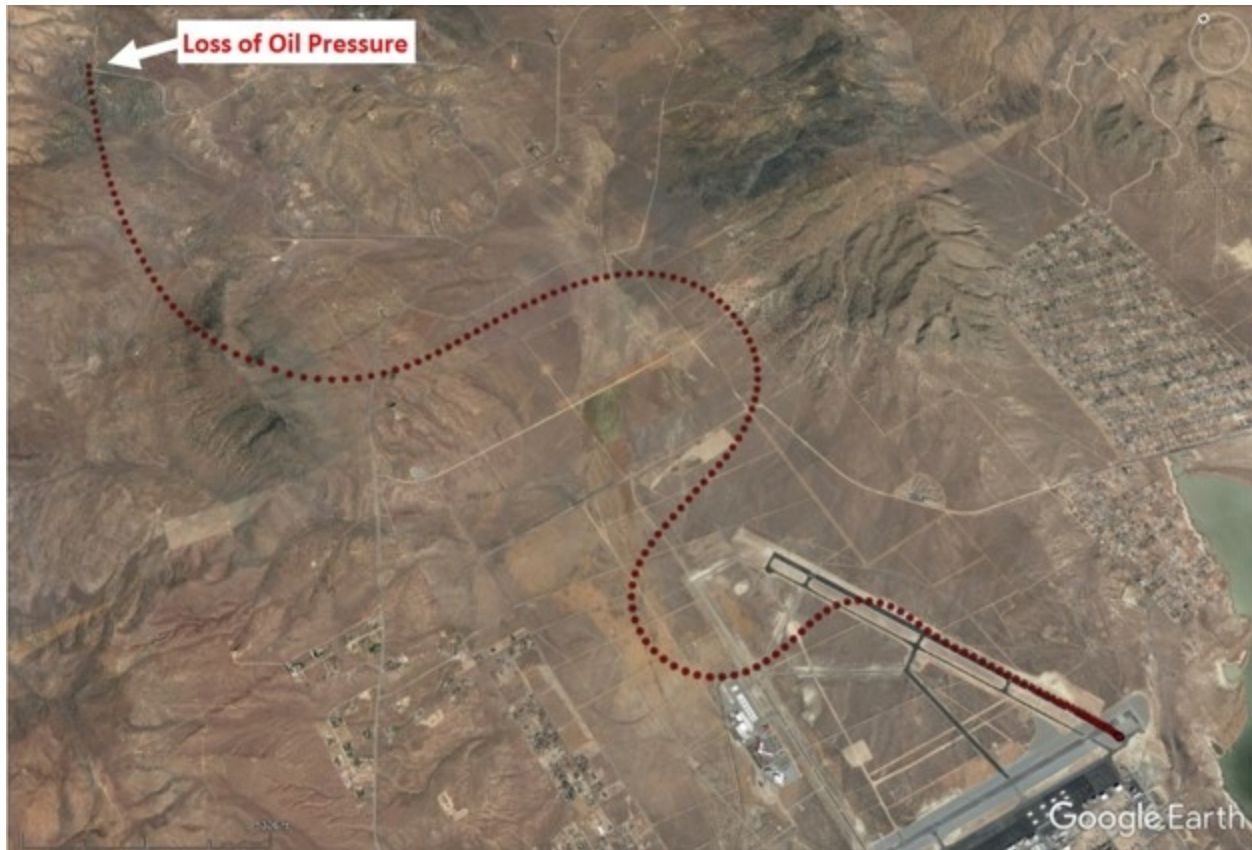
At 1928, while 4 miles north-northwest of the approach end of runway 14, and at a GPS altitude of 8,460 ft (about 2,800 ft above terrain, and 3,410 ft above the airport elevation), the oil pressure dropped from 72 psi to 0. At that time, the auxiliary alternator current flow dropped from 17 amps to 0 amps, while the current supplied by the auxiliary battery increased from 0 to 9.6 amps. The engine speed dropped to about 2,000 rpm, and the airplane began to descend.

Over the next 130 seconds, the airplane initiated a descending 1.5-mile-wide S-turn (Figure 2). The EGTs had decreased to about 1,000°F, and the airplane arrived about 200 ft agl over the runway, 2,400 ft beyond the landing threshold, while traveling at an indicated airspeed of 139 knots (KIAS).

Figure 2 – Accident Flight Track (loss of oil pressure at GPS altitude of 8,460 ft)

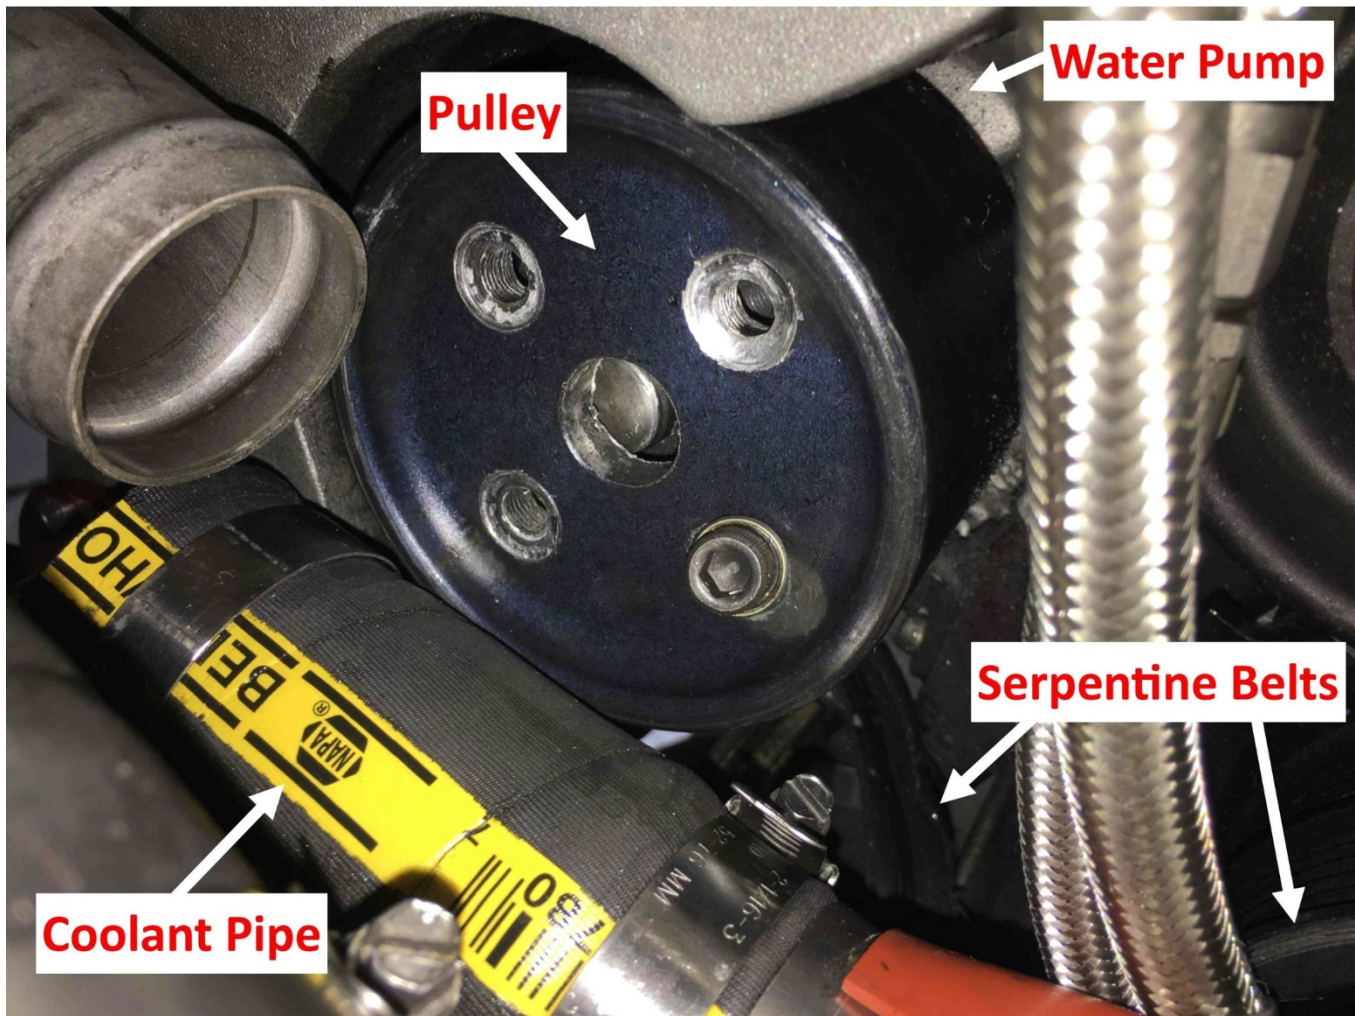
Postaccident examination revealed that the coolant pump pulley had separated from the pump drive flange. The pulley mounting cap screw heads had detached, leaving their threaded stud ends still in the flange. Both serpentine belts had also detached, along with the top of the engine coolant outlet hose, which was adjacent to the pulley (Figure 3).

Figure 3 – Detached Coolant Pump Pulley

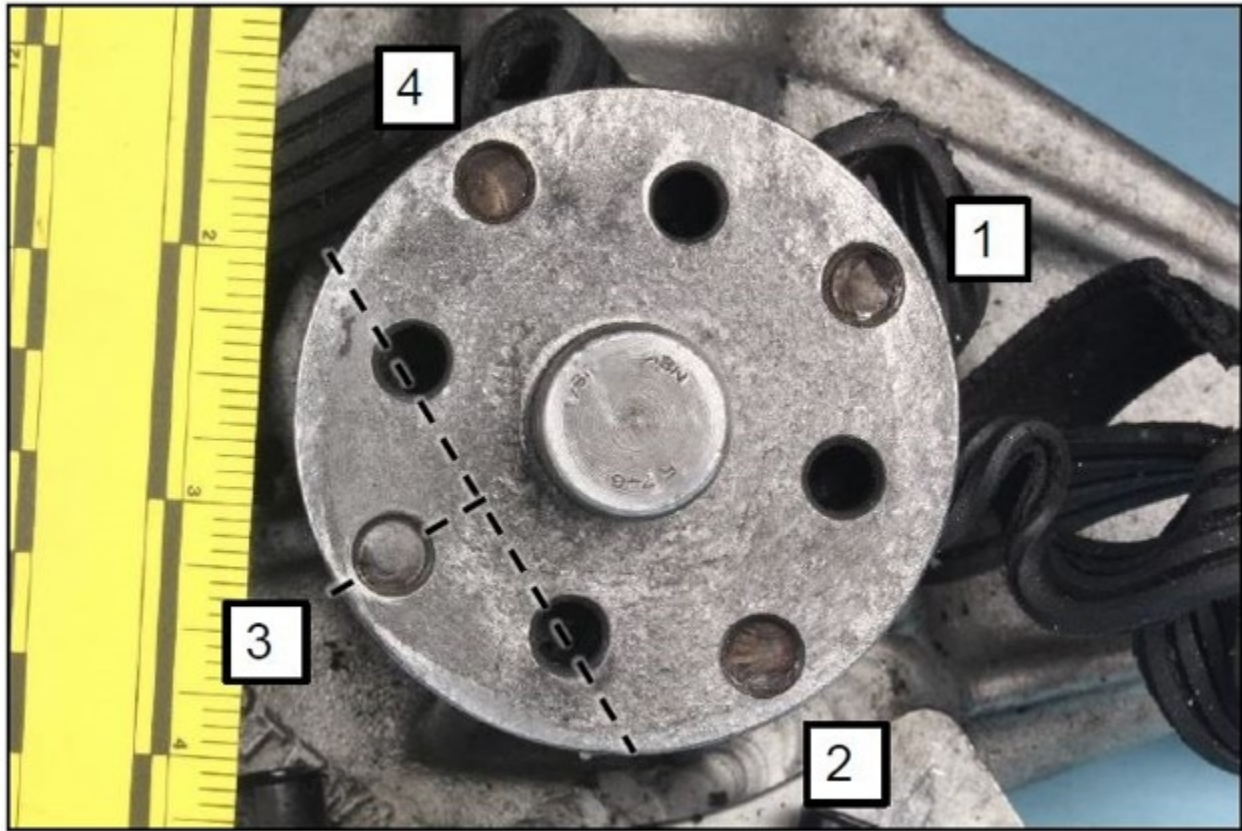
The pulley had been attached to the pump drive flange by its four cap screws, the threaded portions of which remained installed in the flange. The flange and corresponding mating surface of the pulley exhibited rough surface features consistent with heavy fretting contact damage. The areas around the bolt holes of the pulley were significantly abraded, consistent with relative-motion contact wear by the washers. Thread impressions were also observed in the bolt holes, consistent with high-force contact with the threads of the attachment screws.

Figure 4 – Coolant Pump Pulley Drive Flange

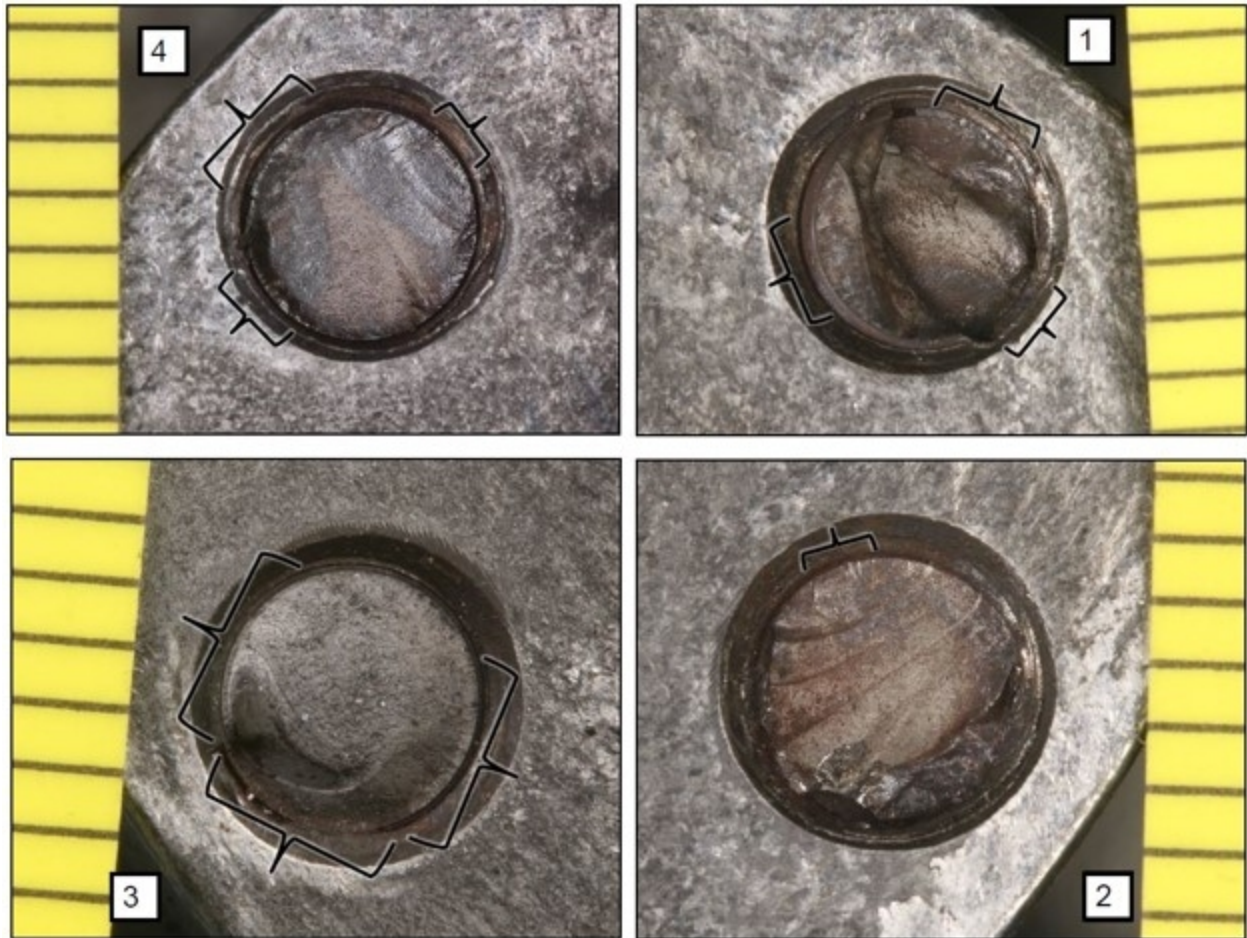
The cap screws were arbitrarily labeled 1 through 4 (Figures 4, 5). Screw 1 had multiple fatigue origins located around its circumference with fracture on multiple planes, a feature consistent with it being the first screw to fracture in the attachment assembly. Screw 2 had relatively prominent crack arrest lines with a fracture origin area located at one side of the screw, features consistent with fatigue fracture under relatively higher cyclic stresses. Screw 3 had small fatigue regions with multiple origins around the circumference, and the remainder of the fracture surface had matte gray features consistent with

ductile overstress fracture. Screw 4 had relatively smooth fracture features with crack arrest marks extending across most of the fracture and origins located around much of the circumference.

Figure 5 - Coolant Pump Pulley Drive Flange Cap Screws (brackets indicate fatigue origin areas)
