# Aviation Investigation Final Report

<b>Location:</b>	New York, New York	<b>Accident Number:</b>	ERA19LA150
<b>Date &amp; Time:</b>	April 13, 2019, 22:15 Local	<b>Registration:</b>	N5296H
<b>Aircraft:</b>	Cessna 172	<b>Aircraft Damage:</b>	Substantial
<b>Defining Event:</b>	Fuel exhaustion	<b>Injuries:</b>	3 Minor
<b>Flight Conducted Under:</b>	Part 91: General aviation - Personal

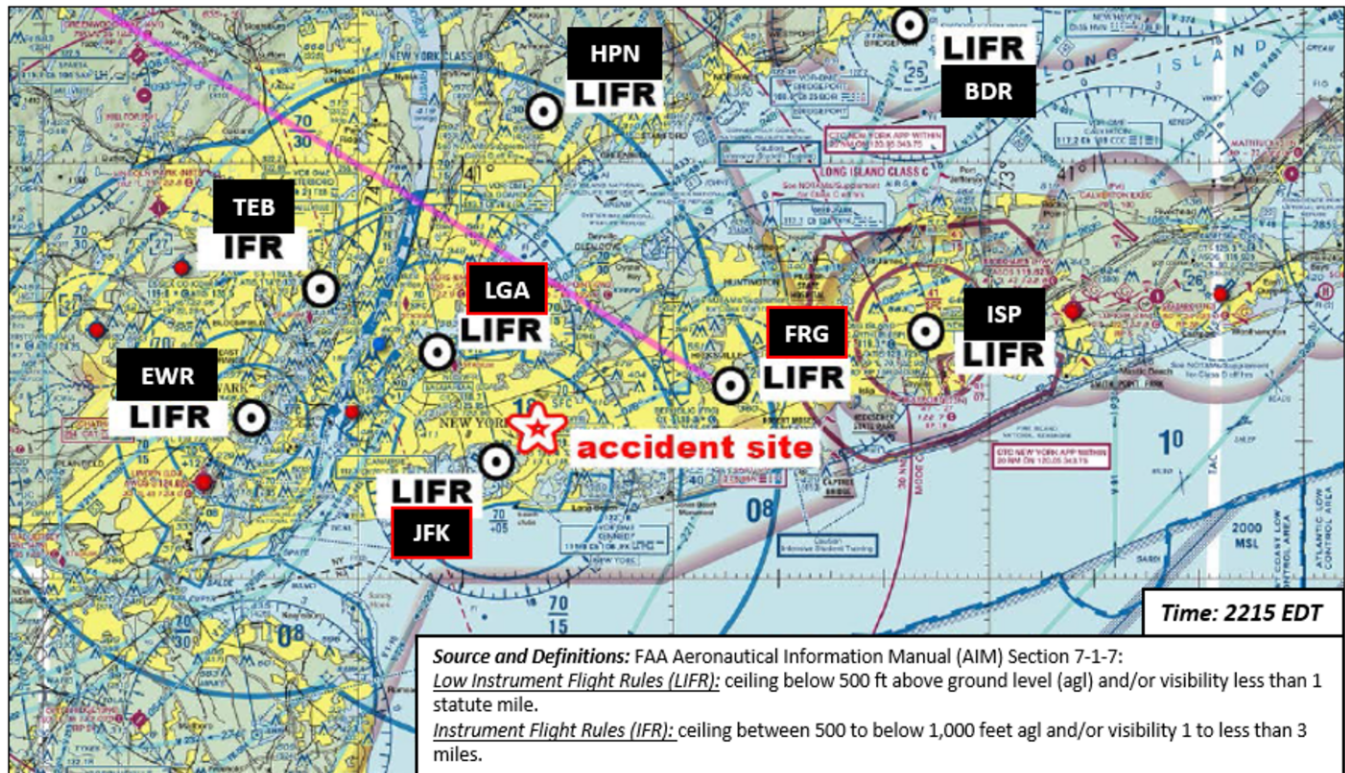
Figure 1: Weather Observations at the Time of the Accident in the New York Area

At 2212 the weather conditions at JFK were, visibility 1/8-mile, fog, vertical visibility 200 ft above ground, wind 180° at 15 knots, temperature 13°C, dew point 13°C, and barometric pressure of 29.64 inches of mercury. About the time of the accident, FRG, JFK, LGA, and several other New York area airports were observing low IFR conditions. Figure 1 depicts the surrounding weather observation reports at the time of the accident.
