Aviation Investigation Final Report

Location:	Passadumkeag, Maine	Accident Number:	ERA18LA190
Date & Time:	July 11, 2018, 19:20 Local	Registration:	N352GL
Aircraft:	GLASAIR SH2	Aircraft Damage:	Substantial
Defining Event:	Loss of engine power (total)	Injuries:	1 None
Flight Conducted Under:	Part 91: General aviation - Personal

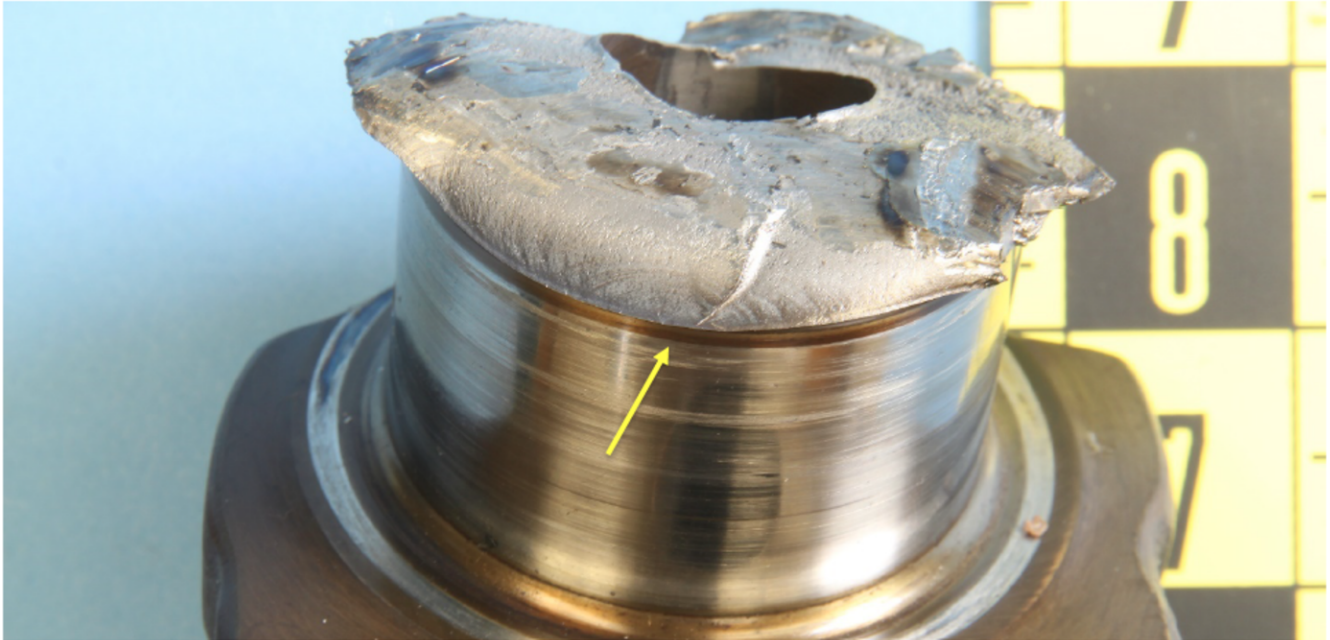
Disassembly and examination of the engine revealed that the crankshaft had fractured at the No. 4 cylinder journal. Further examination of the fracture surface revealed fatigue striations consistent with fatigue crack propagation. These striations were finely spaced and exhibited changing or erratic thicknesses on different areas of the fracture surface, consistent with propagation through high-cycle fatigue. The reason for the crack initiation could not be determined.

The No. 4 cylinder journal had fractured perpendicular to the crankshaft direction, located along the radius at the web forward of the journal. About half of the fracture surface exhibited smearing, consistent with post-fracture damage to the forward surface. The lower half of this fracture surface exhibited crack arrest marks, consistent with progressive crack propagation. The crack initiation site was located on the journal surface, denoted in Figure 1.

Figure 1. Angled view of the aft fracture surface, facing the crack initiation area. Yellow area points to the crack initiation area.

Closer examination of the fracture surface revealed fatigue striations consistent with fatigue crack propagation. These striations were finely spaced and exhibited changing or erratic thicknesses on different areas of the fracture surface, consistent with propagation through high-cycle fatigue. Outside of the fatigue regions, only dimple rupture features were found, consistent with subsequent and final overstress fracture of the crankshaft journal. Examination using a scanning electron microscope found three primary initiation sites, with possible smaller initiation sites collocated in the area. These initiation sites were all located on the fracture surface edge with the journal surface. There were no material features (such as cracks, pores, or voids) located at these initiation sites. However, mechanical defects, such as gouges and streaks, were present at the crack initiation sites. Whether the mechanical damage to the journal surface was entirely present before the crankshaft fracture, or if the damage developed after the final fracture of the part could not be determined.
