Aviation Investigation Final Report

Location:	Kerrville, Texas	Accident Number:	CEN19FA124
Date & Time:	April 22, 2019, 08:51 Local	Registration:	N501CE
Aircraft:	Beech 58	Aircraft Damage:	Substantial
Defining Event:	Loss of control in flight	Injuries:	6 Fatal
Flight Conducted Under:	Part 91: General aviation

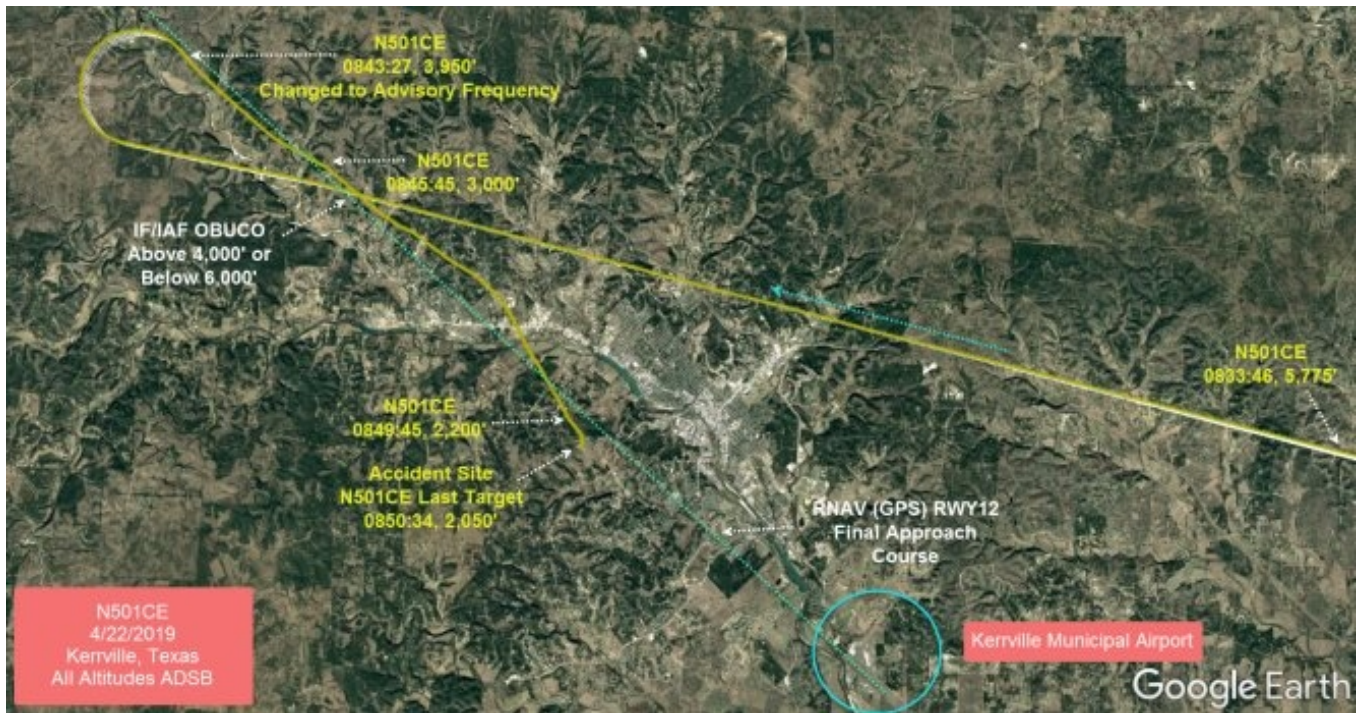
About 0839, the pilot was cleared for the GPS instrument approach to runway 12 and instructed to maintain 4,000 ft to the initial fix for the approach (OBUCO) (see figure 1). Once the airplane was inbound to the airport, about 0843, the controller directed the pilot to switch to the ERV advisory frequency, which was unmonitored. The GPS instrument approach profile for runway 12 included a descent to 3,300 ft msl at 5.3 nautical miles from the runway.

Figure 1. A Google Earth aerial view of terrain near the accident site with overlaid ADS-B data and approach information.

According to ADS-B data, the airplane maintained an altitude of 3,900 ft until about 0844:59, when it began a steady descent; the airplane was about 13 miles from the runway. Data from the airplane's engine data monitor (EDM) indicate that the left engine lost power about 0845 followed by the right engine about 10 seconds later. ADS-B data indicated that the airplane steadily descended well below the approach profile.

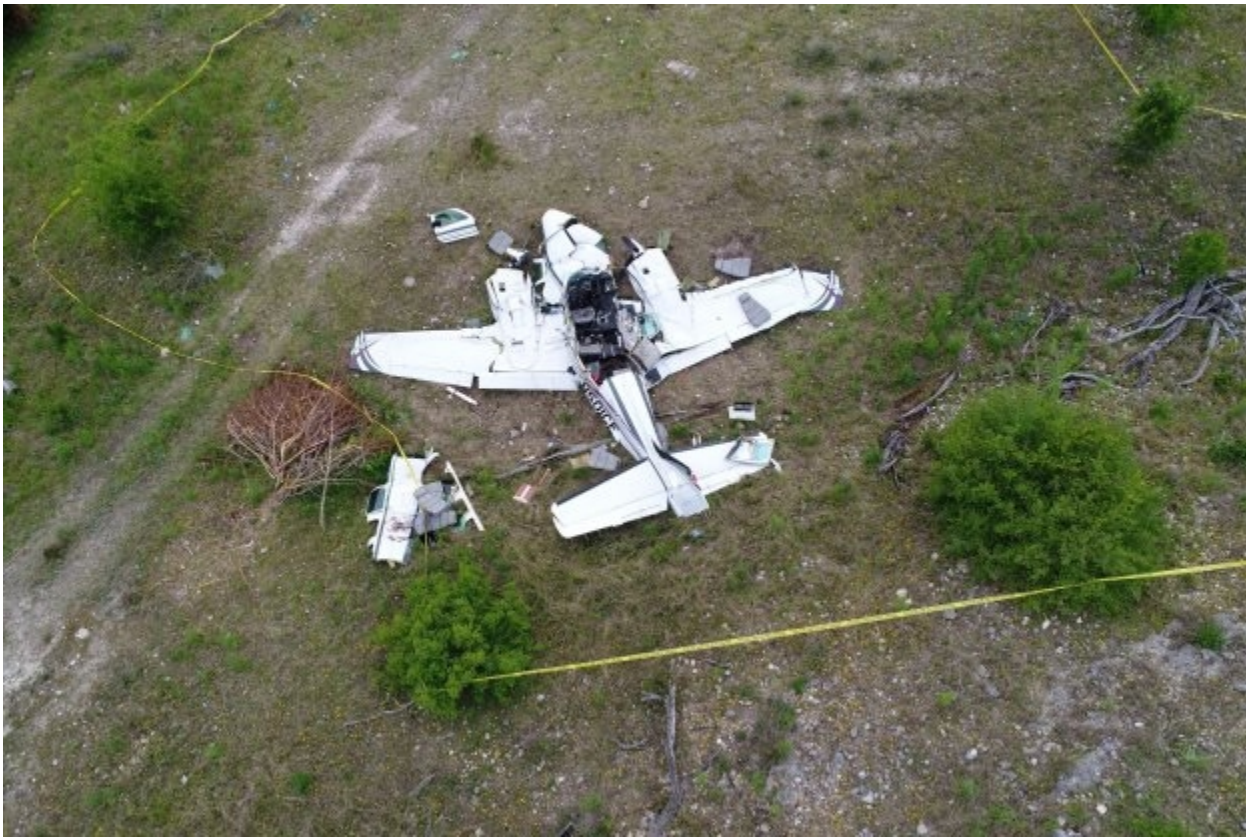
The airplane impacted a rocky ravine about 120 yards from the final radar data point and about 6 miles from the airport. There was no postimpact fire and the airplane came to rest upright on a heading of 246° (see figure 2). The wreckage was contained within the footprint of the airplane, indicating a low forward groundspeed. Elevation at the accident site was 1,868 ft msl and trees about 40 yards northeast were the nearest obstructions.

Figure 2. Photograph of an aerial view of the accident site
