# Aviation Investigation Final Report

<b>Location:</b>	Monmouth, Illinois	<b>Accident Number:</b>	CEN18FA235
<b>Date &amp; Time:</b>	June 24, 2018, 11:15 Local	<b>Registration:</b>	N94070
<b>Aircraft:</b>	Ercoupe 415 D	<b>Aircraft Damage:</b>	Destroyed
<b>Defining Event:</b>	Loss of engine power (total)	<b>Injuries:</b>	2 Fatal
<b>Flight Conducted Under:</b>	Part 91: General aviation - Personal

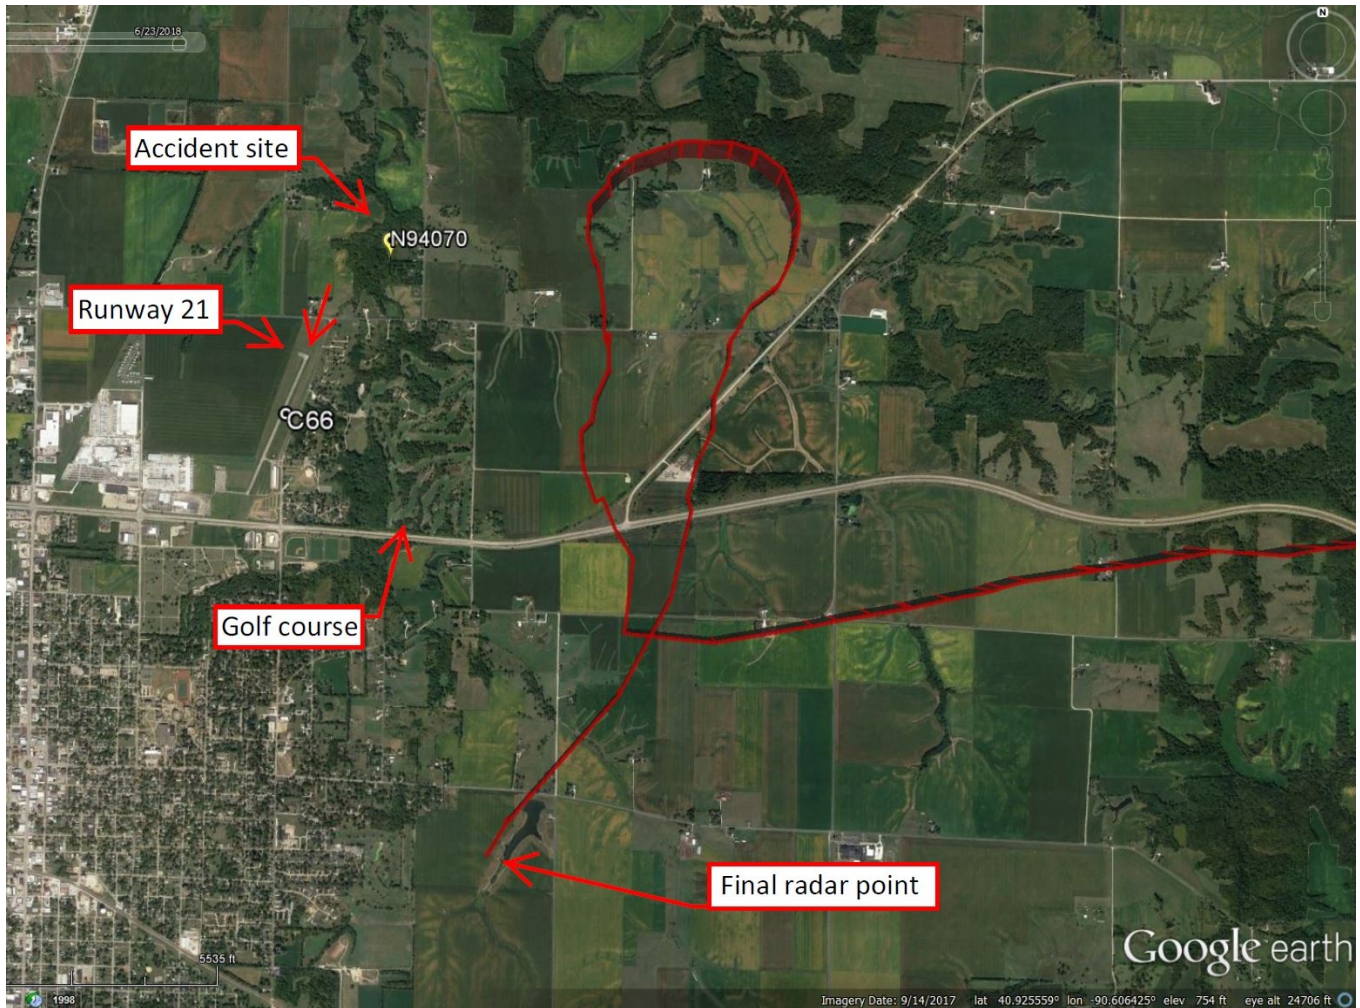
Figure 1 – Radar Track (end of flight)

A review of the radar data revealed that the airplane traveled west after departure from GBG. The radar track showed the airplane made several turns and continued west toward C66. The final radar target was recorded about 2 miles south of the accident site (see figure 1). A review of the GBG common traffic advisory frequency (CTAF) recording revealed that, at 1103, the pilot announced his intentions to complete a touch-and-go landing at C66.

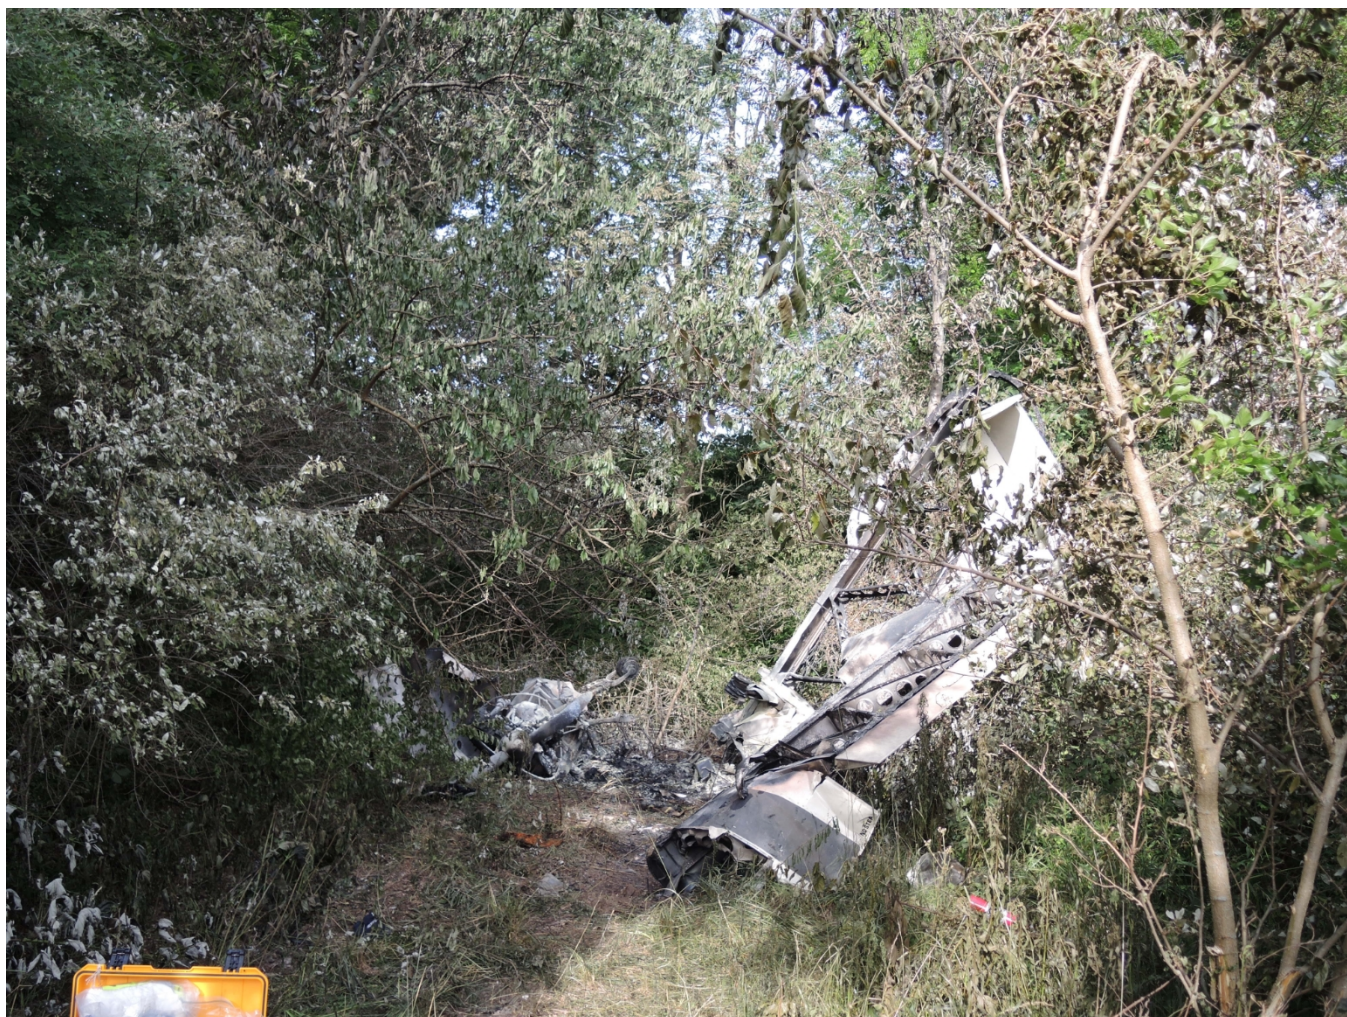
Figure 2 – Accident Site

Two other witnesses, who were 1/2 mile northeast of C66, stated that the airplane was traveling east to west and flew very low over their house and the engine was "sputtering and backfiring." They stated that the airplane flew about 30 ft above them, made a steep left bank, then impacted the ground in a wooded area (see figure 2). After impact, the airplane burst into flames. They both ran to the accident site to provide assistance but were unable to help due to the fire and extreme heat.

A postaccident examination of the airframe revealed that the fuselage was consumed by fire. The empennage remained intact with minor impact and fire damage at the rear fuselage area. The metal structure of both wings remained mostly intact and the fabric covering was consumed by fire. The two wing fuel tanks and the header fuel tank were consumed by fire. The header tank fuel quantity gauge was found in the debris path and the metal rod was bent near the cork end. The elevator and rudder control cables remained intact and were continuous from the cockpit to the control surfaces. The aileron control tubes and associated hardware were intact from the ailerons through the wing to the fuselage;

The engine came to rest inverted and remained attached to the engine mounts and the firewall. The two-blade, fixed-pitch propeller was attached to the crankshaft. One propeller blade was bent aft near mid-span and the other blade was straight with minimal damage. Neither propeller blade exhibited leading edge damage or chordwise scratches. The propeller was rotated by hand and engine continuity was confirmed through the valve train and rear accessory section; the cylinders exhibited suction and compression with the top spark plugs removed. The carburetor had separated from the engine but was sitting on the engine; the carburetor sustained fire and impact damage. The throttle cable remained attached to the throttle control arm. The mixture control cable was loose from mixture control arm and was found immediately next to the carburetor.

Although fire and impact damage to the engine limited the scope of the examination, no preimpact mechanical malfunctions or anomalies were found that would have precluded normal operation.
