# Aviation Investigation Final Report

<b>Location:</b>	Buffalo, Oklahoma	<b>Accident Number:</b>	CEN17LA235
<b>Date &amp; Time:</b>	June 17, 2017, 09:45 Local	<b>Registration:</b>	N6196B
<b>Aircraft:</b>	Cessna 182A	<b>Aircraft Damage:</b>	Substantial
<b>Defining Event:</b>	Part(s) separation from AC	<b>Injuries:</b>	3 None
<b>Flight Conducted Under:</b>	Part 91: General aviation - Personal

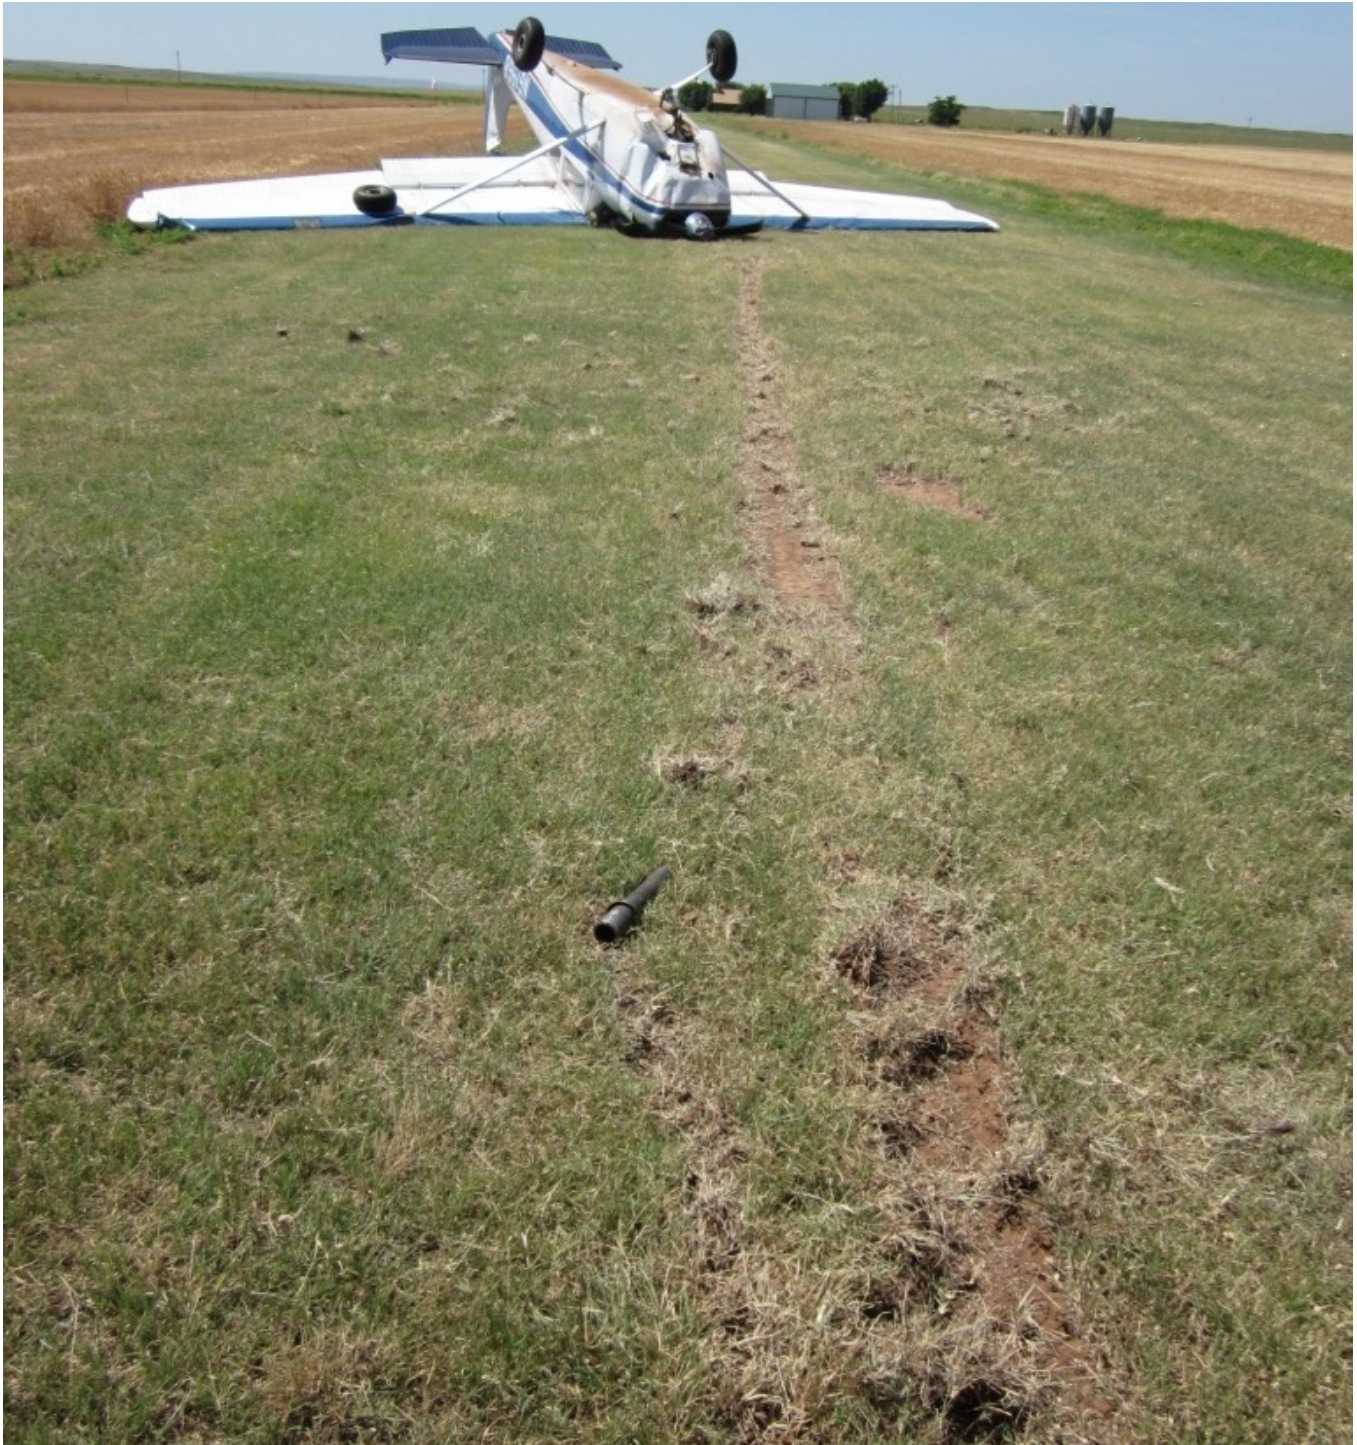
Figure 1 – Accident site

The pilot reported that the airplane touched down about midfield and the landing was normal until the nose wheel touched down. He heard a loud noise from the nose landing gear area. The airplane nosed over on the runway and came to rest inverted (figure 1).

The landing path consisted of three parallel tire marks on the grass runway. A grease seal ring from the nose wheel assembly was found next to the center tire mark. The center tire mark transitioned into two parallel tracks in the grass; the tracks were about 1 ft wide and extended for about 8 ft in a straight line. About 20 ft later, there was a single track in the runway with about 6 perpendicular slash marks through

the track. The nose wheel axle tube was found near the end of the slash marks. The single track continued to the main wreckage.

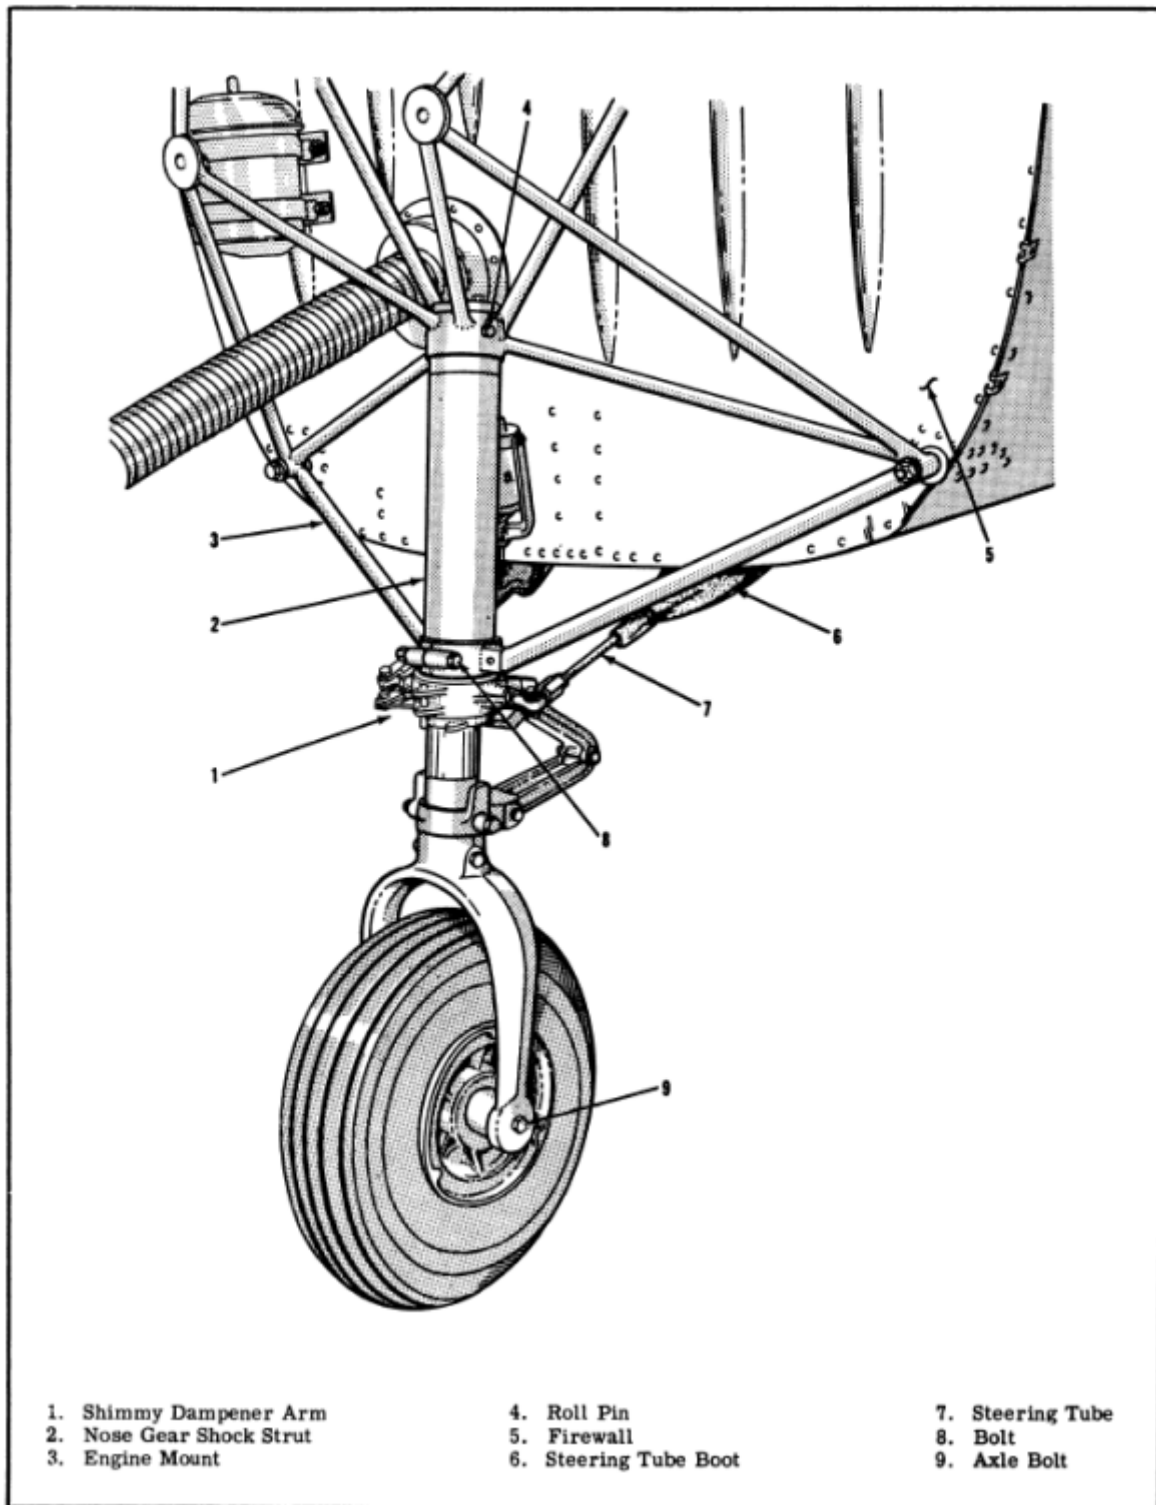
Figure 2 – Nose landing gear depiction

The available evidence is consistent with the nose wheel axle bolt separating from the wheel, which resulted in separation of the nosewheel. The nose wheel axle bolt was not found during the investigation; therefore, the reason for its separation could not be determined.

The responding Federal Aviation Administration (FAA) inspector stated that the airplane sustained substantial damage to both wings, the fuselage, and the vertical stabilizer. The nose wheel was separated from the nose gear fork and the fork separated from the strut. A grease seal ring from the nose wheel assembly and a portion of the nose wheel axle tube were found in the debris path. The nose wheel axle bolt (figure 2) had separated and was not found. There were no preaccident anomalies noted with the recovered components.
