Aviation Investigation Final Report

Location:	Ontario, California	Accident Number:	WPR19LA021
Date & Time:	November 8, 2018, 15:53 Local	Registration:	N9914M
Aircraft:	Cessna 182	Aircraft Damage:	Substantial
Defining Event:	Loss of engine power (partial)	Injuries:	3 None
Flight Conducted Under:	Part 91: General aviation - Personal

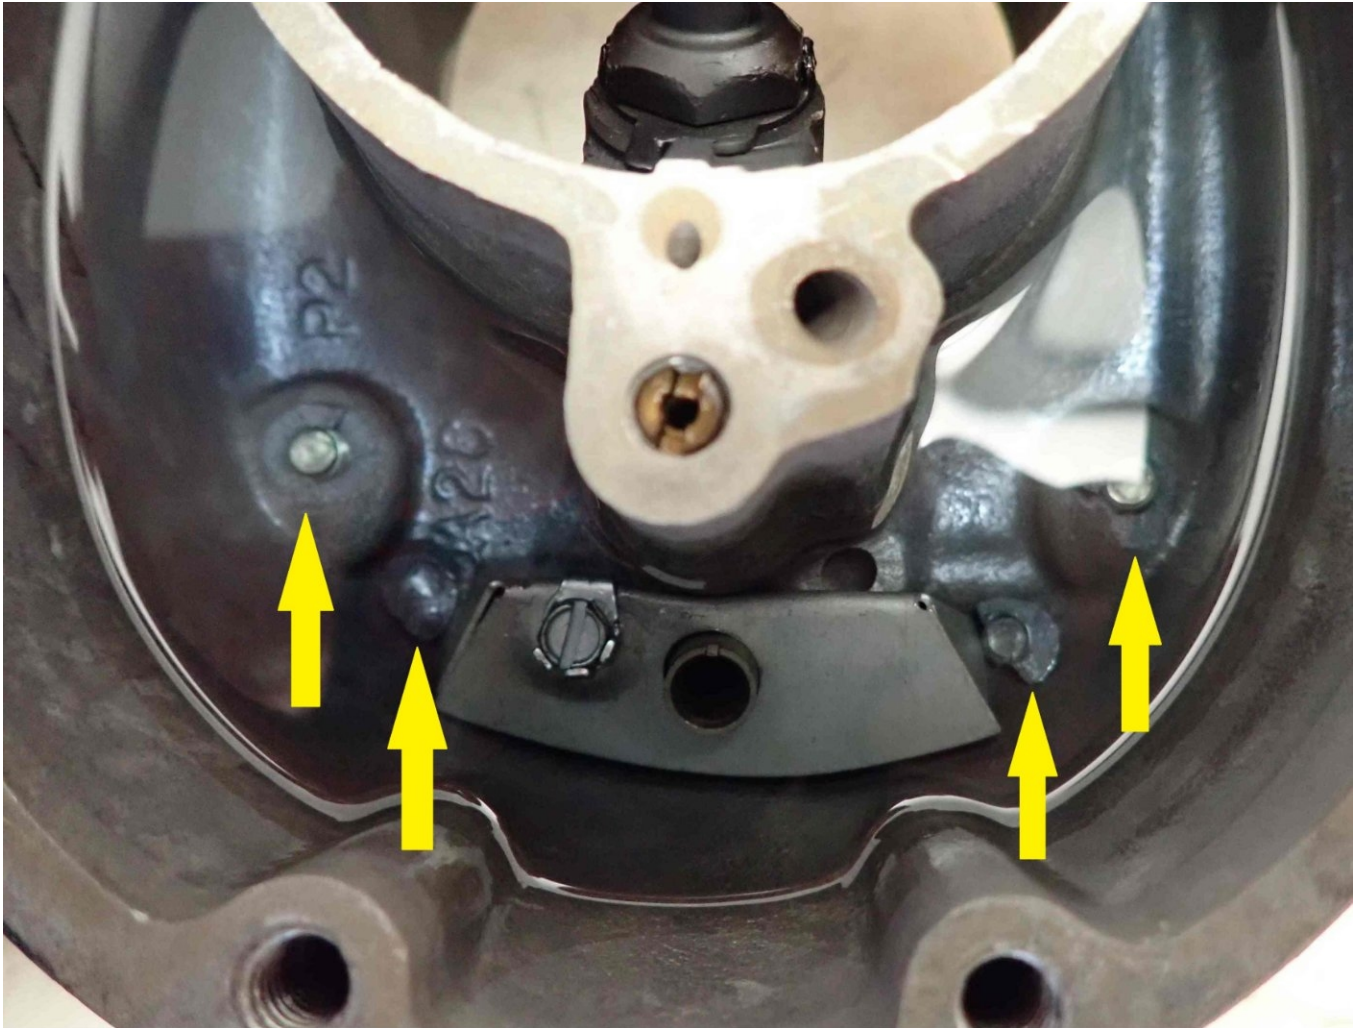
Examination revealed that about 20 years and 300 flight hours before the accident, threaded studs had been used to mount the carburetor airbox to the carburetor inlet, rather than the appropriate bolts. The studs had been overdriven and penetrated the carburetor bowl, fracturing the bowl housing. Fragments of the damaged housing lay at the bottom of the bowl until the accident flight, when the turbulence likely caused them to migrate and interfere with either the float or the fuel mixture metering system.

The carburetor was disassembled and examined. Brass floats had been utilized and bore a date stamp of May 1997. The floats were intact and showed no evidence of leak. Examination revealed that four 1-inch-long studs had been used to mount the airbox assembly to the carburetor bowl, and the forward studs appeared to have penetrated about 1/8 inch into the carburetor bowl. (see Figure 1.) Three fragments of aluminum material ranging in size from 1/8 to 5/8 of an inch were found at the bottom of the bowl. (see Figure 2.) The material had a polished appearance and a shape that matched that of the bowl housing where the studs had broken through.

Figure 1 – Yellow Arrows Indicate Forward Studs Penetrating into the Bowl Housing, along with Housing Fragments

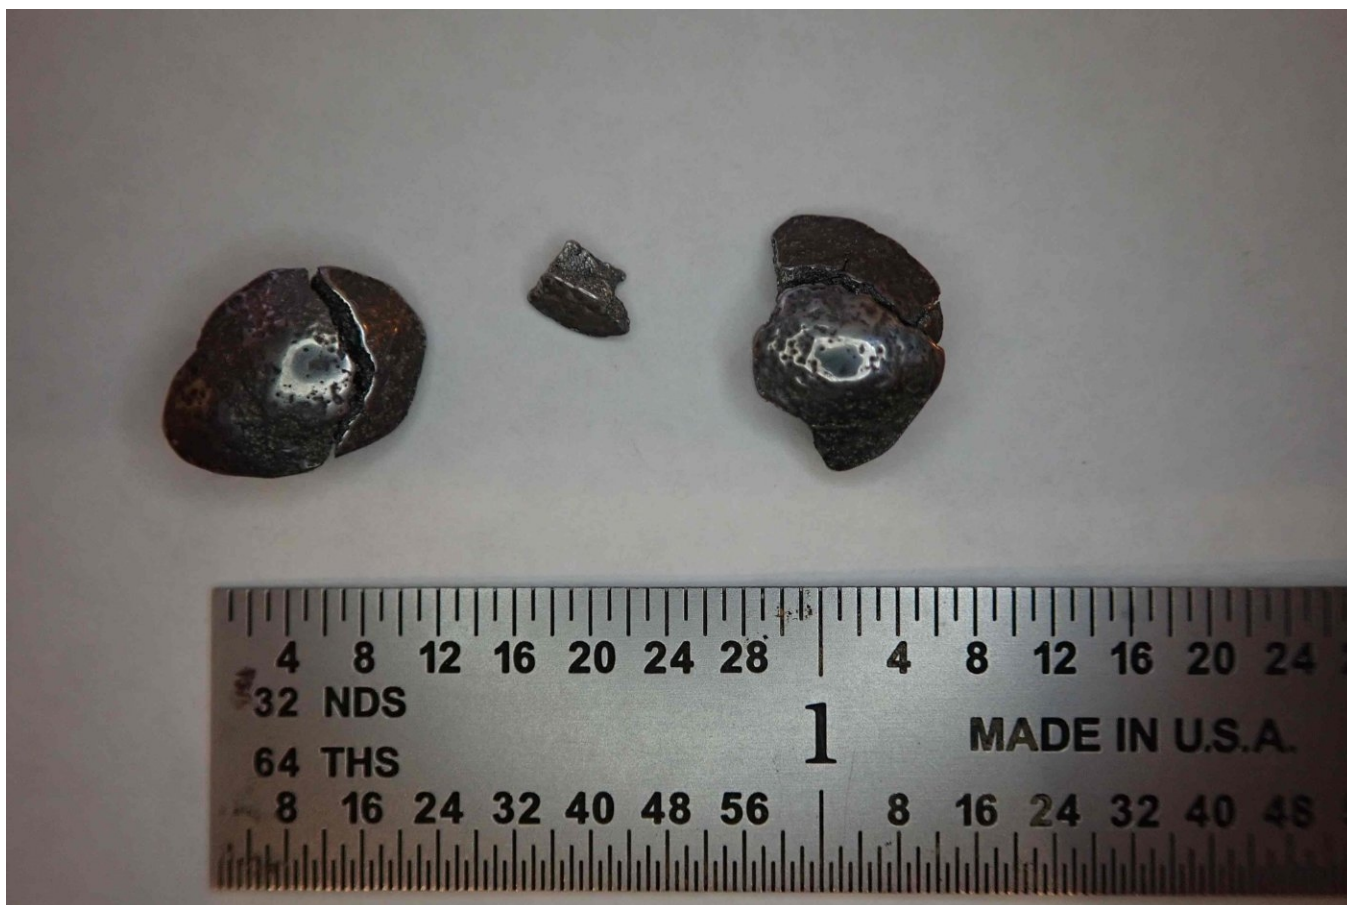
The carburetor was sent to the facilities of Marvel-Schebler for further examination under the oversight of an FAA inspector. During the examination, additional metallic particles were found within the fuel mixture metering sleeve, along with scratches and abrasions on the sides of the float.

Figure 2 – Bowl Housing Fragments

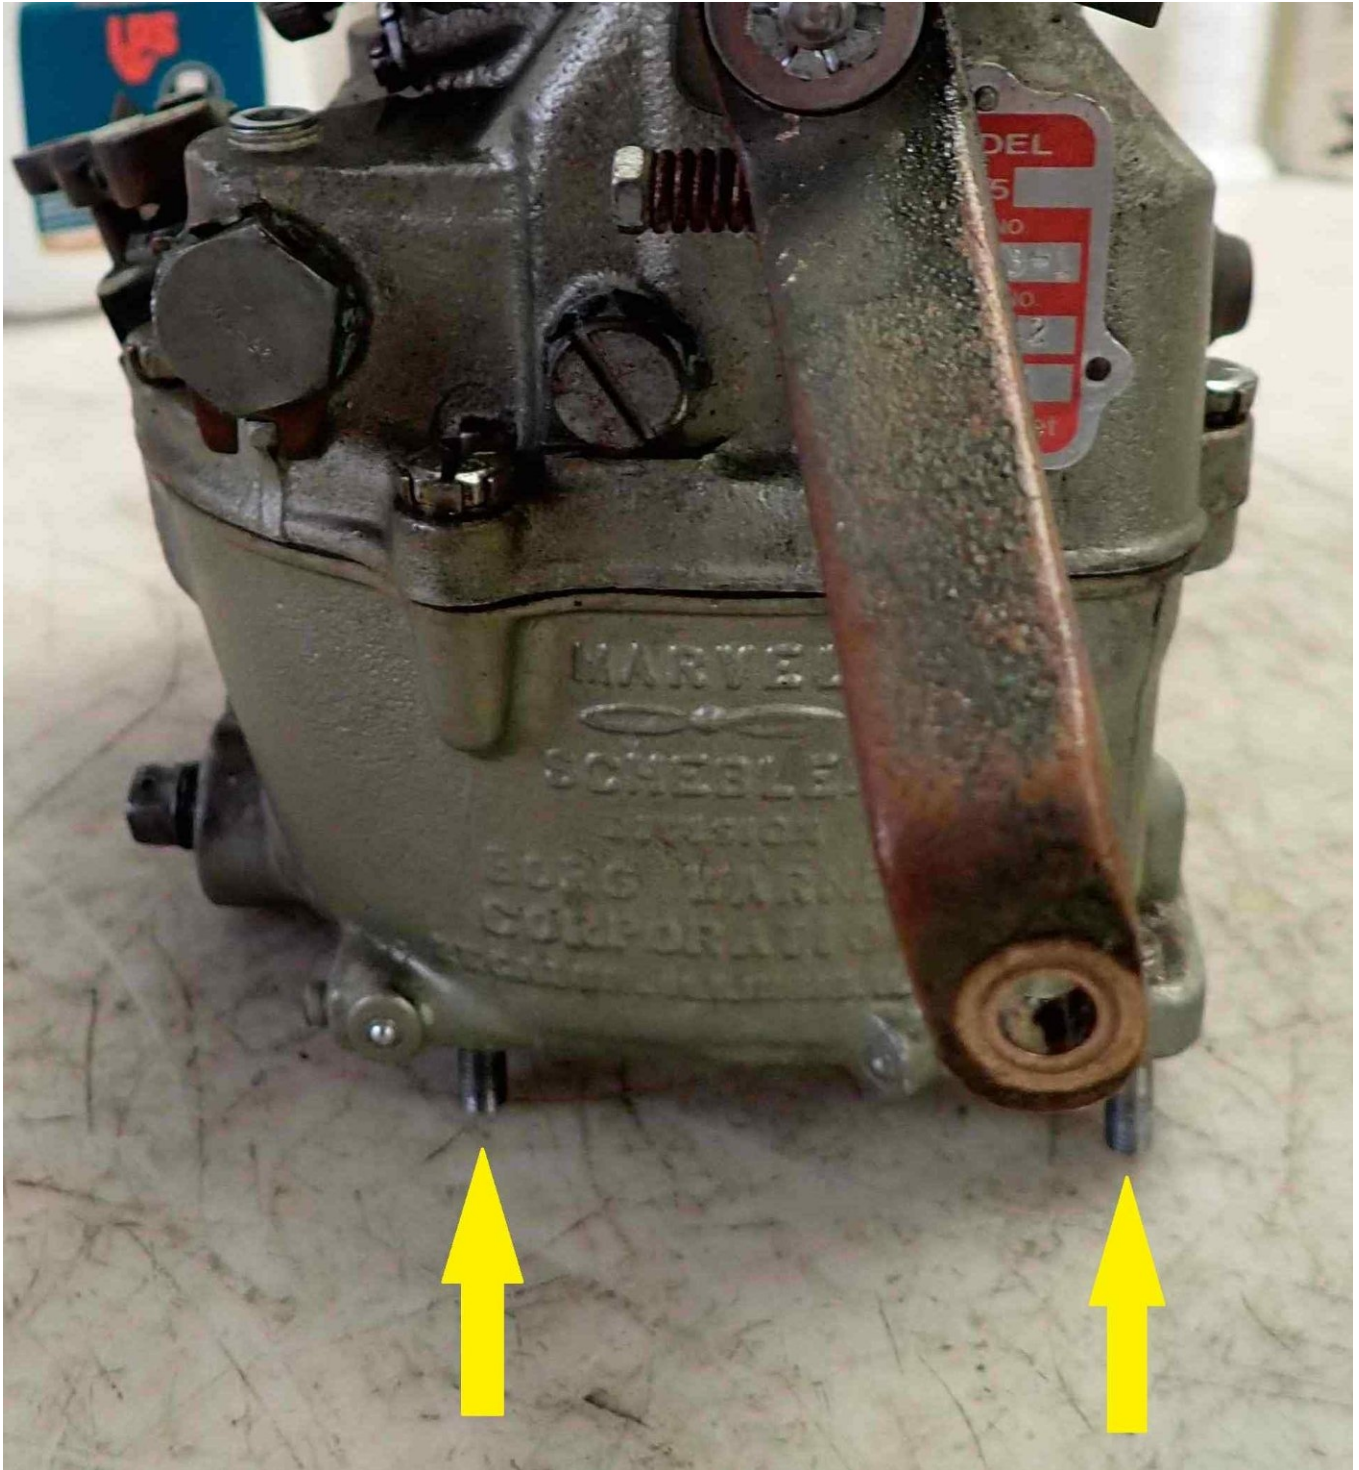
Examination of the Cessna illustrated parts catalog applicable to the accident airplane revealed that the appropriate hardware for mounting the airbox to the carburetor was four MS20074-04-3, 0.4690-inch-long bolts, rather than the 1-inch studs used. (see Figure 3.)

Figure 3 – Studs in Bowl Housing
