Aviation Investigation Final Report

| Location: | Festus, Missouri | Accident Number: | CEN18FA384 |
| Date & Time: | September 20, 2018, 22:30 Local | Registration: | N7152S |
| Aircraft: | Cessna 150 | Aircraft Damage: | Substantial |

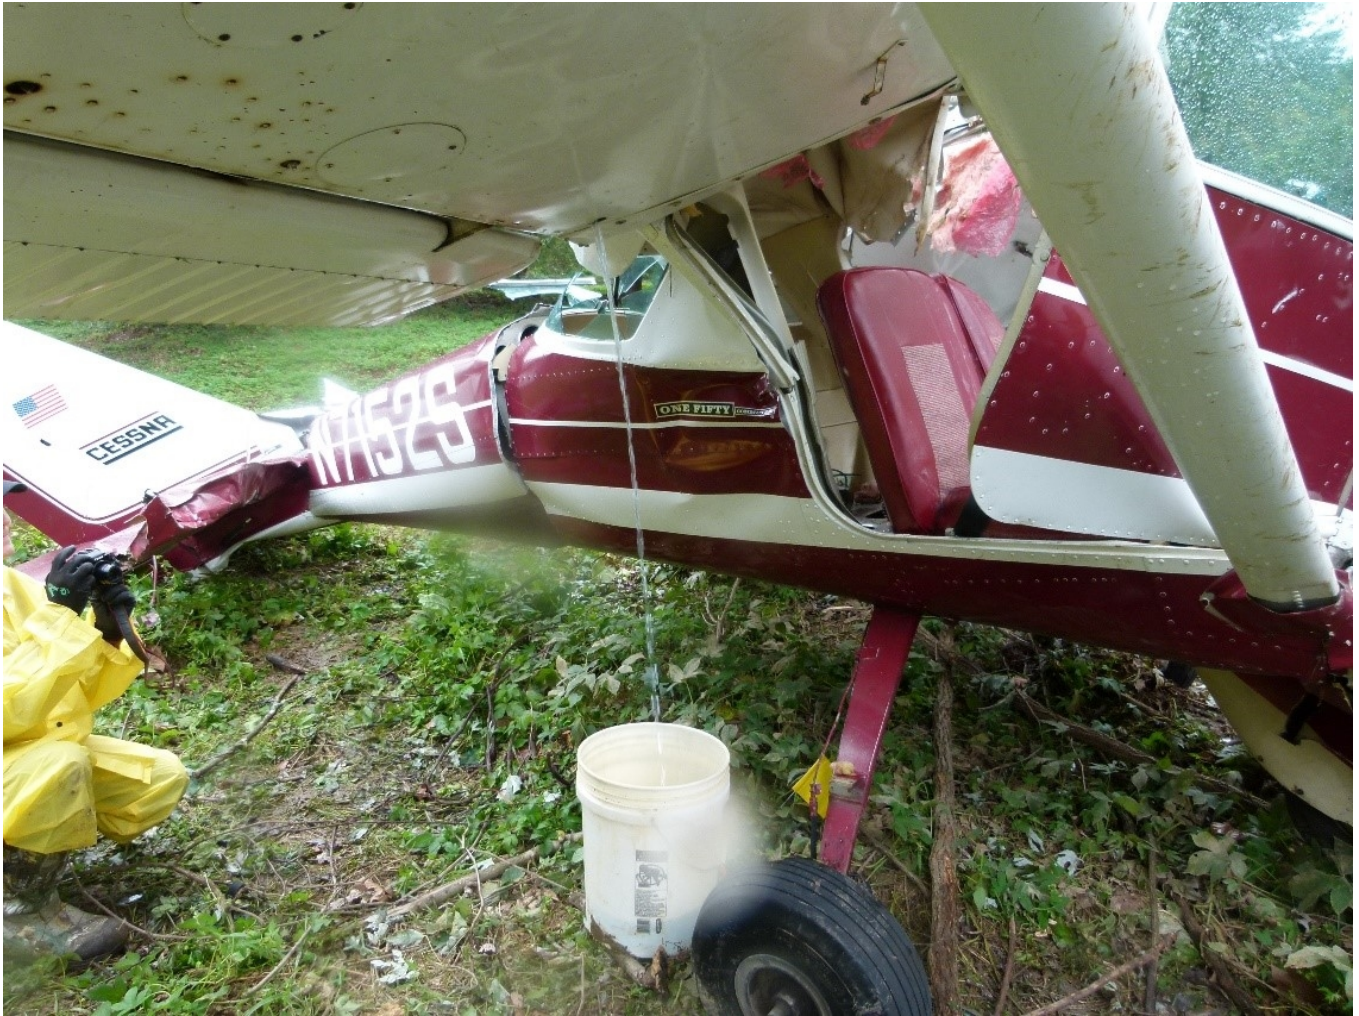
Flight control continuity was established for the airframe. All structural components of the airplane were located at the accident site. The airplane sustained substantial damage to both wings, the fuselage, and the empennage. Both wings sustained substantial impact damage from contact with trees. The fuel tanks remained intact, and a total of about 2.25 gallons of fuel were extracted from the two fuel tanks. The propeller blades did not exhibit chordwise scratches or torsional deformation

Figure 1 - View of the fuel being extracted to a five-gallon plastic bucket (courtesy of Continental Motors).
