Aviation Investigation Final Report

Location:	Katy, Texas	Accident Number:	CEN18LA195
Date & Time:	May 27, 2018, 17:15 Local	Registration:	N67Y
Aircraft:	CIRRUS DESIGN CORP SR20	Aircraft Damage:	Substantial
Defining Event:	Flight control sys malf/fail	Injuries:	1 Minor
Flight Conducted Under:	Part 91: General aviation - Personal

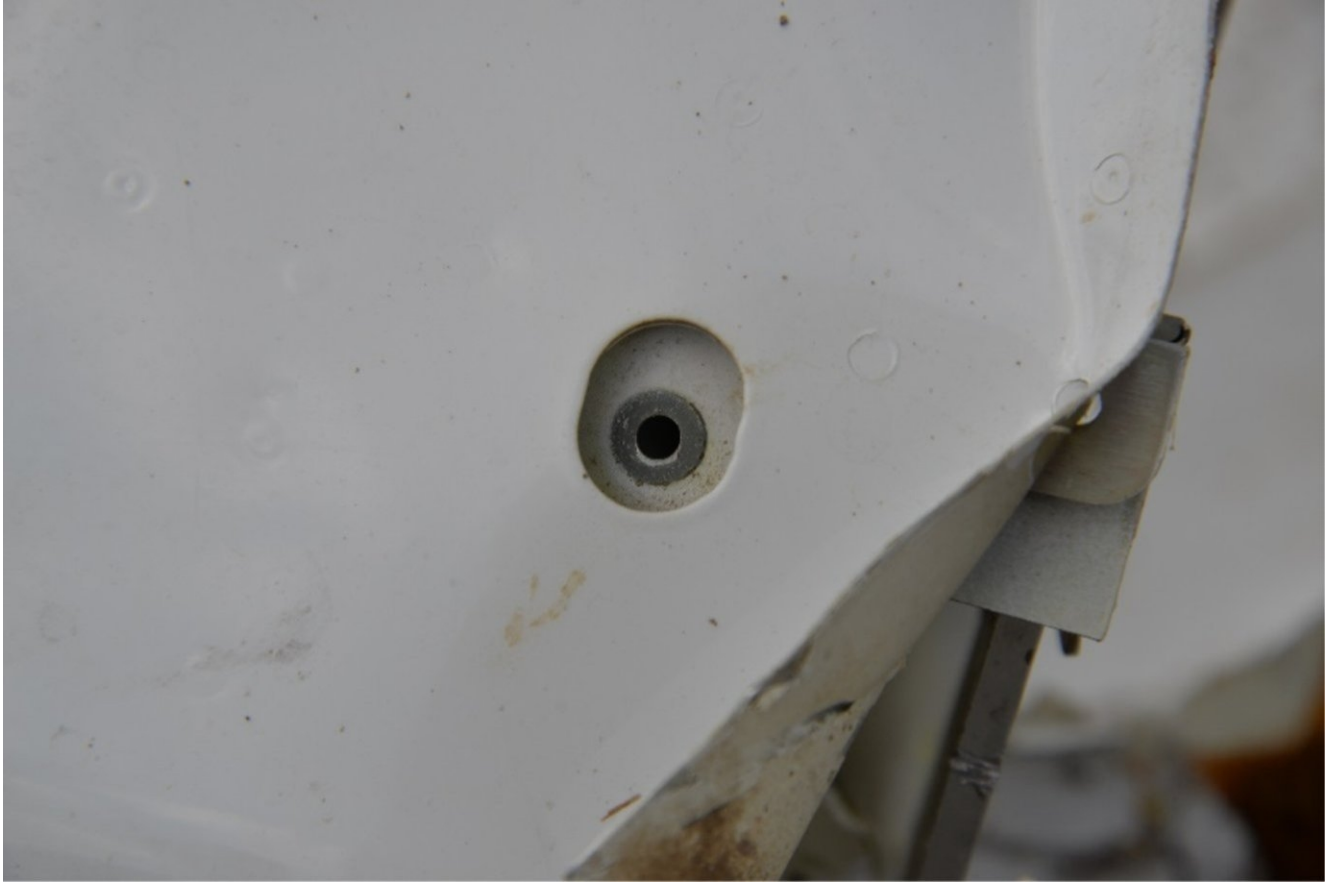
Examination of the wreckage showed that the left aileron actuation arm and attachment bolt were missing; there was no associated impact damage. Impact marks were present on the inboard hinge consistent with the aileron striking it. No distress or markings were found in the hole for the attachment bolt. The bolt or remnants of safety wire were not found.

The loss of airplane control on takeoff due to the absence of the attachment bolt for the left aileron actuation arm.

Figure 1. Missing left aileron attachment bolt.

As the bolt is readily visible during a walk around inspection, we recommend that all owners and operators visually verify the presence of the required safety wire before further flight. If safety wire is not present, have a qualified maintenance provider correct the situation before further flight.

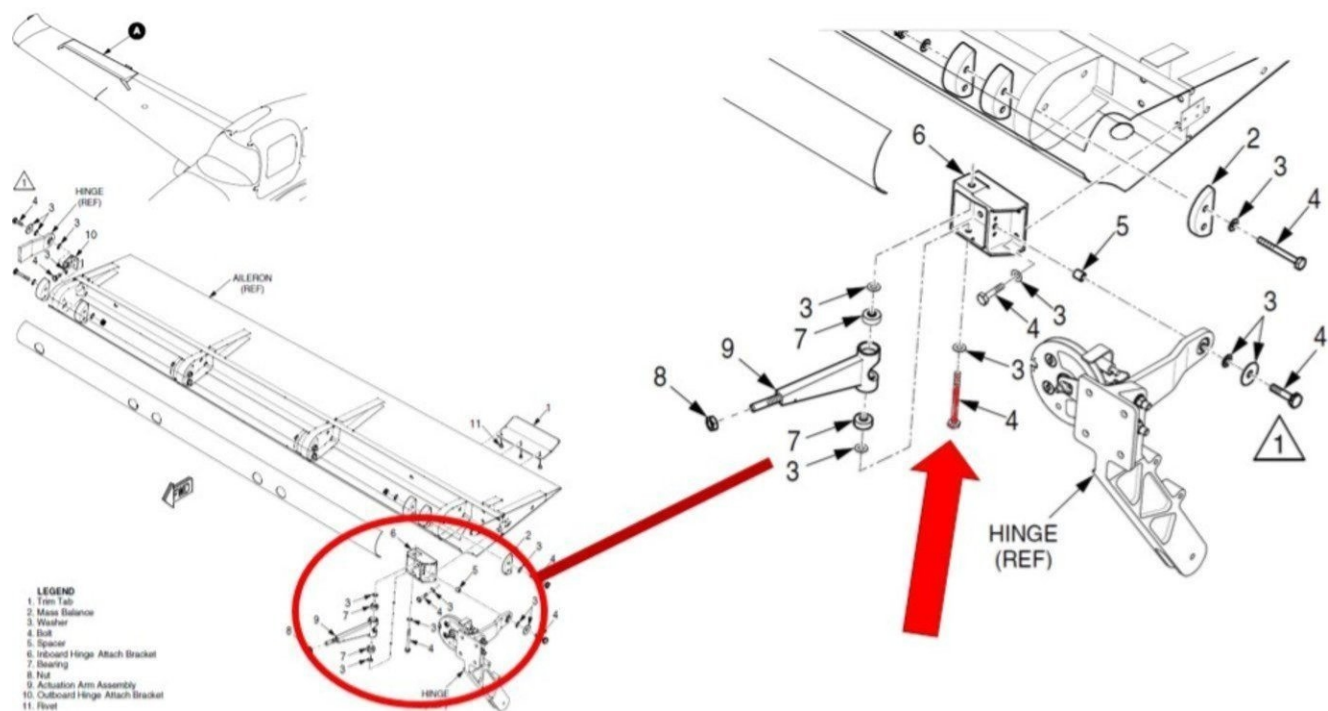
Figure 2. Schematic of aileron attachment hardware. Item 4 denotes missing bolt.

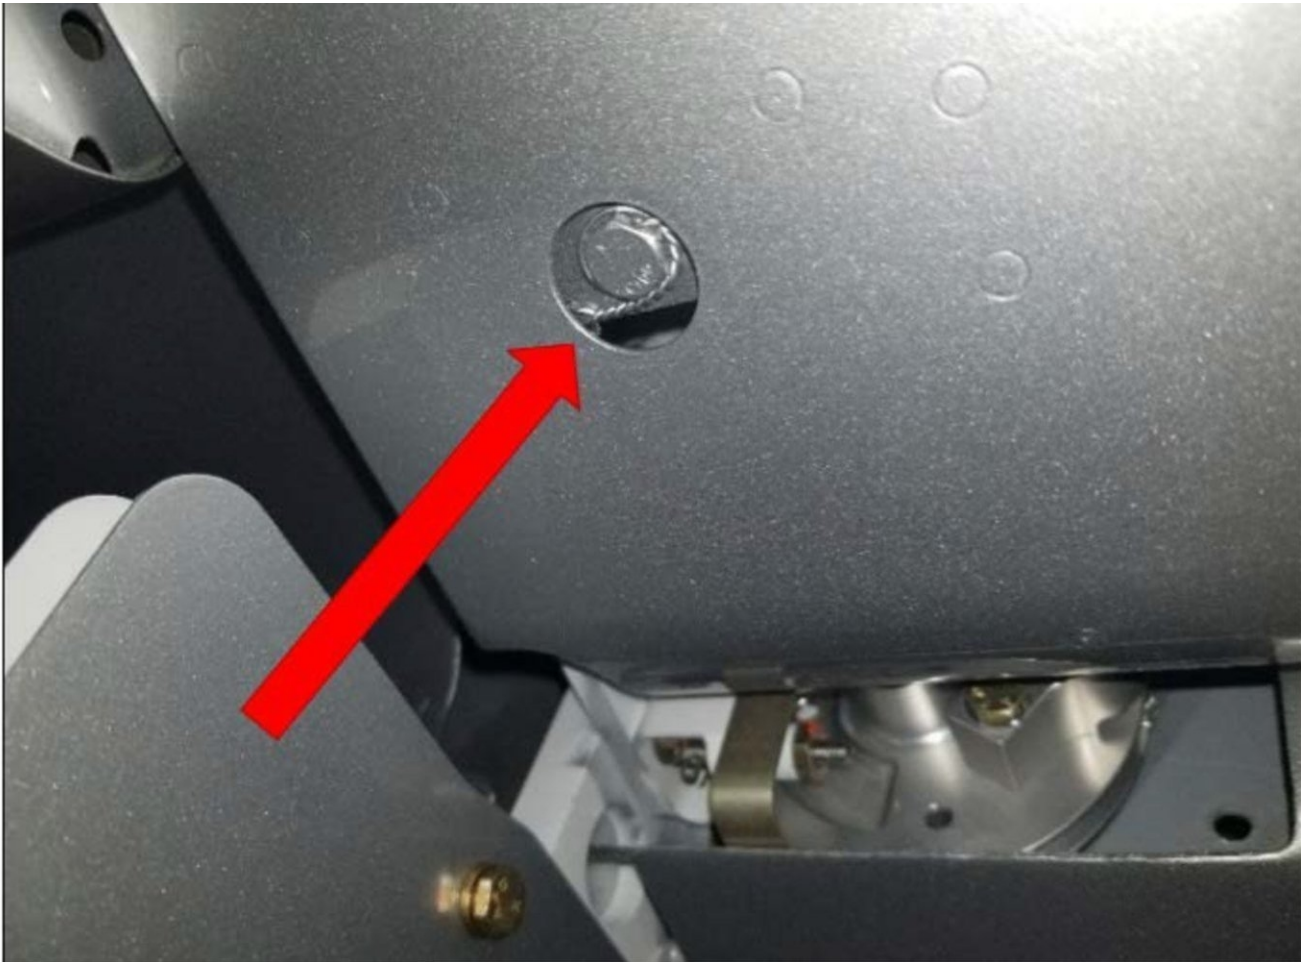
Figure 3. Exemplar properly installed bolt and safety wire.

In addition, Cirrus aircraft will be updating their recommended pilot preflight walk around to better define the examination of the Aileron area and the maintenance manuals to emphasize the requirement of proper safety wiring of associated hardware. We recommended that all operators adopt the new manual practices and revisions.
