# Aviation Investigation Final Report

<b>Location:</b>	Springfield, Missouri	<b>Incident Number:</b>	OPS18IA014
<b>Date &amp; Time:</b>	June 27, 2018, 12:51 Local	<b>Registration:</b>	N655AE
<b>Aircraft:</b>	Embraer EMB145	<b>Aircraft Damage:</b>	None
<b>Defining Event:</b>	Air traffic event	<b>Injuries:</b>	
<b>Flight Conducted Under:</b>	Part 121: Air carrier - Scheduled

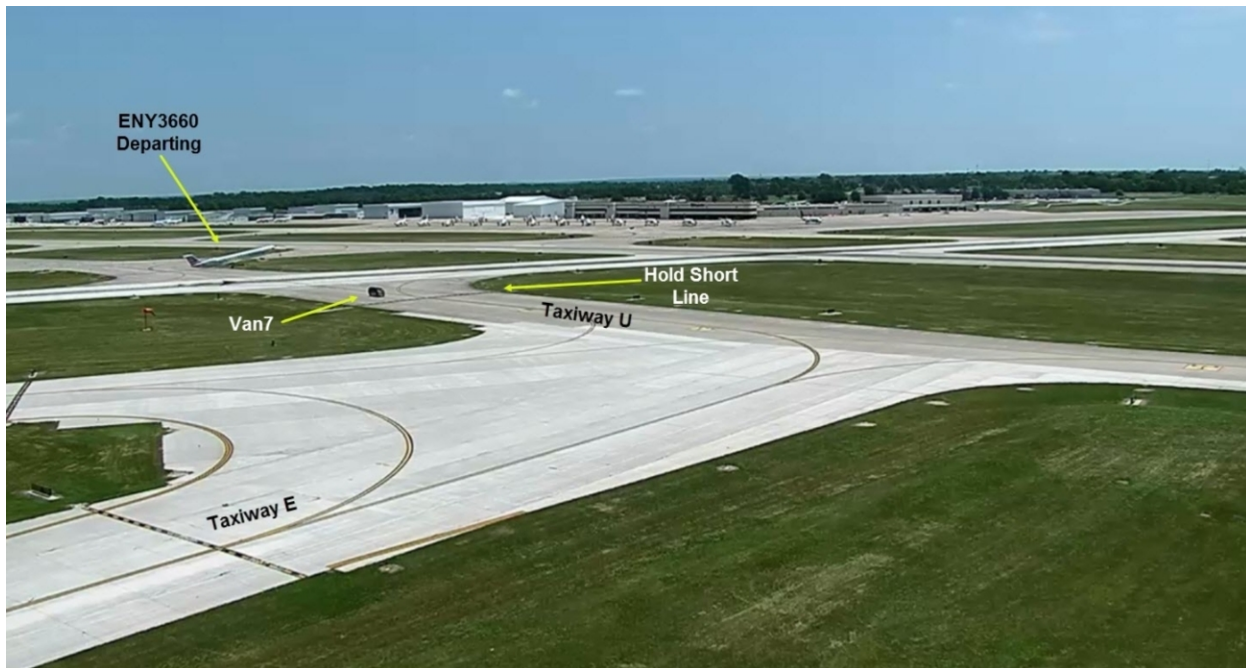
The SGF airport operations surveillance video was from a camera located on top of the control tower and captured the incident (see figure 1). The airport video showed VAN7 departing a hangar complex near taxiway N on the general aviation side of the airport and entering taxiway C. VAN7 held short of runway 20 at taxiway C for about 26 seconds and then proceeded across runway 20. After crossing runway 20, VAN7 turned left onto taxiway U. VAN7 then proceeded across runway 14. About 3 seconds after VAN7 crossed the southwest edge of runway 14, and still within the runway safety area (RSA), ENY3660 is seen on the video passing through the intersection of runway 14 and taxiway U. VAN7 continued down taxiway U and turned right onto taxiway E and to the KSGF fire station (see figure 2). The distance from the runway threshold of runway 14 to the intersection of taxiway U is about 5,900 feet.

Figure 1 - Screen grab from video of runway incursion incident.

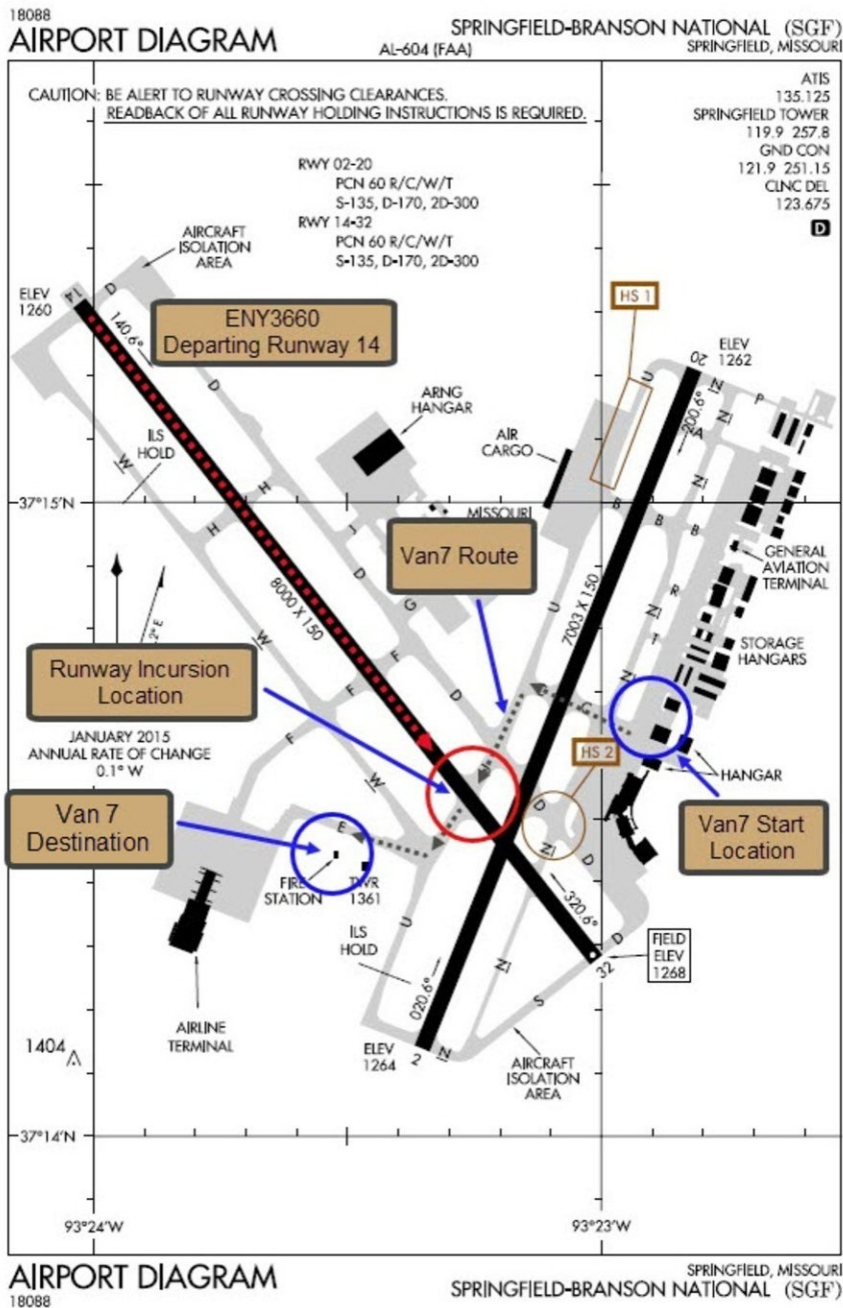
Figure 2 - Airport diagram showing VAN7 route of travel and ENY3660 departure runway.

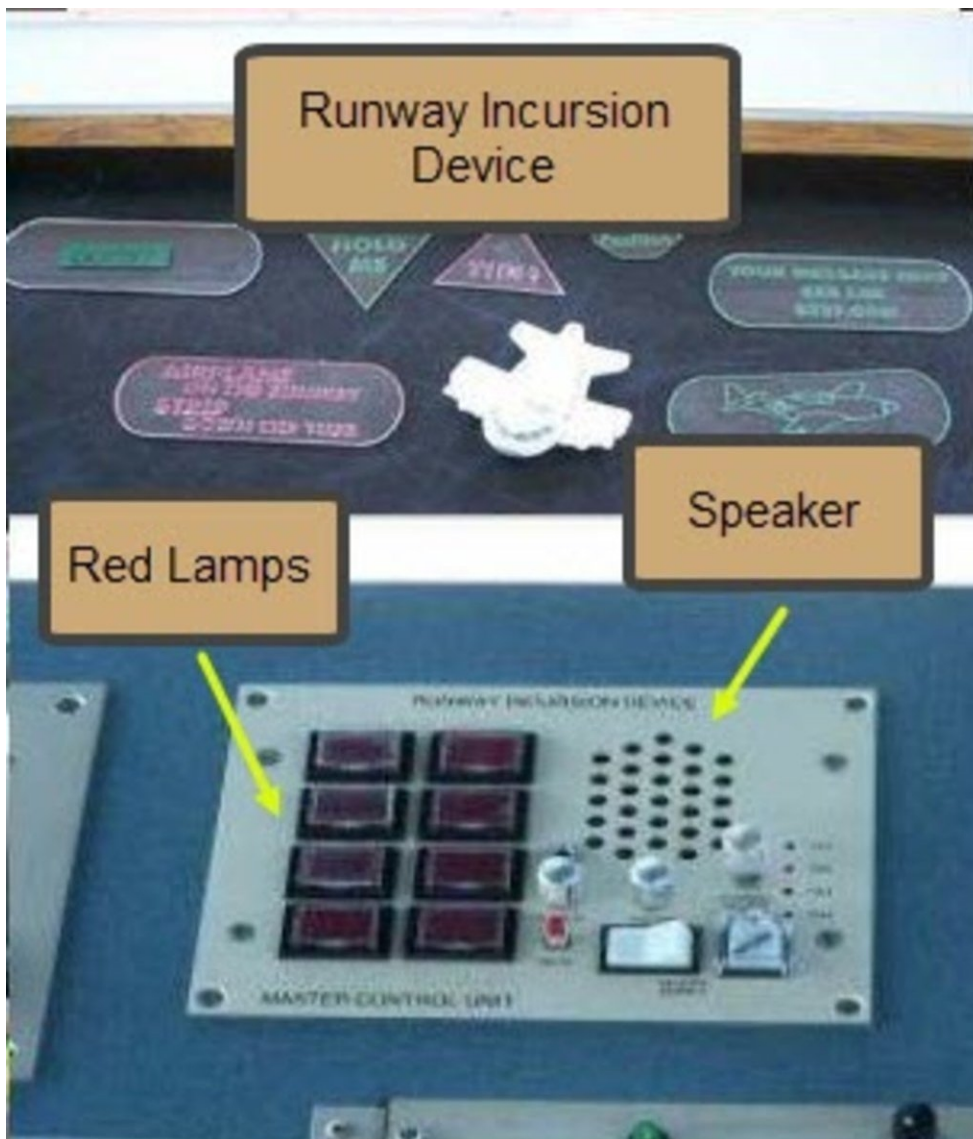
At SGF, the RID was installed at the local control and ground control positions. They are linked into the headset jack associated with each of those positions. The RIDs were interconnected and when one RID was activated, all the RIDs in the tower cab would flash in the same configuration. Only the RID that was activated would trigger an aural alert each time that position PTT was pressed.

Figure 3 - Exemplar of the SGF Runway Incursion Device.
