# Aviation Investigation Final Report

<b>Location:</b>	Wickenburg, Arizona	<b>Accident Number:</b>	WPR16FA176
<b>Date &amp; Time:</b>	September 9, 2016, 07:00 Local	<b>Registration:</b>	N126P
<b>Aircraft:</b>	Cessna 310N	<b>Aircraft Damage:</b>	Substantial
<b>Defining Event:</b>	Fuel starvation	<b>Injuries:</b>	4 Serious
<b>Flight Conducted Under:</b>	Part 91: General aviation - Personal

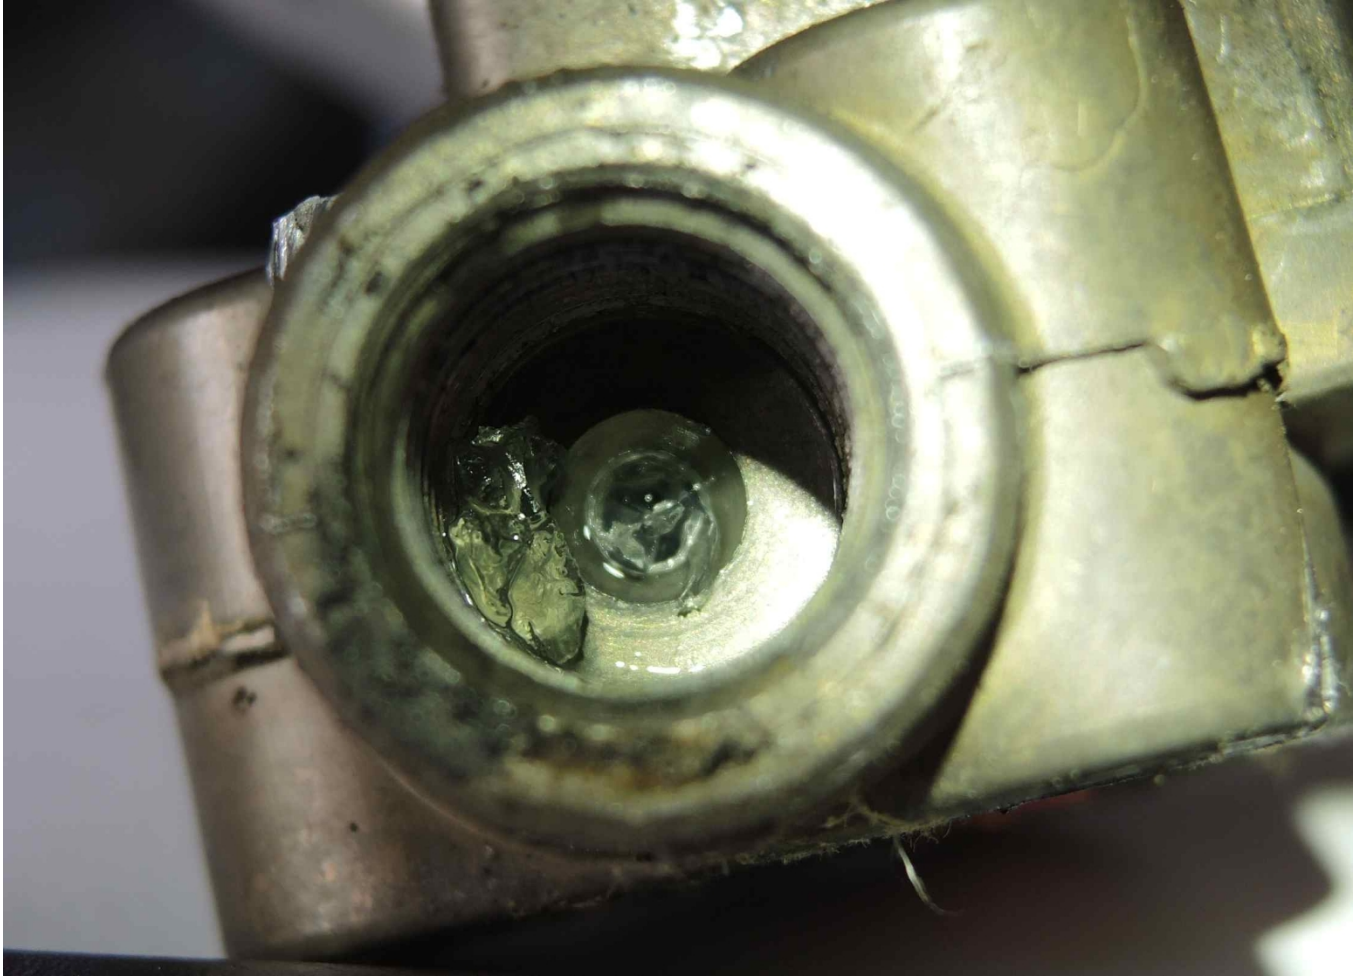
Examination of the right engine revealed that a clear, gelatinous substance had blocked the inlet port of the fuel flow transducer, leading to fuel starvation. The substance was determined to be silicone, most likely room-temperature-vulcanization silicone sealant. There were no indications that this material had been used anywhere within the fuel system, nor were there any signs of recent maintenance that could have resulted in the introduction of this contaminant. To get to the fuel flow transducer, the silicone would have had to pass through multiple fine mesh filters, which was unlikely based on the material's size when dry. However, silicone becomes semi-soluble once in contact with aviation gasoline, and it is possible that it was extruded through the filters in this state, and eventually coalesced in the flow divider inlet port. Smaller fragments of the silicone were found in the fuel manifold valve, beyond the flow divider, and a fuel injector valve port was partially occluded, possibly with the same material.

Disassembly of the fuel lines revealed that a clear gelatinous substance had completely blocked the fuel flow transducer inlet port (metering orifice) (Photo 1). The material was removed, and had a slimy wet texture. After one hour of exposure to air, the material had hardened and took on a texture similar to room-temperature-vulcanization (RTV) silicone. Six fragments were recovered, which, after drying for 24 hours, ranged in size from 1 to 3 mm. Further examination of the fuel manifold valve revealed a similar fragment of the material within the manifold cavity on the pre-filtered side of its screen.

Photo 1 - Fuel Flow Transducer Inlet Port

The rubber-like material was sent to the NTSB Materials Laboratory Division for analysis using a Fourier Transform Infrared spectrometer. The results revealed spectral peaks, which when evaluated, were a strong match to polydimethylsiloxane, also known as silicone.
