Aviation Investigation Final Report

Location:	Harrisville, Michigan	Accident Number:	CEN18TA374
Date & Time:	September 1, 2018, 14:00 Local	Registration:	N5321E
Aircraft:	Beech 35	Aircraft Damage:	Substantial
Defining Event:	Runway excursion	Injuries:	1 Minor, 3 None
Flight Conducted Under:	Part 91: General aviation - Personal

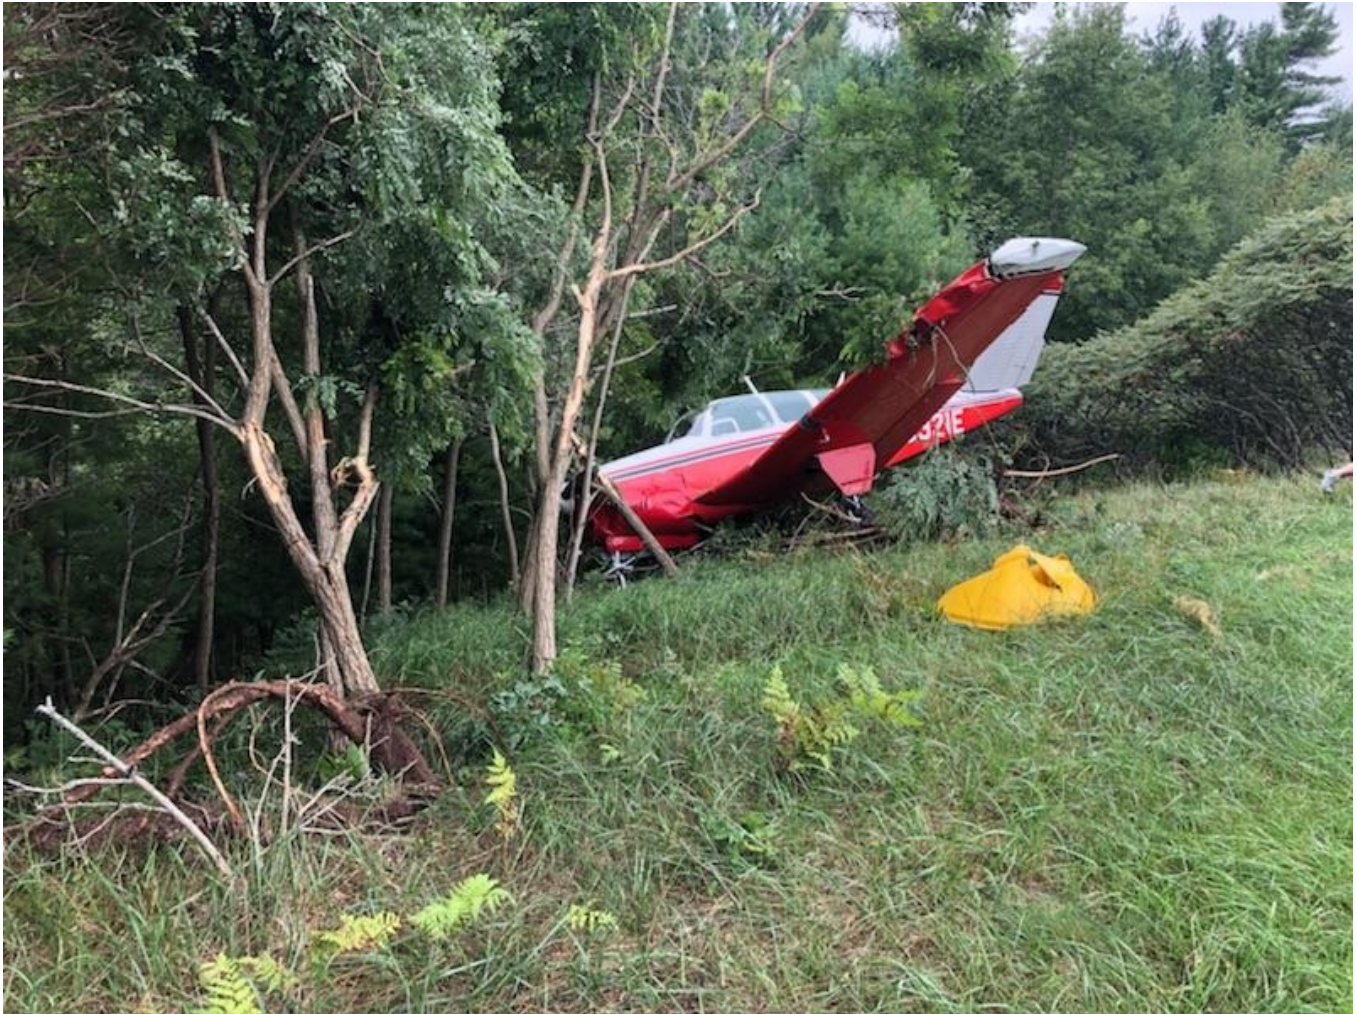
Figure 1 – Accident site (Courtesy of FAA)

The pilot's delayed decision to abort the takeoff, which resulted in the loss of lateral control of the airplane and collision with trees at the end of the runway. Contributing to the accident was the pilot's decision to depart with a center of gravity exceeding the aft limit and his inadequate preflight planning of the airplane's weight and balance calculations and runway length data.

A 32 second video of the takeoff attempt was reviewed and showed the following. As the video began the airplane was already in the takeoff roll on the grass runway that was defined by large yellow cones. At 14 seconds the airplane veered toward the left side of the runway until 22 seconds when a loud noise was heard from the end of the runway. The airplane made a sharp right turn then slid on the runway toward the trees where it came to rest (figure 1).

The deputy's photos from the accident site revealed several lopped tree limbs and tire marks in the grass beyond the left side of the runway.
