# Aviation Investigation Final Report

<b>Location:</b>	Descanso, California	<b>Accident Number:</b>	WPR18FA237
<b>Date &amp; Time:</b>	August 22, 2018, 16:15 Local	<b>Registration:</b>	N1682G
<b>Aircraft:</b>	Champion 7KCAB	<b>Aircraft Damage:</b>	Substantial
<b>Defining Event:</b>	Loss of control in flight	<b>Injuries:</b>	2 Fatal
<b>Flight Conducted Under:</b>	Part 91: General aviation - Instructional

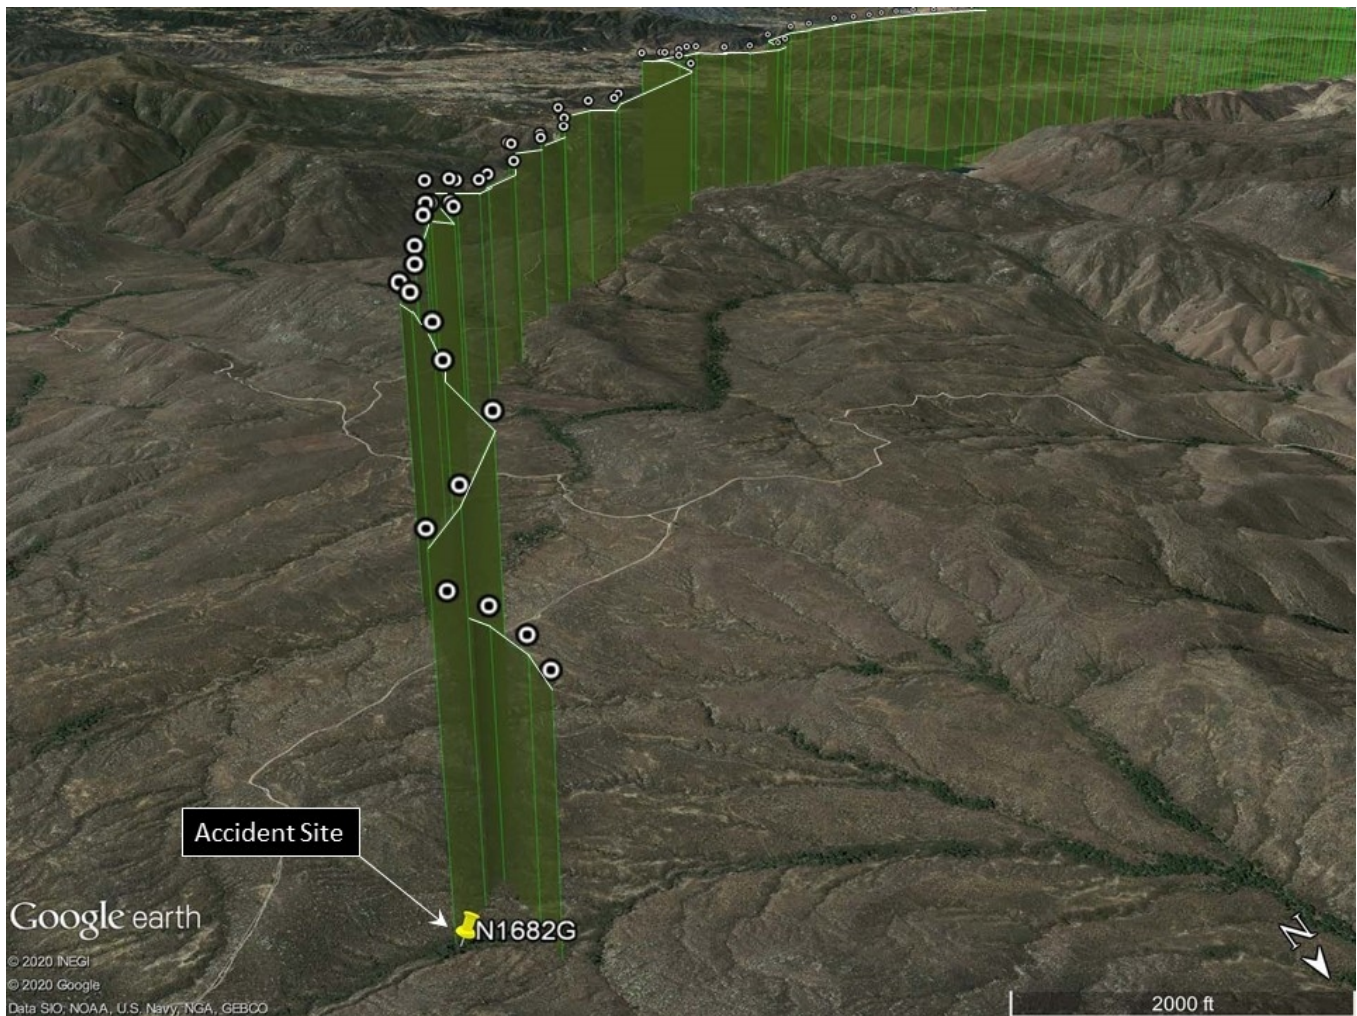
A review of radar data showed the airplane depart Gillespie Field Airport (SEE), San Diego/El Cajon, California and proceed in a northeasterly heading, climbing to about 3,200 ft above ground level (agl) across rising terrain. About 15 minutes into the flight, the radar data showed the airplane in a slight left turn at about 2,400 ft agl then enter a right 360<sup>o</sup> decreasing turn before dropping off radar. The last radar hit was about 1,500 ft above the accident site. (See Figure 1)

Figure 1-Radar flight track and accident site.

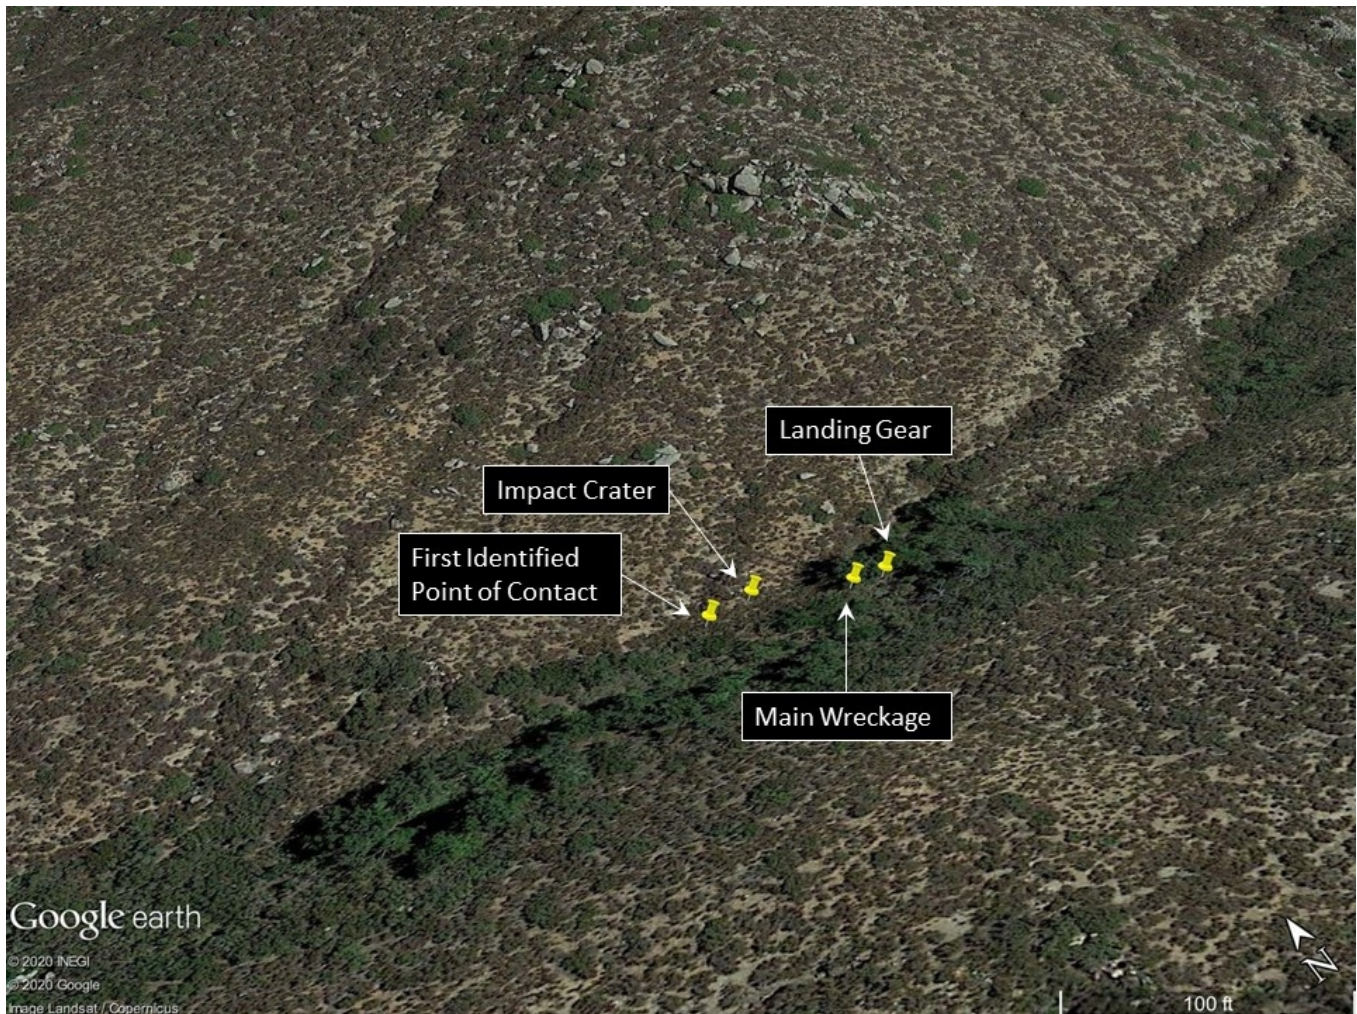
The airplane came to rest in a wooded ravine, which had an elevation of 2,585 ft msl and was situated within a mountainous area. The main wreckage was contained within a debris field about 120 ft in length and about 20 ft wide on a directional heading of 112° magnetic. The debris field was level compared to the surrounding terrain that was increasing in elevation to the north. (See figure 2)

Figure 2-Accident site.
