# Aviation Investigation Final Report

<b>Location:</b>	Anderson, Indiana	<b>Accident Number:</b>	CEN19FA135
<b>Date &amp; Time:</b>	May 5, 2019, 08:30 Local	<b>Registration:</b>	N999CR
<b>Aircraft:</b>	Piper PA34	<b>Aircraft Damage:</b>	Substantial
<b>Defining Event:</b>	Aerodynamic stall/spin	<b>Injuries:</b>	1 Serious
<b>Flight Conducted Under:</b>	Part 91: General aviation - Personal

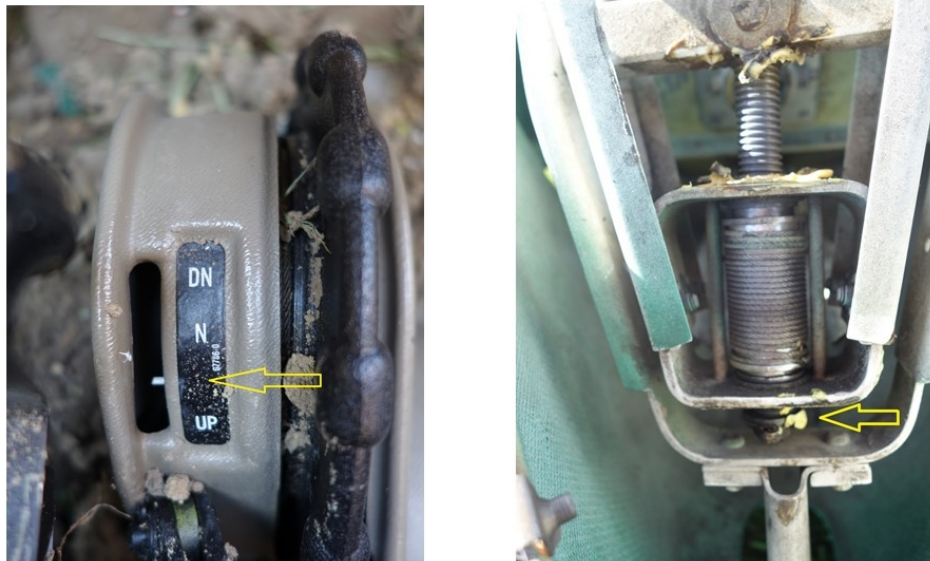
The rudder trim actuator screw corresponded to a partial tab deflection to the right (aircraft nose left) setting. The stabilator trim actuator screw was extended about 0.5 inch aft from the barrel, which corresponded to nose up trim setting and 0.05 from maximum travel. An inspection of the pilot's pitch trim indicator revealed a slight nose up indication. The examination was unable to determine if the indicator was mis-rigged or damaged during the accident sequence.

Figure 1: {left} Pilot's pitch trim indication and {right} pitch trim actuator Photos - Piper Aircraft Company

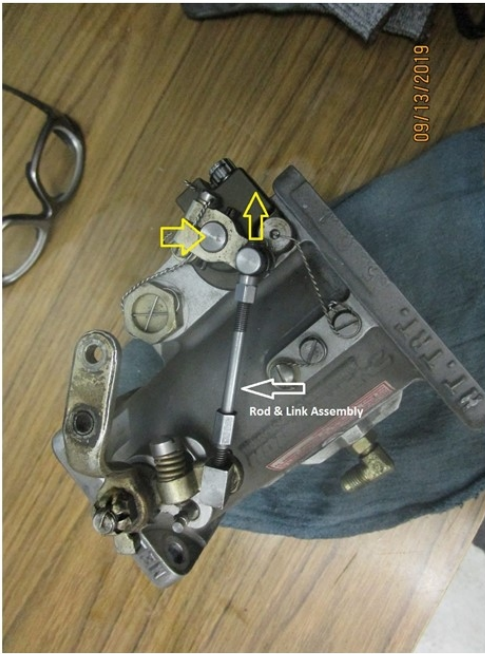
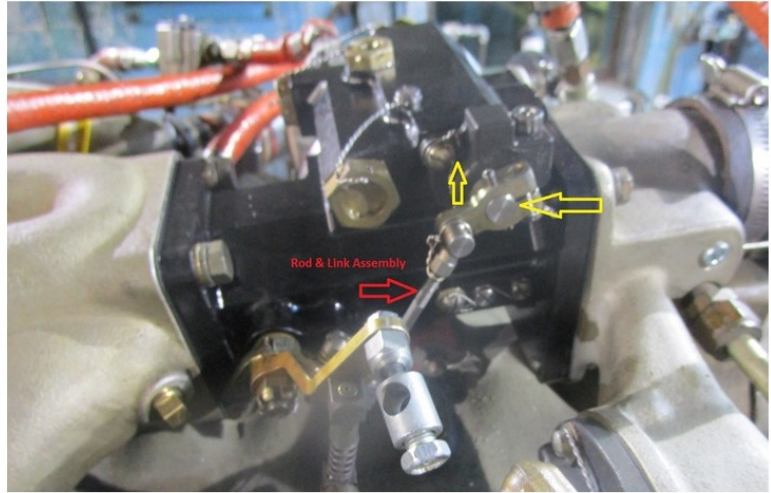
The loss of left engine power due to an incorrectly adjusted fuel servo and the airplane's nose up trim which resulted in the airplane steep climb, loss of airspeed, and aerodynamic stall and subsequent impact with terrain.

The NTSB IIC and technical representative from the engine manufacturer conducted the test. The left engine was functionally tested in a test cell. In order to run the engine, several damaged items had to be replaced or repaired, including: engine mounts, oil cooler, No. 6 valve cover, No. 6 ignition lead was repaired, and the left magneto was retimed from 50° before top dead center (BTDC) to match the right magneto at 26° BTDC. A test propeller, exhaust system, and waste gate controller were also installed for the engine run. The engine was started. The engine did not produce full rated horsepower and on occasions produced black exhaust. An exemplar fuel servo was installed on the engine and adjusted; the engine was able to produce rated horsepower. The engine's original fuel servo was examined, and it was found that the fuel servo's control linkage (rod and link assembly) was installed incorrectly.

Figure 1: {left} fuel servo on accident airplane and {right} exemplar servo. Yellow arrows point in the direction that the shaft would rotate.
