Aviation Investigation Final Report

Location:	Sutter, California	Accident Number:	WPR19LA137
Date & Time:	May 5, 2019, 10:06 Local	Registration:	N3630D
Aircraft:	Grumman G164	Aircraft Damage:	Substantial
Defining Event:	Powerplant sys/comp malf/fail	Injuries:	1 None
Flight Conducted Under:	Part 137: Agricultural

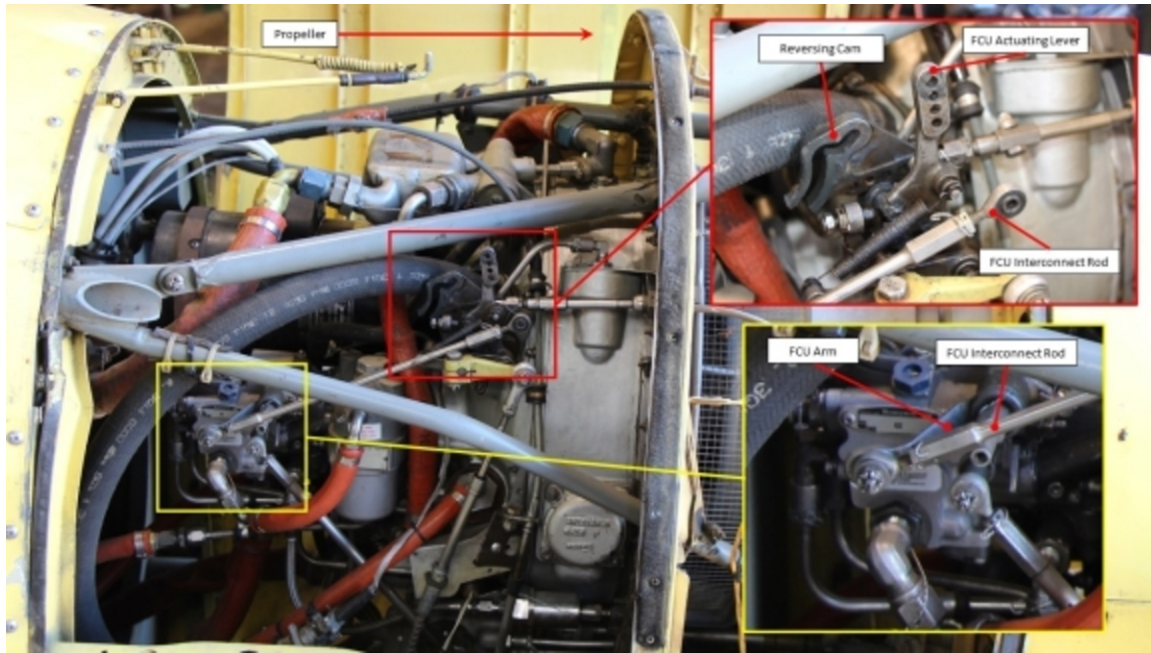
Figure 1: Fuel control unit connections

Examination of the airplane found that an interconnect linkage between the fuel control unit (FCU) and propeller governor had separated from its mount and the bolt, nut, spacer and cotter pin normally used to secure the FCU interconnect rod to the FCU actuating lever were missing. Additionally, the cam designed to adjust the FCU and propeller governor conditions simultaneously through cockpit control inputs had fractured. This fracture was the result of overstress and likely occurred after the interconnect linkage separated.

A detailed examination of the engine supervised by the National Transportation Safety Board (NTSB) investigator-in-charge revealed that the fuel control unit (FCU) interconnect rod was disconnected at the FCU actuating lever and the connection hardware was not recovered. The examination further showed that the reversing cam had fractured. The engine did not display any preimpact mechanical anomalies.

During engine operation, a reversing cam and FCU actuating lever coordinate inputs from the three cockpit controls with the FCU and propeller governor. The FCU interconnect rod joins the FCU to the propeller governor through the actuating lever and reversing cam (see figure 1). According to the engine

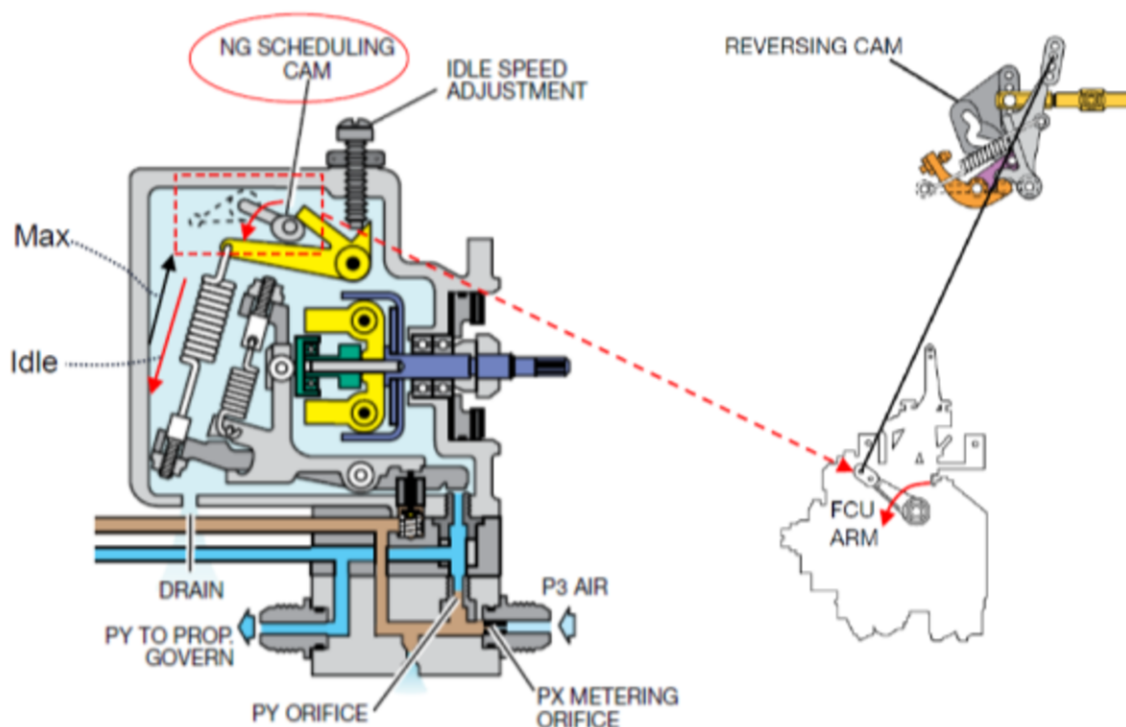
Figure 2: Fuel Control Unit Schematic

Based on the design of the FCU, it is likely that the loss of power occurred when the FCU interconnect linkage disconnected in flight, which caused the FCU to revert to its idle power condition. The engine examination revealed no further anomalies, and the pilot reported that the engine continued to function on idle power after the airplane came to rest. As maintenance records indicated that the FCU intermediate linkage had recently been removed, it is likely that maintenance personnel disconnected the interconnect rod for easier access to the FCU. However, as the securing hardware was not recovered, the actual circumstances that led to the separation of the bolt, nut, and washer from the FCU could not be determined.

manufacturer, if the interconnect is disconnected during flight, the FCU arm, which moves the spring-loaded compressor speed scheduling cam within the FCU, will rotate counterclockwise under spring tension and bring the operating condition of the FCU back to idle power automatically (see figure 2). The FCU arm will remain at idle as long as the interconnect rod is separated. A bolt, nut, spacer, and cotter pin are normally used to secure the FCU interconnect rod to the FCU actuating lever.
