Aviation Investigation Final Report

Location:	Myrtle Beach, South Carolina	Accident Number:	ERA19LA043
Date & Time:	November 12, 2018, 14:15 Local	Registration:	N840JC
Aircraft:	Aero Commander 690	Aircraft Damage:	Substantial
Defining Event:	Turbulence encounter	Injuries:	1 Serious
Flight Conducted Under:	Part 91: General aviation - Personal

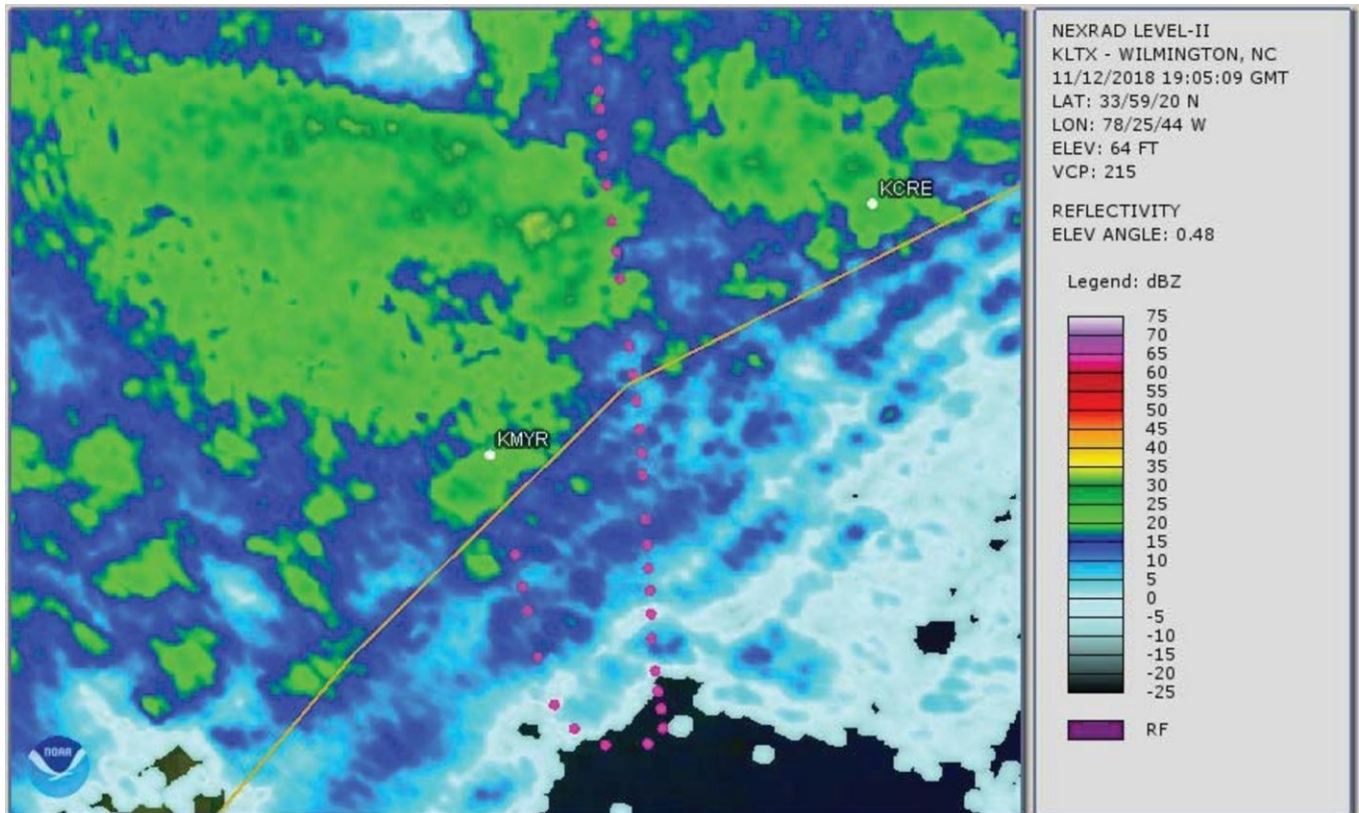
Figure -Base reflectivity image with flight track overlay

The following figure shows the accident airplane's flight track overlaid on base reflectivity radar imagery. The flight track showed the last radar target at 650 ft mean sea level near the accident site. Echoes of 5 to 15 dBZ extended over the flight track and accident site. No strong reflectivity echoes or gradients were noted over or in the vicinity of the accident site to indicate any thunderstorms and the radial velocity data did not detect any divergent couplets typically associated with microbursts.
