Aviation Investigation Final Report

Location:	Chugiak, Alaska	Accident Number:	ANC17LA028
Date & Time:	June 5, 2017, 18:00 Local	Registration:	N35700
Aircraft:	Cessna 172	Aircraft Damage:	Substantial
Defining Event:	Fuel related	Injuries:	2 Minor
Flight Conducted Under:	Part 91: General aviation - Personal

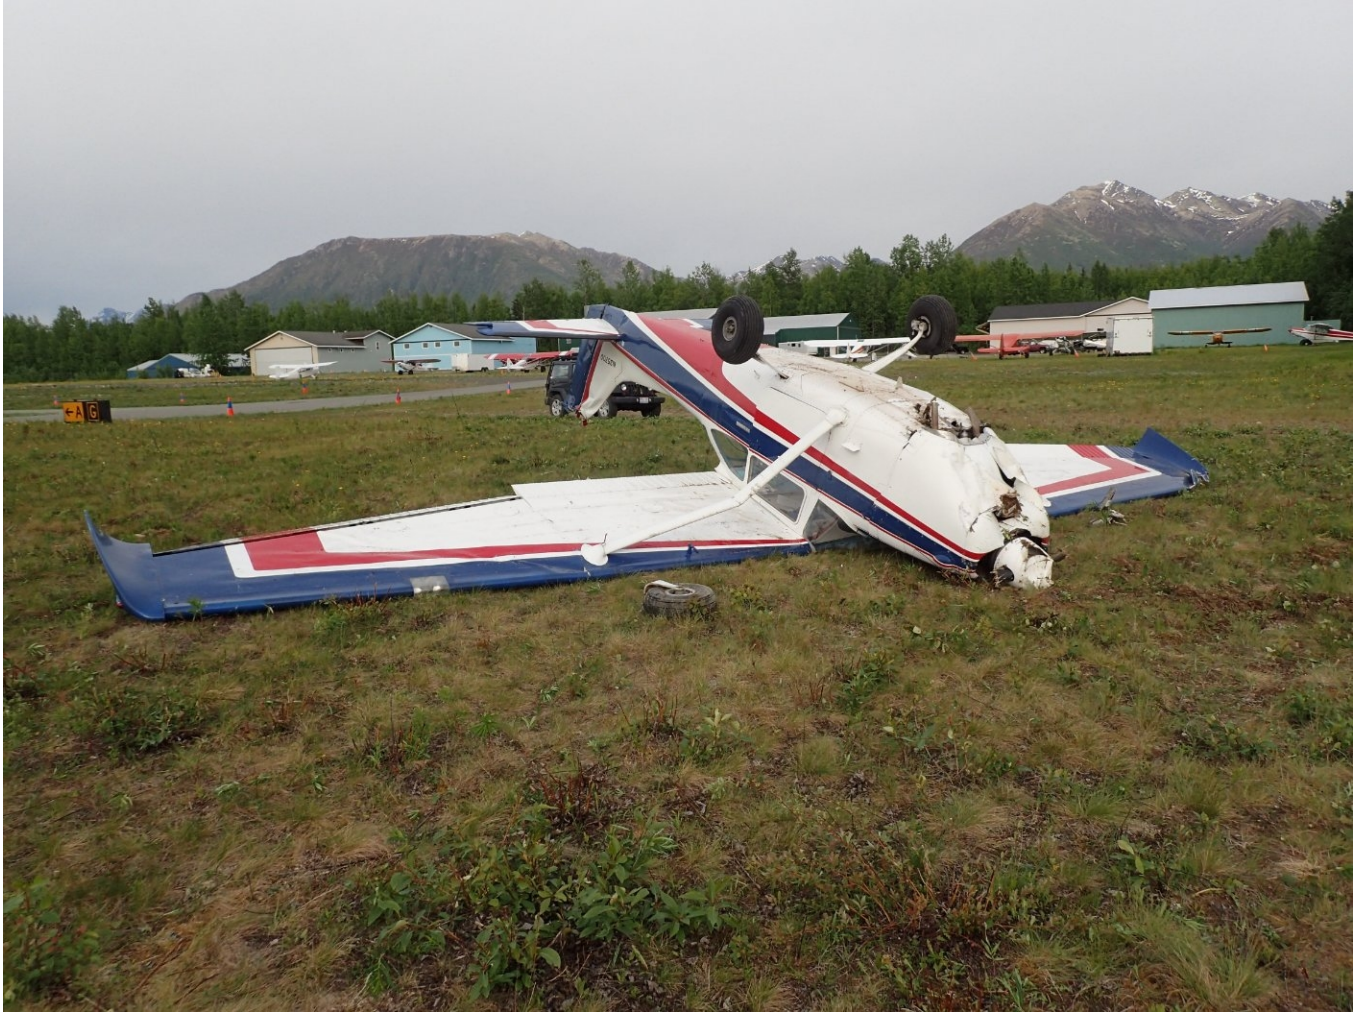
The pilot attempted to conduct a forced landing at the nearest airport and maneuvered the airplane for a landing to runway 02L at BCV. Subsequently, the airplane touched down short of the runway in a flat open field about 20 ft south of the airport. During the landing roll, the airplane impacted the airport perimeter chain-link fence, the nose wheel separated, the propeller impacted terrain, and the airplane came to rest inverted in the grass, about 150 ft to the southeast of the threshold of runway 02L as shown below in figure 1. The airplane sustained substantial damage to both wings, the fuselage, and the empennage. The two occupants egressed from the inverted airplane without further incident.

Figure 1 – View of the inverted airplane at BCV (courtesy of the NTSB).

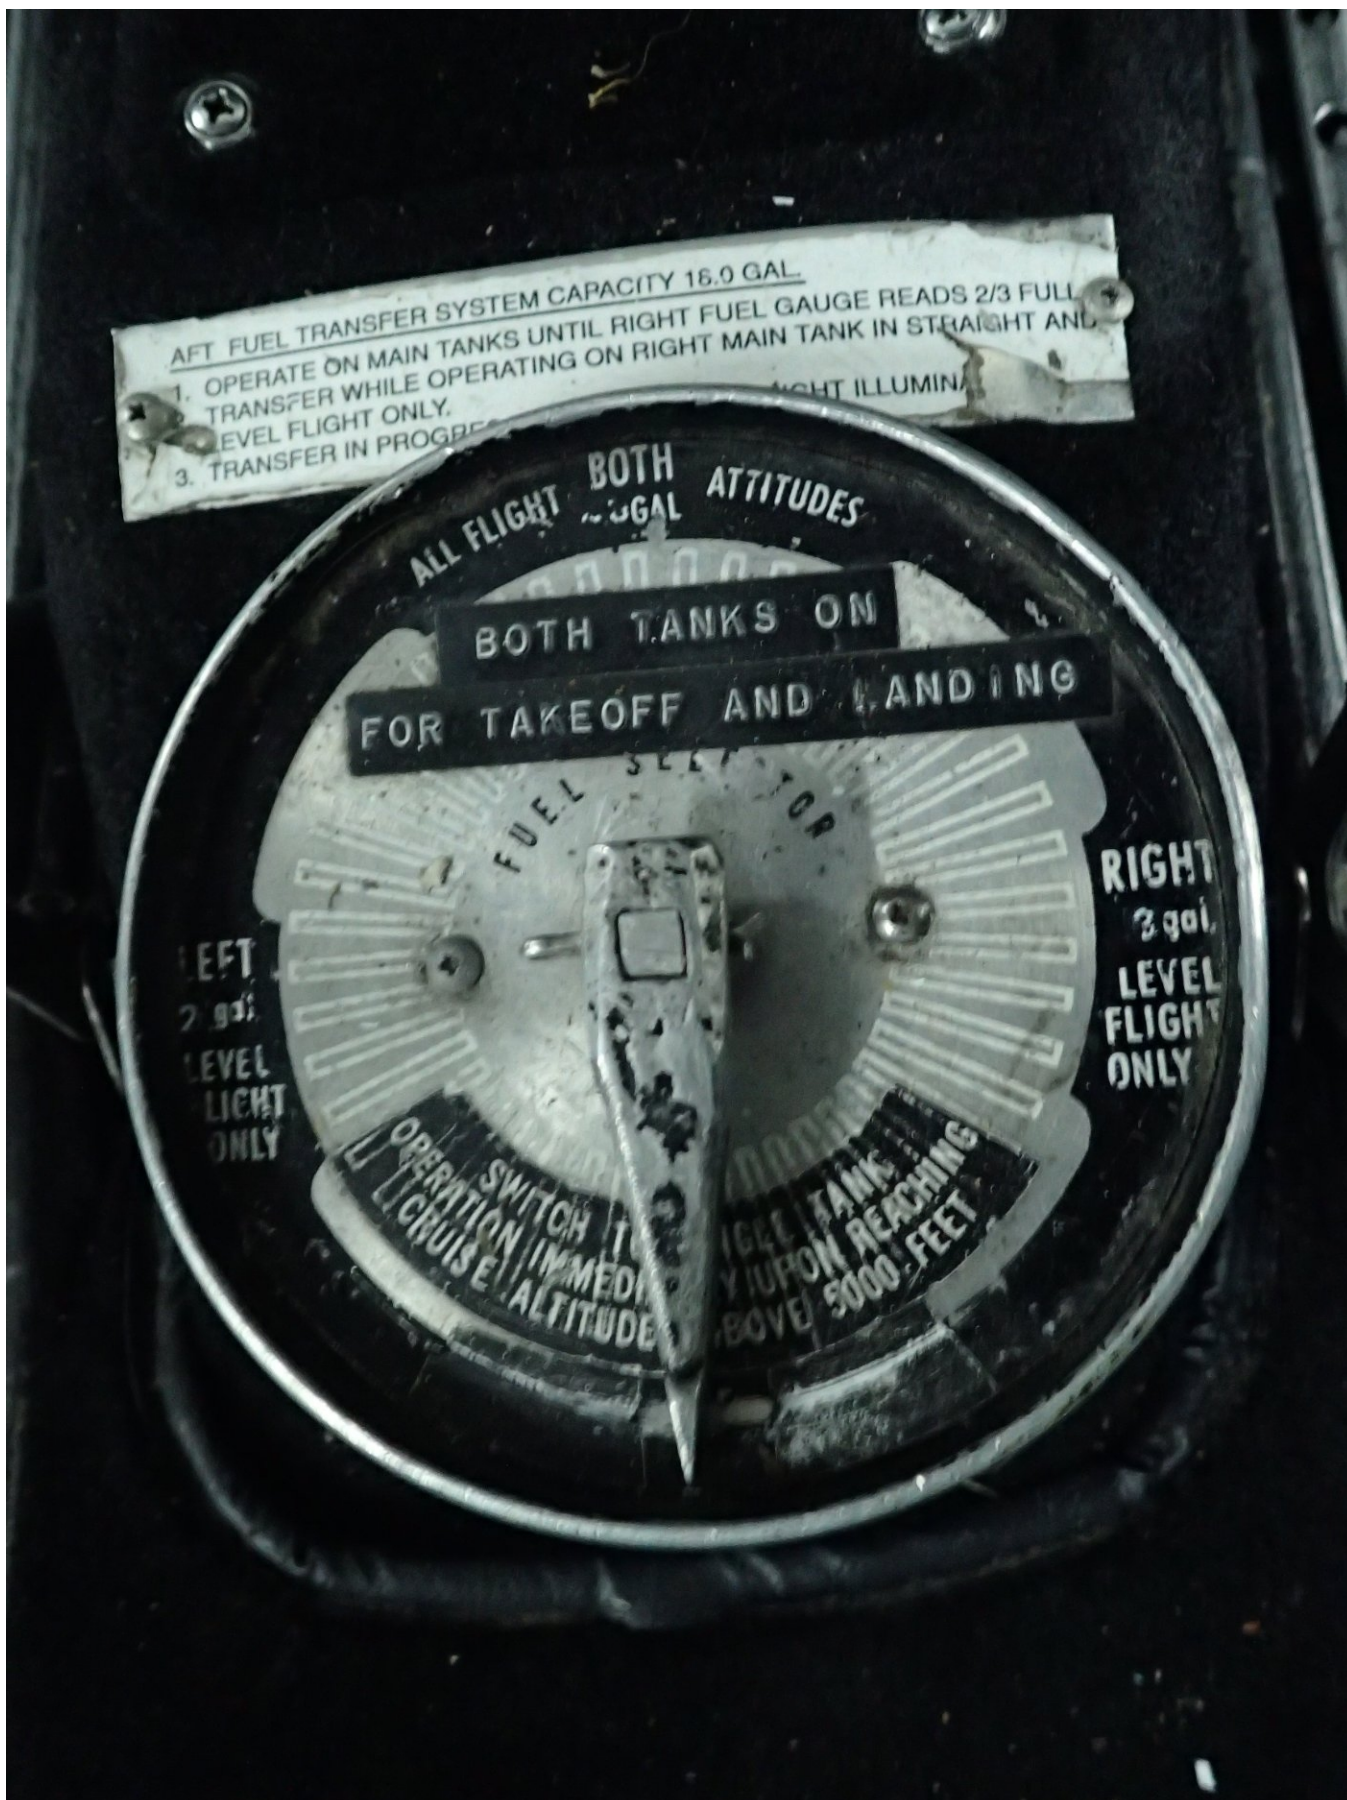
The fuel selector valve, as shown below in figure 2, was examined and manipulated freely to all four positions (left tank, right tank, both tanks, and off) with no issues noted. Heavy usage marks were observed on the valve, which was intact and connected to the system via a split pin. The placard on the fuel selector valve stated, "Switch to single tank operation immediately upon reaching cruise altitude above 5,000 feet."

Figure 2 – Fuel selector valve (courtesy of the NTSB).

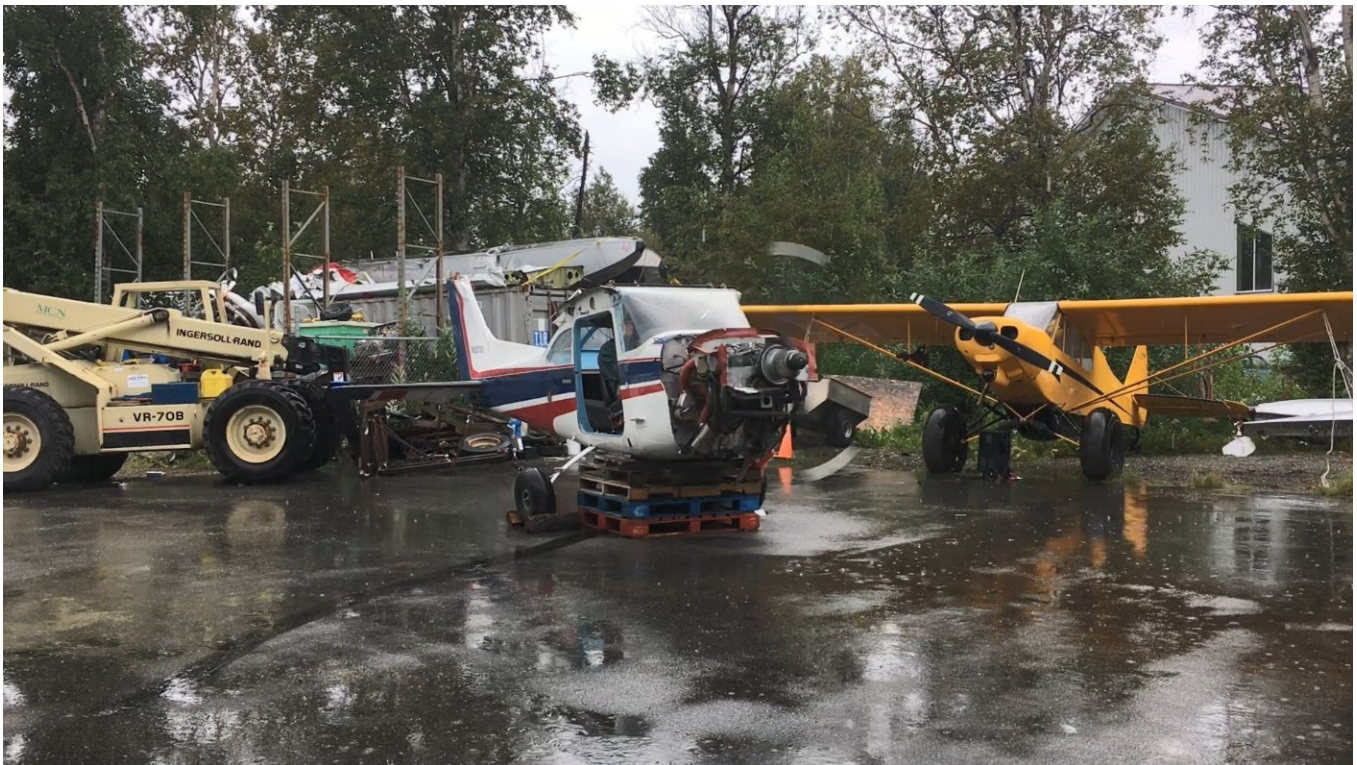
The engine was functionally tested on the airframe as shown below in figure 3. A fuel can, containing about 2 gallons of fuel that had been recovered from the wing tanks, was plumbed directly to the boost pump. The engine was started normally and operated at idle for about 5 minutes. The throttle was advanced to 1,700 RPM and a magneto check was performed; both magnetos dropped about 100 RPM. The throttle was advanced to a higher power momentarily and then power was reduced to further stabilize the airframe. The engine was shut down by pulling the mixture lever to cutoff.

Figure 3 – View of the engine operating (courtesy of the NTSB).
