Aviation Investigation Final Report

Location:	Lopez Island, Washington	Accident Number:	WPR18FA210
Date & Time:	August 2, 2018, 17:05 Local	Registration:	N56039
Aircraft:	Mooney M20J	Aircraft Damage:	Substantial
Defining Event:	Aerodynamic stall/spin	Injuries:	2 Fatal
Flight Conducted Under:	Part 91: General aviation - Personal

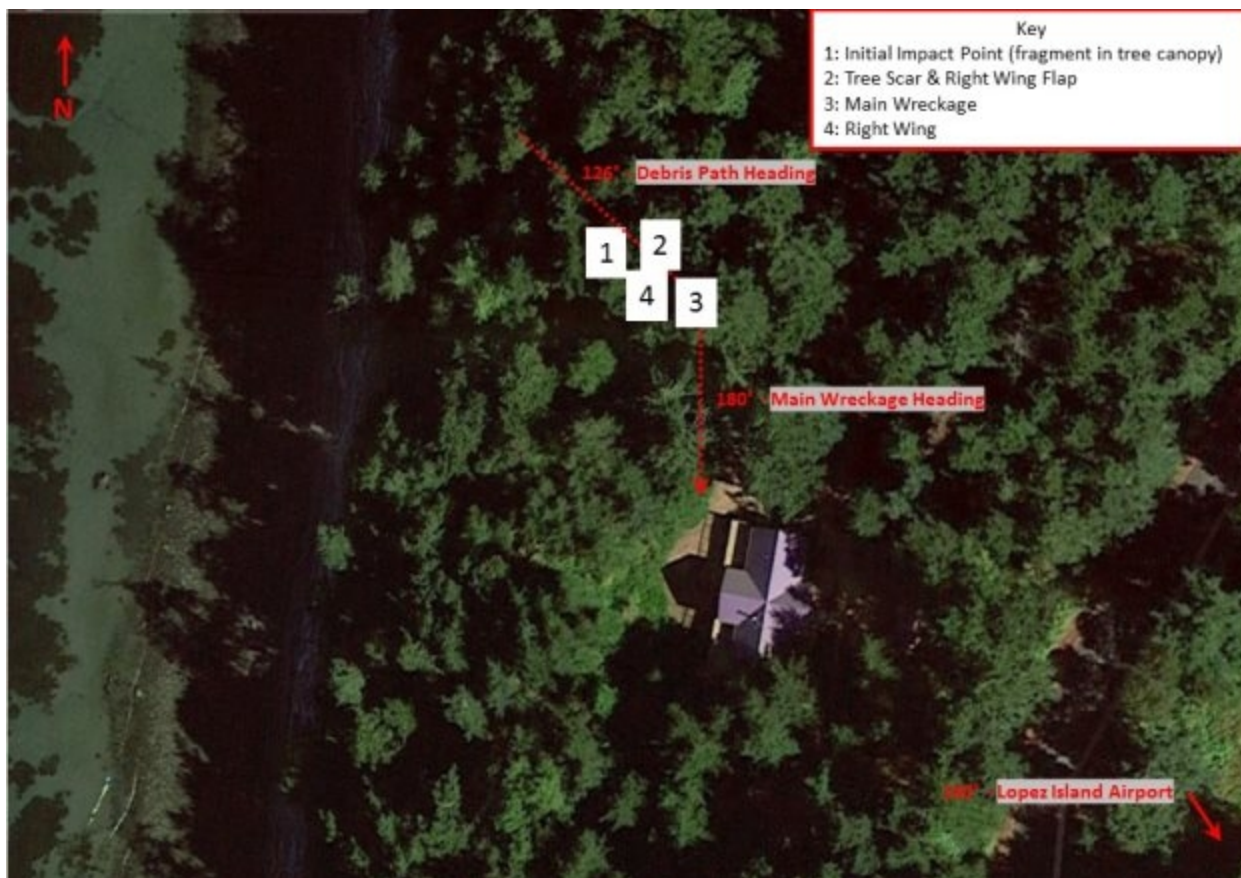
Figure 1: Wreckage Diagram

The airplane came to rest in wooded area about 400 ft from the western shore of Lopez Island and about one half nm northeast of S31. An initial impact point (IIP) was identified by an airframe fragment in the canopy of a tall tree. A tree scar that measured about 5 ft was observed about halfway up a 100-foot tall tree. The main wreckage, which comprised the empennage, left wing, right wing root, fuselage, and engine, was located a few feet forward of the scarred tree oriented on a magnetic heading of 180°, and marked the end of the debris path. The debris path was oriented on a heading of 126° magnetic and the distance between the IIP and the main wreckage was about 60 ft. The right wing separated at the wing root and was found in the debris path a few feet to the right of the main wreckage, also near the scarred tree. The inboard top skin of the right wing displayed brown and yellow transfer signatures consistent with tree contact. Both propeller blades remained attached to the propeller hub, which remained attached to the engine. Refer to Figure 1 for an illustration of the debris path.
