Aviation Investigation Final Report

Location:	Hurricane, Utah	Accident Number:	WPR19LA010
Date & Time:	October 21, 2018, 12:00 Local	Registration:	N413LL
Aircraft:	Piper PA46	Aircraft Damage:	Substantial
Defining Event:	Powerplant sys/comp malf/fail	Injuries:	2 Serious, 3 None
Flight Conducted Under:	Part 91: General aviation - Personal

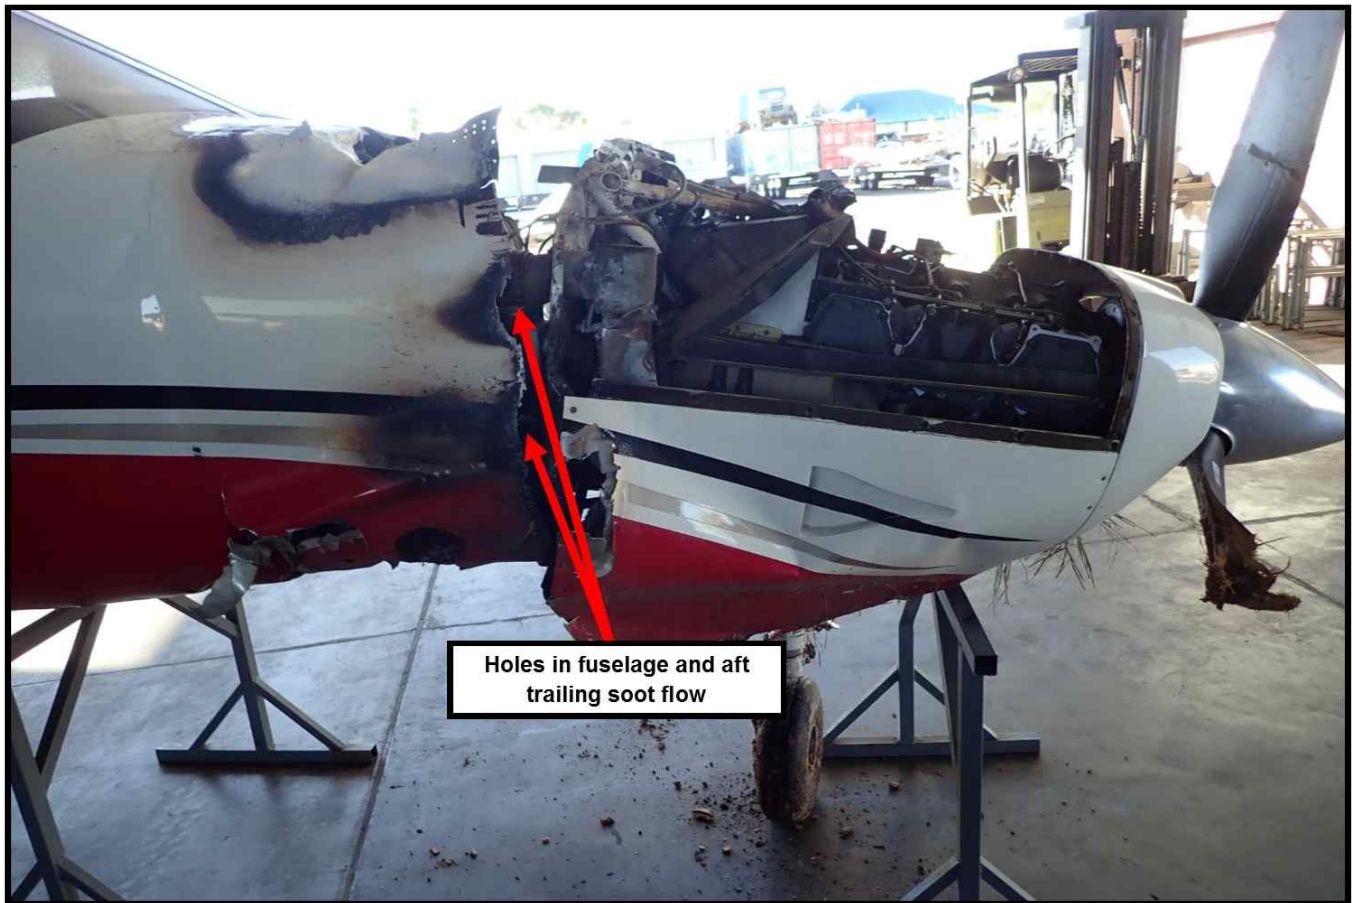
Figure 1 – Fire Damage to Right Side

The airplane sustained fire damage limited to the roof and forward end of the baggage compartment along with the engine accessory area between the firewall and aft air baffles. Soot and splatter marks trailed aft from two holes in the right side of the fuselage at the firewall (see Figure 1); in the remaining areas around the baggage compartment and windshield, soot marks were trailing upwards.

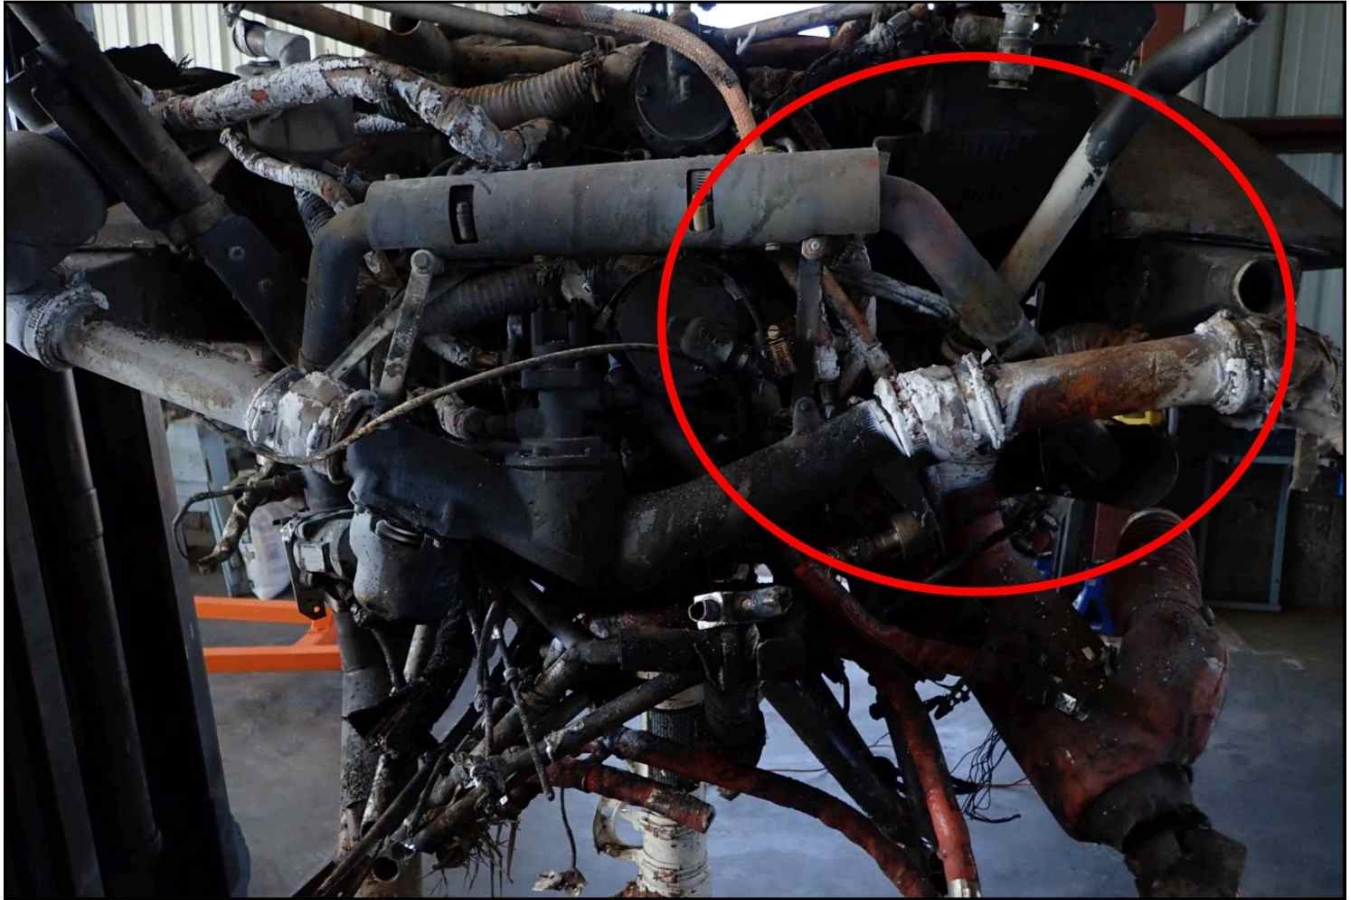
Figure 2 – Engine Accessory Area

Thermal damage was more pronounced in the accessory area on the right side of the engine, consuming the cabin climate scot tubes, vacuum lines, and the housing of the oil pressure sender. The right intercooler inlet pipe assembly, located in the same area, exhibited orange discoloration with a lateral flow pattern (see Figure 2). The firewall exhibited yellow-blue thermal discoloration to most of its surface, transitioning to orange discoloration on its upper right side (see Figure 3).

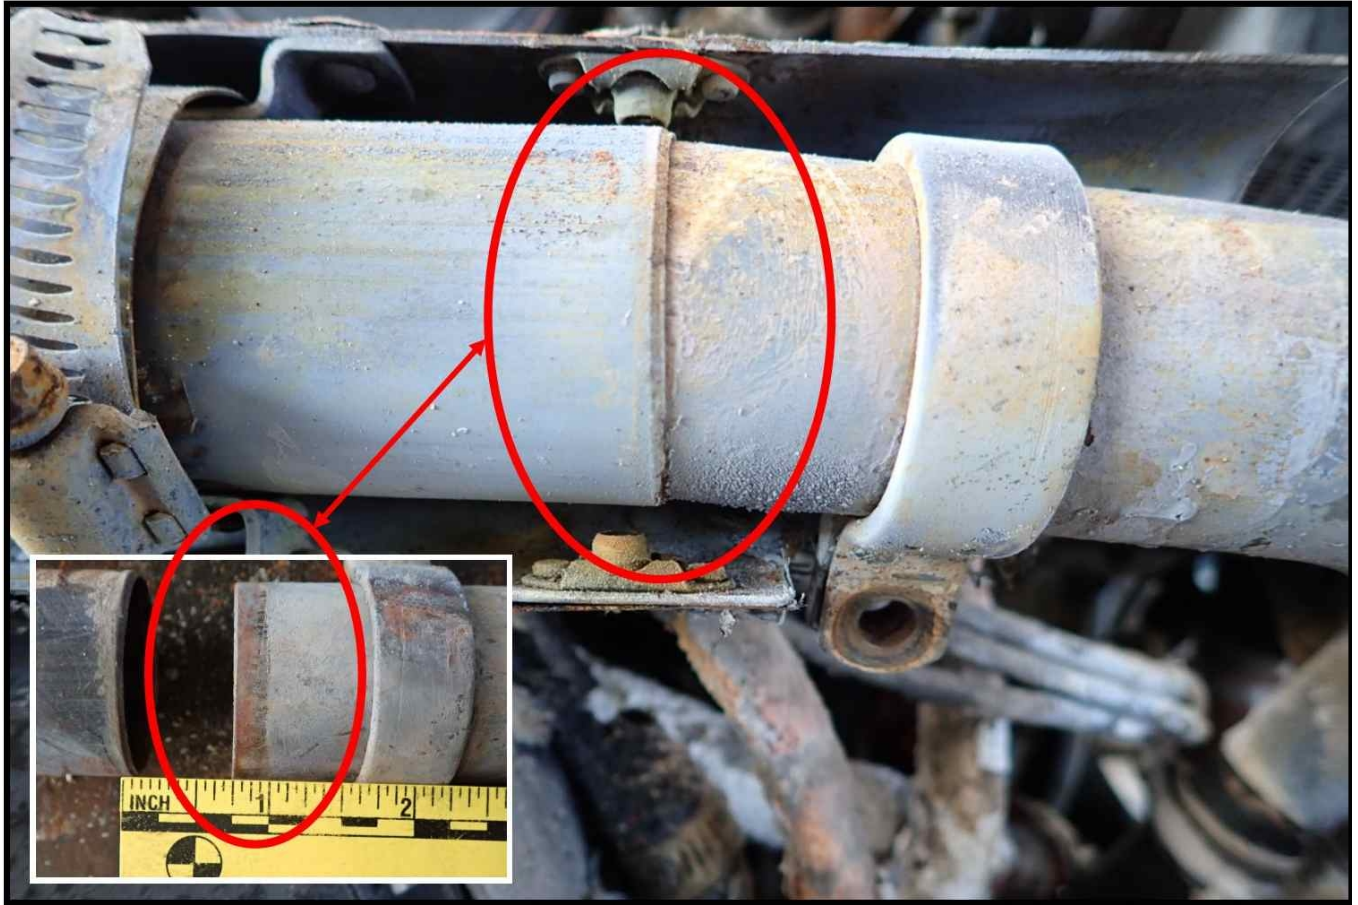
Figure 4 – Right Exhaust Crossover Slip Joint

The mechanic's failure to properly align the engine exhaust crossover pipe during replacement, and his supervisor's failure to properly inspect the installation, which resulted in an in-flight fire and the loss of engine power.

Further disassembly revealed that the exhaust crossover pipe assembly appeared misaligned at the slip joint on the right side (see Figure 4). Orange/yellow discoloration was present around the pipe joint, and similar discoloration was present on the inner surface of the heat shield adjacent to the joint. The discoloration on the heat shield appeared to show a swirling form, leading to a lateral flow pattern to the right (see Figure 5). The crossover pipe hardware and support brackets were in place and secure, and the assembly did not exhibit evidence of impact damage.

Lycoming Service Bulletin (SB) 521, issued February 1995, called for inspections of the exhaust system slip and flange joints annually or at every 250 hours of operation, whichever comes first. The SB was intended to identify misaligned exhaust components, which could ultimately lead to their failure and the escape of exhaust gases. The SB indicated that the right pipe should have been engaged at the slip joint with an overlap of 3/4-inch (see Figure 5). Examination revealed that the right pipe had about 1/16-inch engagement on its forward side, and 3/16-inch engagement on the rear (see Figure 4).

graphite marker before installation, to aid in visual confirmation that the right pipe had penetrated 3/4 inch into the sleeve of the intermediate pipe. The mechanic stated that he did not use a marker to gauge penetration, but instead utilized anti-seize compound to judge the depth by the mark the compound left behind. He stated that access to the pipes was very limited at the rear of the engine, requiring him to open the triangular baggage access panel to perform the alignment. It took him three attempts to get the pipe properly aligned, following which he secured the assembly and installed the heat shield. He stated that he had disassembled and reinstalled crossover pipes on similar PA46 airplanes twice before, about a year prior, and in his experience, they are typically hard to access and disassemble. The first time he worked on the system was with another mechanic at the maintenance facility, following which he was signed off to perform the procedure on his own.

The work was subsequently inspected by the Chief Inspector of the maintenance facility, who stated that with the heat shield in place, he was unable to confirm the pipe overlap. He stated that using anti-seize compound to gauge overlap was standard practice, and that he trusted the mechanic to perform the procedure correctly. To confirm there was no leak, he reached in through the baggage compartment access panel and pulled the tubes to confirm they were secure. He also started the engine, and again reached in through the access panel to feel and confirm there was no "blow-by" of exhaust gasses.
