# Aviation Investigation Final Report

<b>Location:</b>	Guthrie Center, Iowa	<b>Accident Number:</b>	WPR19FA022
<b>Date &amp; Time:</b>	November 9, 2018, 17:15 Local	<b>Registration:</b>	N91770
<b>Aircraft:</b>	Piper PA28	<b>Aircraft Damage:</b>	Substantial
<b>Defining Event:</b>	Powerplant sys/comp malf/fail	<b>Injuries:</b>	4 Fatal
<b>Flight Conducted Under:</b>	Part 91: General aviation - Personal

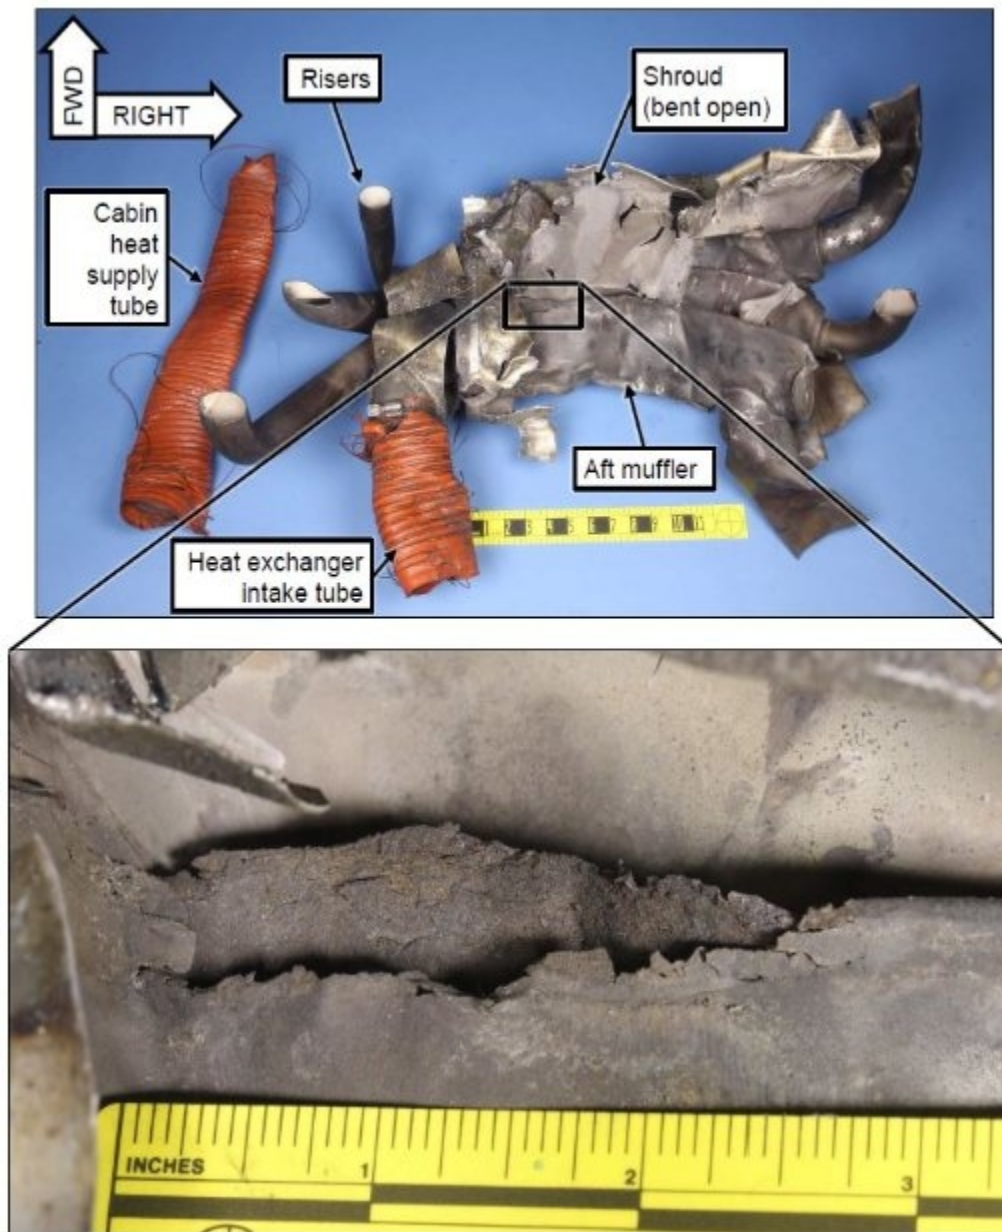
The muffler's crack developed as a result of corrosion and thinning of the muffler wall. The crack and small perforations in the muffler wall were likely present at the time of the last inspection, which occurred shortly before the accident; however, due to damage from impact, it could not be determined if the extent of cracking was readily visible at the time of inspection. Also, the crack could have opened just before the accident flight due to an engine backfire that occurred during startup.

At the upper forward side of the aft muffler, shown in Figure 2, a longitudinal crack extended 2.75 inches at the location of a longitudinal seam weld. The crack was gapped open, and portions of wall material were missing at the crack opening.

Figure 2 - Overall view of the muffler assembly with a closer view of an open crack at the upper forward side of the aft muffler (lower image)

The longitudinal crack fracture surface at the upper forward side exhibited oxidation with dark-colored deposits on the surface, consistent with a preexisting crack.

The thickness of the muffler wall adjacent to the longitudinal crack at the upper forward side was 0.018 inch, with the loosely adhering oxides and deposits removed. For comparison, the wall thickness near the middle of the muffler adjacent to the crack was 0.109 inch thick.

Use of a pressure check during an inspection could help identify cracks and small perforations that can be obscured by oxides and deposits during a visual inspection; however, the manufacturer's service manual only recommended a pressure check when a visual inspection could not be accomplished.
